Synopsis

Shortly after departure from Surjány airfield (LHSU), a Scheibe SF-25B motor glider, registered as HA-1279 lost altitude in a right turn and collided with the ground with two persons on board, both licensed pilots. The crash site is 300 meters NE of the departure runway 31.

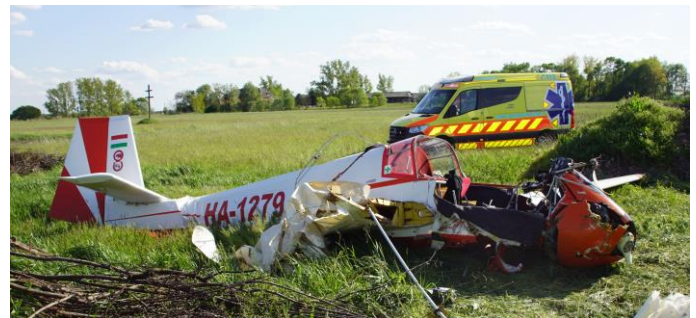
Figure 1. Aircraft Wreckage

In course of the site inspection the IC discovered the marks of the spinning propeller that shredded through the top branches of the patch of small trees short before the impact. The aircraft then hit the ground with its right wingtip first, which was caught in a pile of construction debris on the site, that spun the aircraft around. The right wing was largely destroyed on impact and absorbed a reasonable amount of the energy, thus increasing chances of survival for the occupants. The aircraft's nose came down next and further increased the spin, while the turning propeller blades shattered and the nose section with the engine separated from the fuselage. The tail section hit the ground next and the deformation of its tubular framework structure absorbed further kinetic energy. At the end of the 180-degree spin the aircraft came to rest on its belly heading NE, opposite the fly-in direction. No fire ensued, which proved indispensable for the survival of the right side occupant, who got trapped in the wreckage.

As a result of the impact and the rescue team's activity, the flight controls were damaged to such an extent that made it impossible for the IC to determine whether they had been properly functioning before the crash. However, on the basis of personal testimonies of those involved and the previous flights done that day, the IC had no reason to suspect any flight control malfunction in connection with the event.
