## Synopsis

In the course of landing on runway 30 of Győr-Pér airport, the pilot of a C-172RG light aircraft failed to extend the landing gear due to human error and landed gear up on the runway with two passengers on board. No one was injured in the occurrence. The aircraft sustained significant damage and the runway surface was slightly damaged.

| <b>Aircraft make, model and registration</b> | | Cessna 172 RG, HA-PAK | | | |

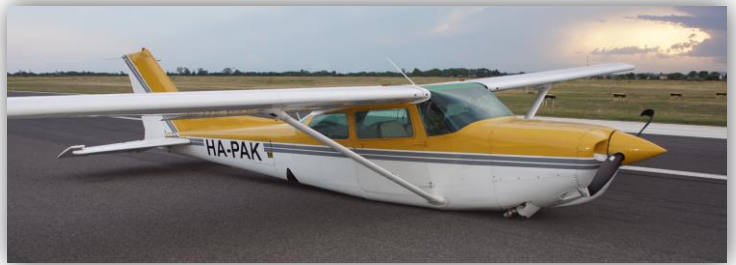
Figure 1 – The occurrence aircraft on the runway

Both propeller blades were damaged beyond repair. The underside antennas and the fuselage skin were also damaged in the skid.

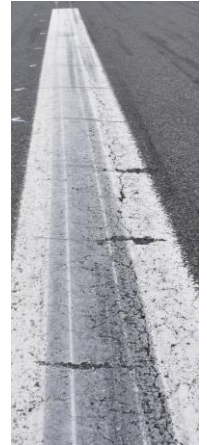
Figure 2  
Runway damage

The aluminium alloy propeller blades caused minor pitting damage to the runway surface, which the airport personnel subsequently repaired during the airport closure until the next morning hours.
