MINISTRY FOR
INNOVATION AND TECHNOLOGY
TRANSPORTATION SAFETY BUREAU

FINAL REPORT

2021-0195-4

Discus bT

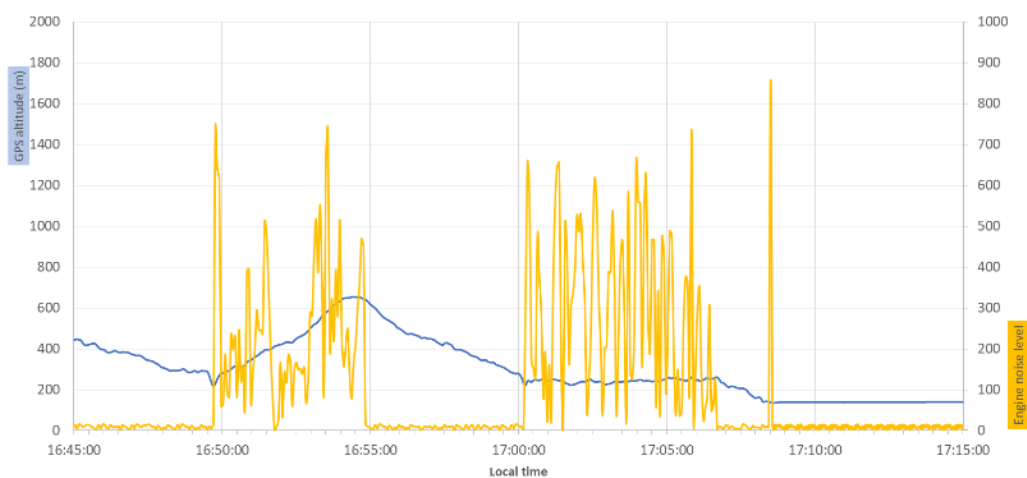
At 17:00 at 139 meters over Dunaegyháza east the Pilot started his limping engine again, only to encounter a similar loss of power following 4 to 5 seconds of normal operation. Leaving the struggling engine on, the Pilot continued heading north while hardly maintaining altitude (90-130 meters) on engine power. At 17:04:58 he reached the south-eastern limits of Apostag at 117 meters AGL, where he started spiralling left in an attempt to gain altitude. He kept on trying for nearly 3 minutes while he was continuously losing altitude and only abandoned spiralling at 28 meters AGL (*Figure 3, 1*). The Pilot then rolled out, heading for the southern edge of his intended landing stretch in crossing tailwind, while he shut down the engine and initiated the stowing sequence. At 17:08:18, reaching the end of his intended landing strip at 8 meters over the ground, the Pilot engaged in a left turn to line up for landing (*Figure 3, 2*). During the turn, at 17:08:, the aircraft hit a combine harvester at work in the field, with the landing gear snagging at the harvester's grain hold doors (*Figure 3, 3*). The aircraft then impacted the ground nose first and came to a halt across the harvester (*Figure 3, 4*).

Figure 4: Altitude and noise level data of the last 30 minutes before impact (extracted from the logger of D-KITB)

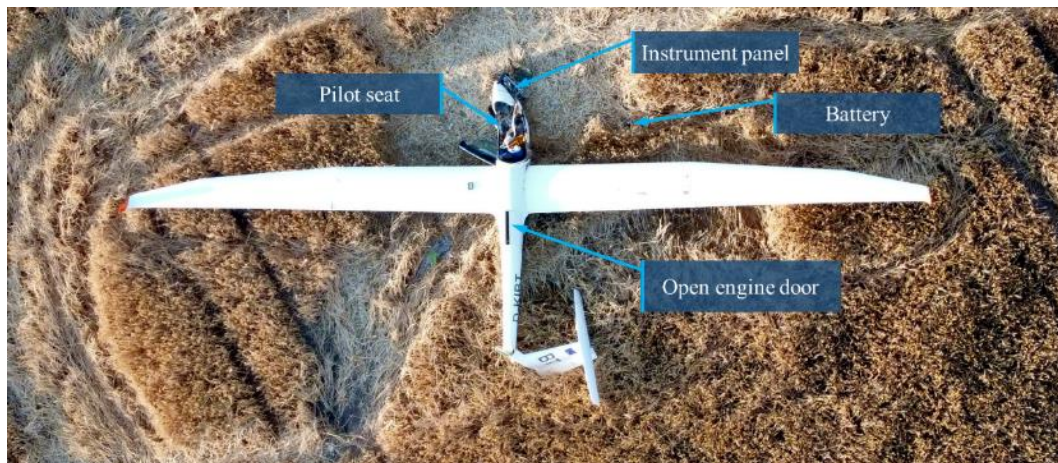
The aircraft was substantially damaged in the ground collision (*Figure 5*). Ground impact forces damaged the wings. The left wing trailing edge cracked open at about 26 cm from the root rib and there were several breaches on the wing skin around this area. The left wing's composite skin buckled and cracked over the root rib and main spar joint. The left spar stub dislocated and the left aileron's outboard section was also damaged. Scrape marks were found on the right wing's skin surface.

The nose section forward of the canopy broke off with the instrument panel expelled, ending up on the ground in front of the wreckage. The aircraft's batteries were found outside the aircraft, disconnected from the aircraft electric systems. Landing gear suspension and its immediate surrounding area also sustained heavy damage. The tail boom snapped and broke clean off with the tail assembly still holding the rudder and elevator.

Figure 5: Aircraft wreckage

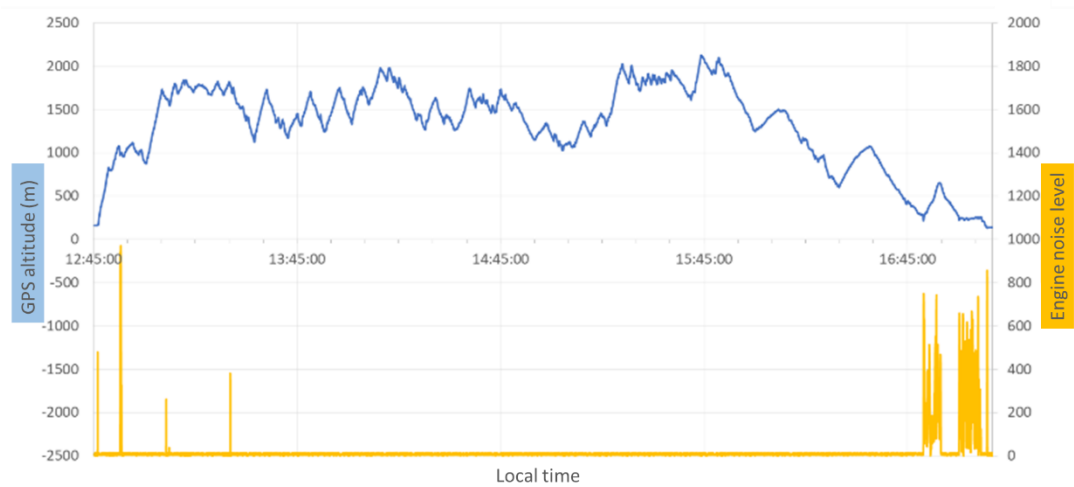
- For periods between 16:49:46 to 16:52:54 and 17:00:14 to 17:06:38 engine noise level was significantly lower than regular.

Figure 7: Altitude and noise level data for 3 July, as extracted from D-KITB's logger

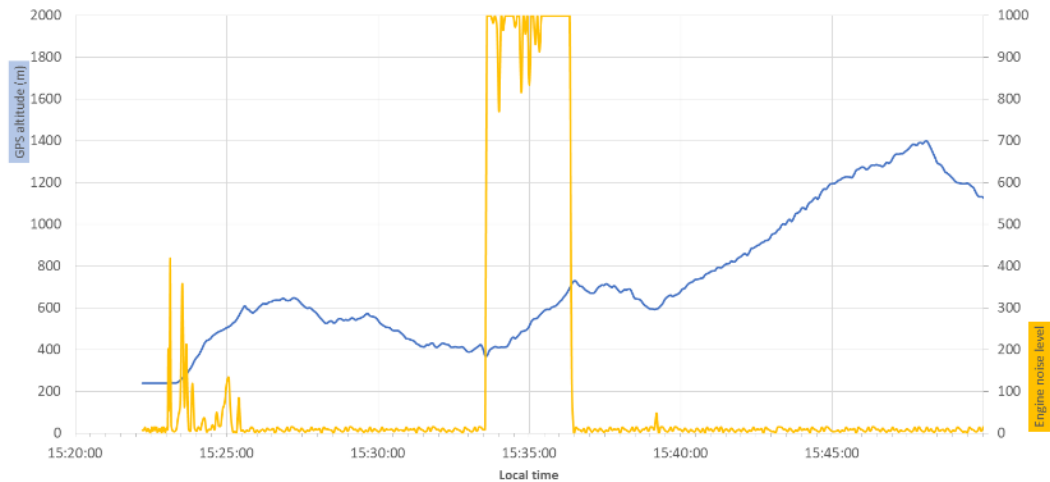
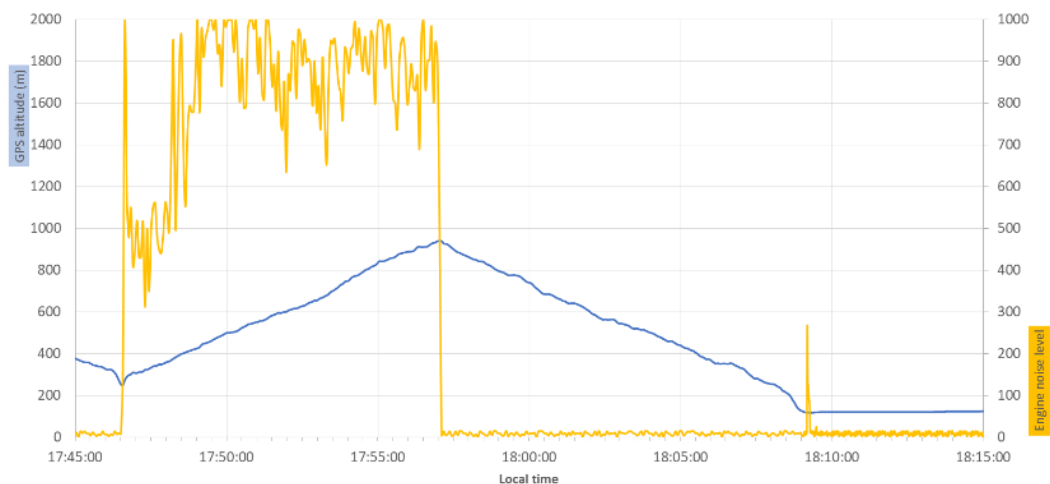
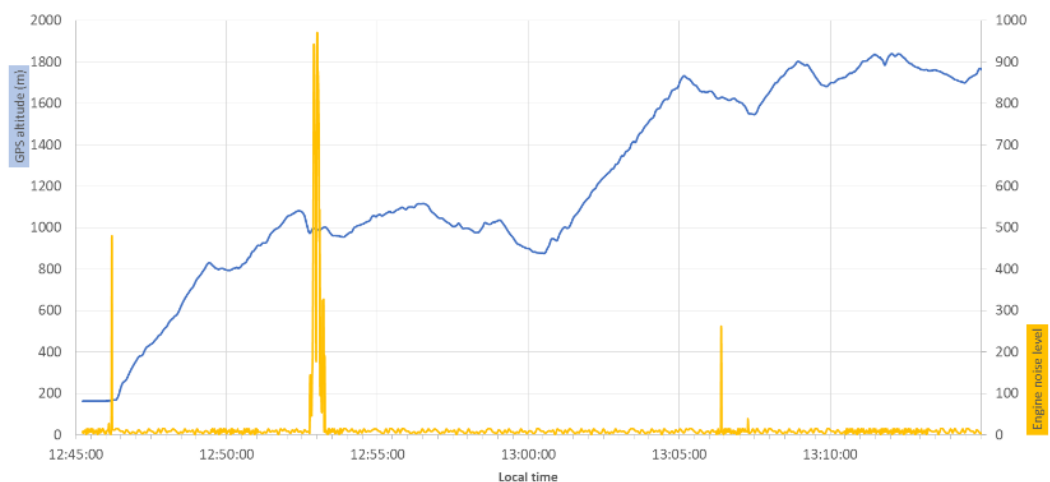
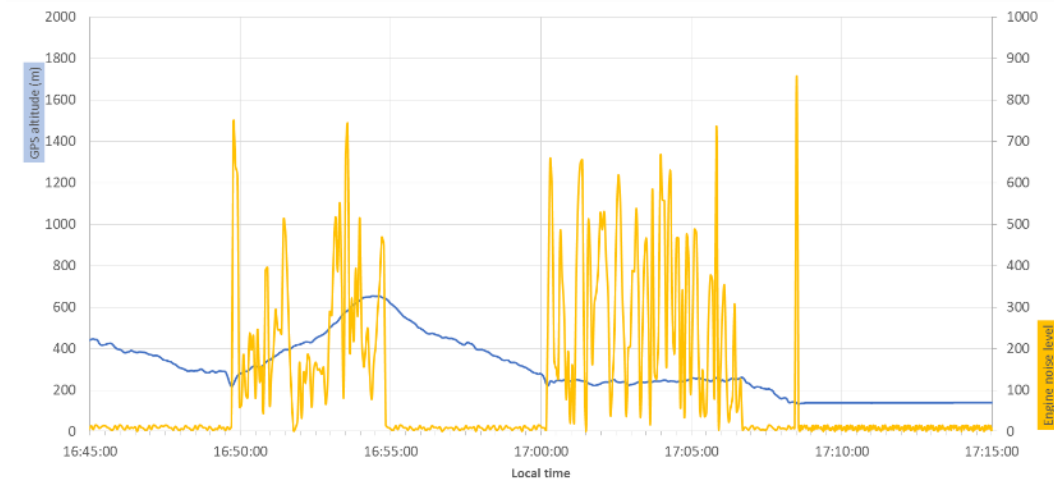
The IC examined previous logger data (*Figure 8**Figure 11*) and found 5 flights of 2021, about 13 hours in total, that the Pilot did not account for in his written statement. In this statement the Pilot also said to have only used the sustainer engine since the 5-year maintenance in 2021 for engine sound stamp registration.

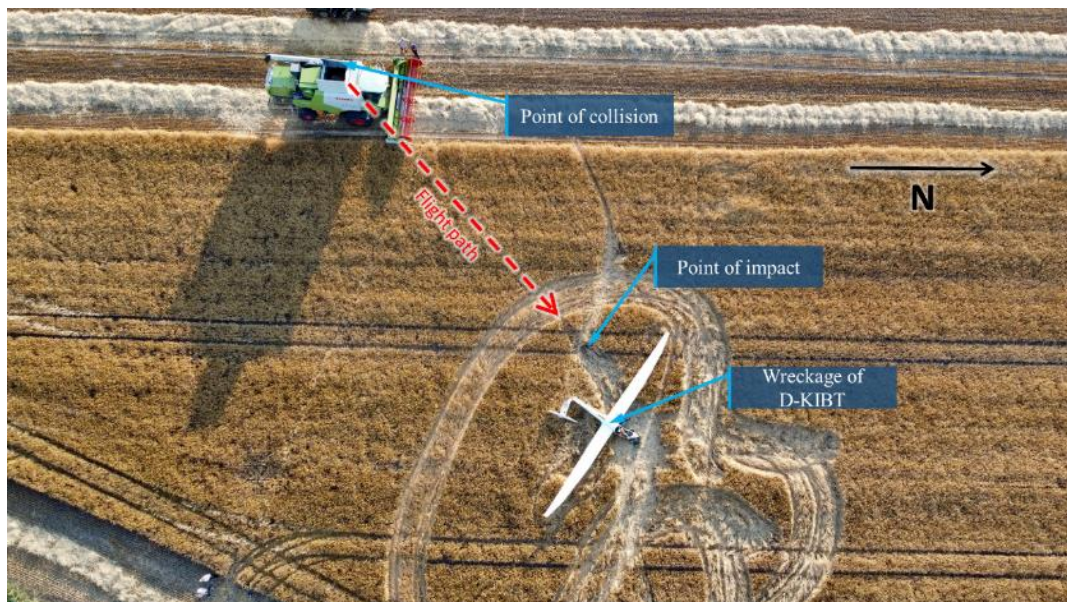
The accident took place in the southern part of a fairly smooth plough field of about 25 hectares, with furrows running more or less north to south. It is bordered by roads 51 and 513. The impact with the harvester was recorded at 46.873200°, 18.977267°, the aircraft hit the ground 25.4 m northeast at 46.873350°, 18.977517°, coming to rest after a 5.3-meter slide (Figure 12).

The IC found the fuel cock open and the landing gear extended. The sustainer engine was not fully retracted in the hull and the engine bay doors were found ajar with the propeller blade tips outside the fuselage.

Figure 12: Crash site

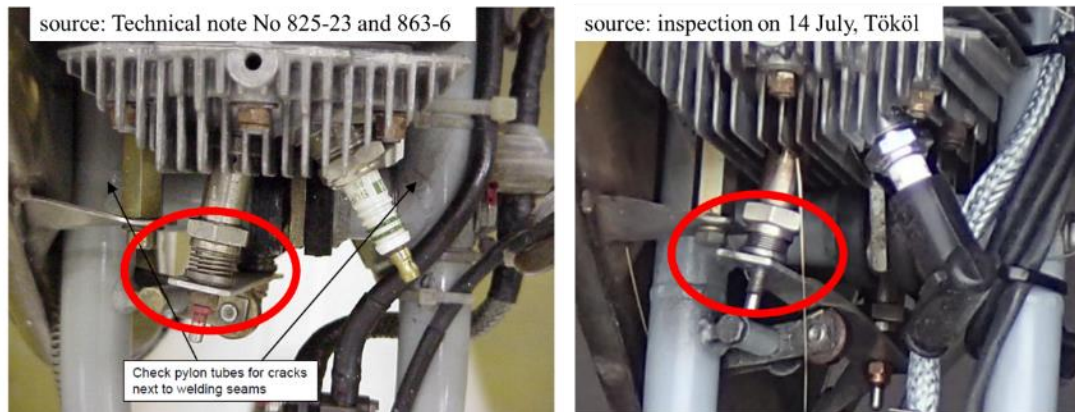
On removal of the engine it became apparent that the locking nut on the front decompression valve was missing and the decompression valve on the rear cylinder had run loose. The valve stem threads were intact on both valves, the rear valve could be tightened. No damage was found on the valve sealing surfaces. The spark plug in the rear cylinder was partially fouled, indicative of insufficient fuel burn. Spark testing this plug still yielded a passing result.

It was determined during the supplementary site inspection that engine power loss was caused by the loosening of the compression release valve (1.16).

The IC assessed previous flight data preserved in the logger memory (1.11) and analysed engine noise level signals. These data show that from 29 March 2020 onward there is a distinct dropping tendency in engine noise levels. The IC opines a direct relation between engine noise level and performance, and the analysed data show a continuously decreasing engine noise throughout the examined period. The IC believes that a properly performed daily inspection any time during the period in question, done as described in and mandated by the AFM (1.18.6), would have revealed the engine issues early enough through the discovery of the missing locking nut, and the unusual status of the spring and spring plate as shown in *Figure 16*.

Figure 16: The missing decompressor valve nut

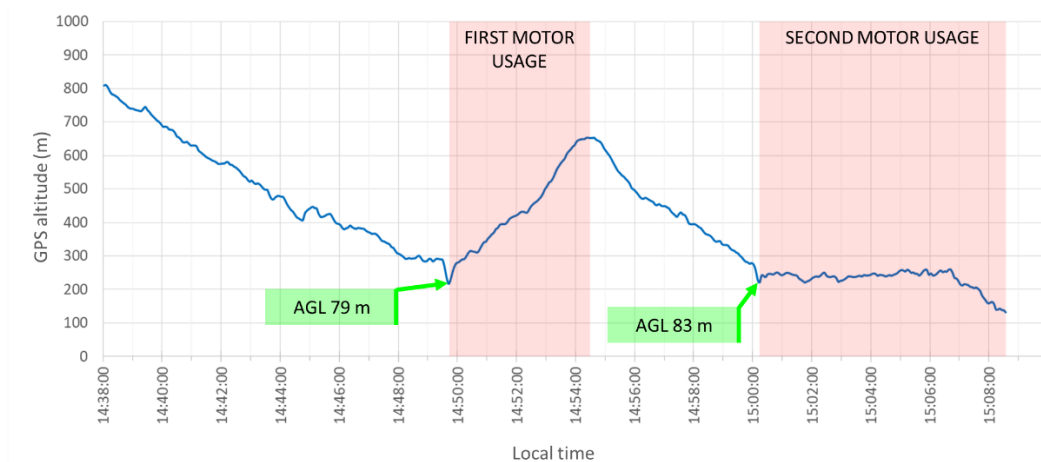
Figure 17: Altitude information for D-KIBT with highlighted motor usage information

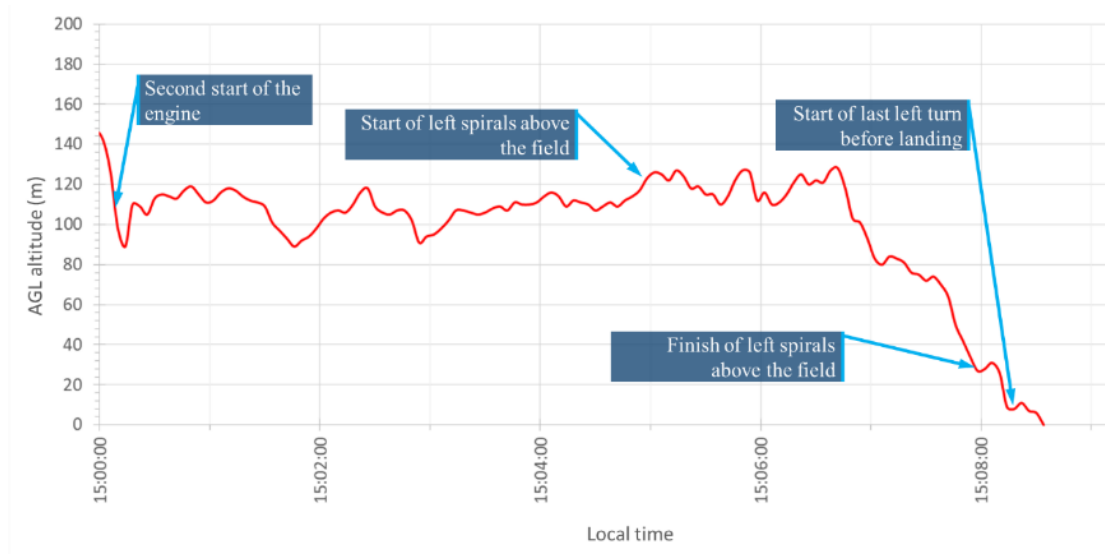
While in the AFL engine deployment is not recommended below 300 m AGL, preceding the event the Pilot first deployed the aircraft’s engine 3 km north of Harta at 128 m AGL and started climb on engine power from approx. 80 m AGL (Figure 17). In 4 minutes after engine start a loss of power occurred, so the Pilot shut down and retracted the engine at 500 m AGL. This altitude would have given him sufficient time and latitude to pick a suitable landing spot, line up and land safely, never having to use the engine again. The Pilot despite opted for continuing gliding northbound. At 17:00, 3 km east of Dunaegyháza at 139 m AGL he extended the engine again and started it up. As he recalls, after a few seconds of normal the engine lost power again. On his limited power the Pilot continued level flight in a northerly direction, maintaining altitudes between 90 and 130 m AGL. 5 minutes later, reaching SE of Apostag, he started spiralling left at 120 m AGL to find lift in a thermal. His efforts to gain altitude were unsuccessful and soon enough he found himself as low as

25 m AGL overhead the accident site (*Figure 18*), in a gruelling situation where safe standard approach for landing was not achievable any more.

Figure 18: Altitude information for the last 8 minutes of the flight
