FINAL REPORT

Piper PA-34-200, HA-YCI
Békéscsaba Airport, 04 Aug 2021

Serious Incident
2021-0286-4

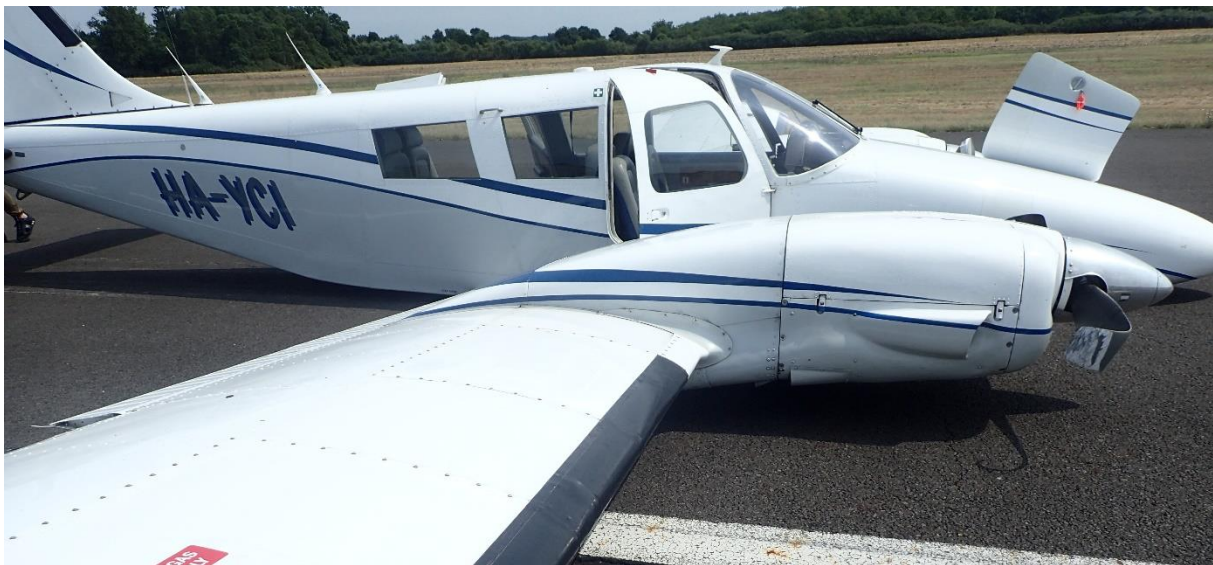
Figure 1.the aircraft after the accident

The propellers of both engines of the aircraft were damaged, the antennas located on the belly of the aircraft were broken, and the sliding plates located on this part were damaged.

While touching the ground, the still rotating propeller blades left small impact marks on the asphalt surface, which slightly damaged the surface of the asphalt runway. No other damage came to the attention of the IC.
