FINAL REPORT

MOONEY M20M, N999U

28 September 2021

2021-0436-4

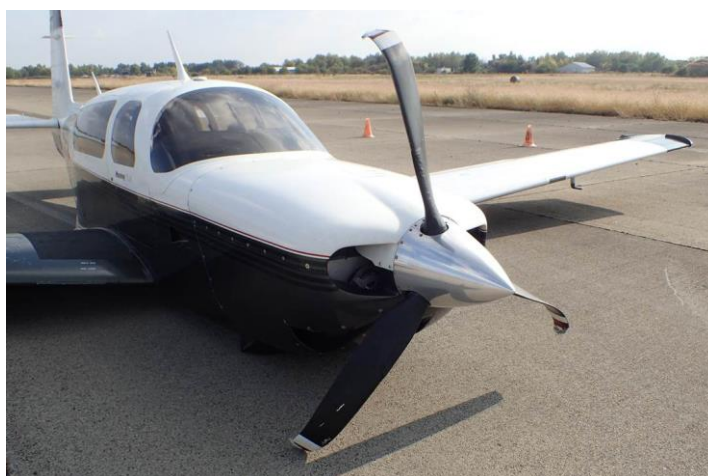
Figure 1: The aircraft after the occurrence

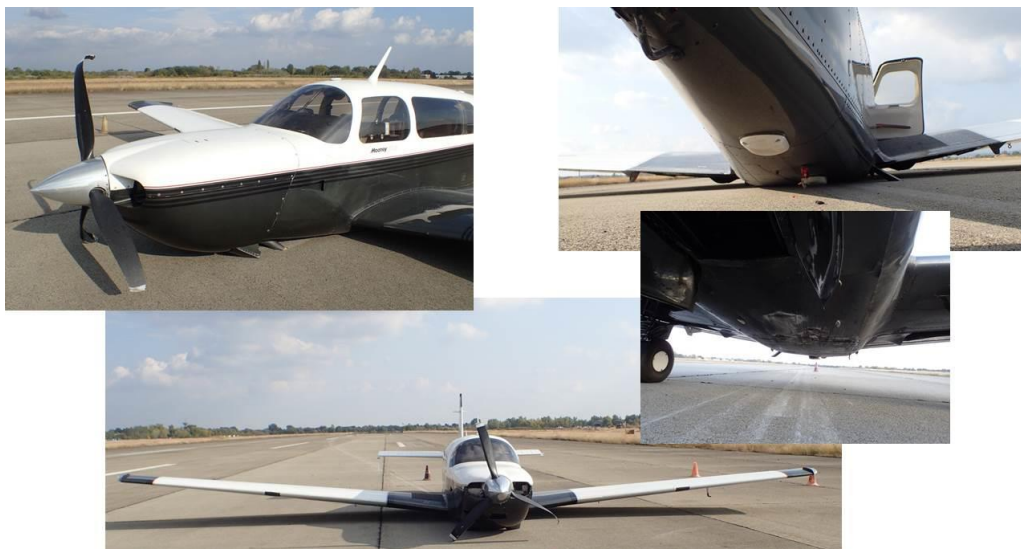
During the belly-landing, all three blades of the three-bladed propeller were bent and became deficient in material. The fixed step and the antenna on the underside of the fuselage snapped off, the underside of the fuselage was worn, and the sheet metal covering had holes in it (Figure 2).

Figure 2: Visible substantial damage to the aircraft
