Synopsis

The pilot of Grob Astir G-102 CS sailplane, registred HA-4518 arrived at Farkashegy airfield in order to practice flying. During the initial phase of the winch launch, the winch operator saw people walking towards the winch cable therefore he aborted the winch launch process. The pilot responded too late, and he was not able to accumulate sufficient speed for the landing already, which resulted in a hard landing. No one was injured in the incident, but the aircraft had minor damage.

Occurrence class:	Incident				
Date of occurrence:	12 September 2021, 12:15 LT ¹				
Location of occurrence:	Farkashegy airfield (LHFH)				
Aircraft make, model and registration:	Grob Astir CS, HA-4518				
Year of manufacture, serial number:	1976, 1269				
Purpose of flight:	Non-commercial (private, local)				
People		Crew	Passenger	Other	
	Number:	1	0	0	
	Injured:	None	-	-	
Damage to property:	Aircraft: minor 3rd party: None				
License and ratings of PIC:	SPL ²				
Age and citizenship of PIC:	17 years old, Hungarian				
Flight experience of PIC	Total	On the type	Last 90 days	Last 7 days	
	Flight hours:	82:58	21:53	19:44	0:01
	Number of take-offs:	223	22	20	1
Sources of information:	event re

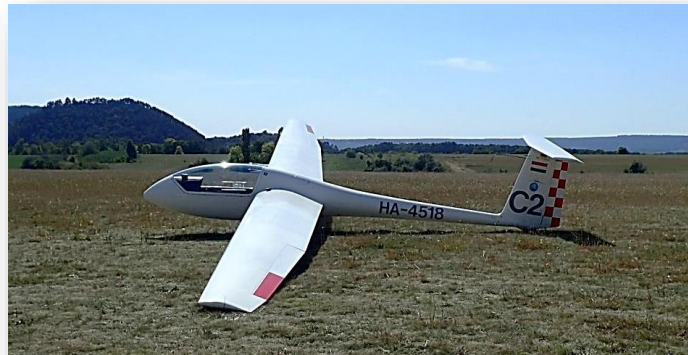
Figure 1 – The aircraft after the occurrence

Figure 1 depicts the aircraft's position after it stopped at the airstrip at Farkashegy airfield. The IC could not identify any ground marks related to the incident at the scene.

According to the examination of the aircraft, the main frame of the fuselage was damaged: it buckled on both sides; no other damage was found on the aircraft, or on anything else at the scene.

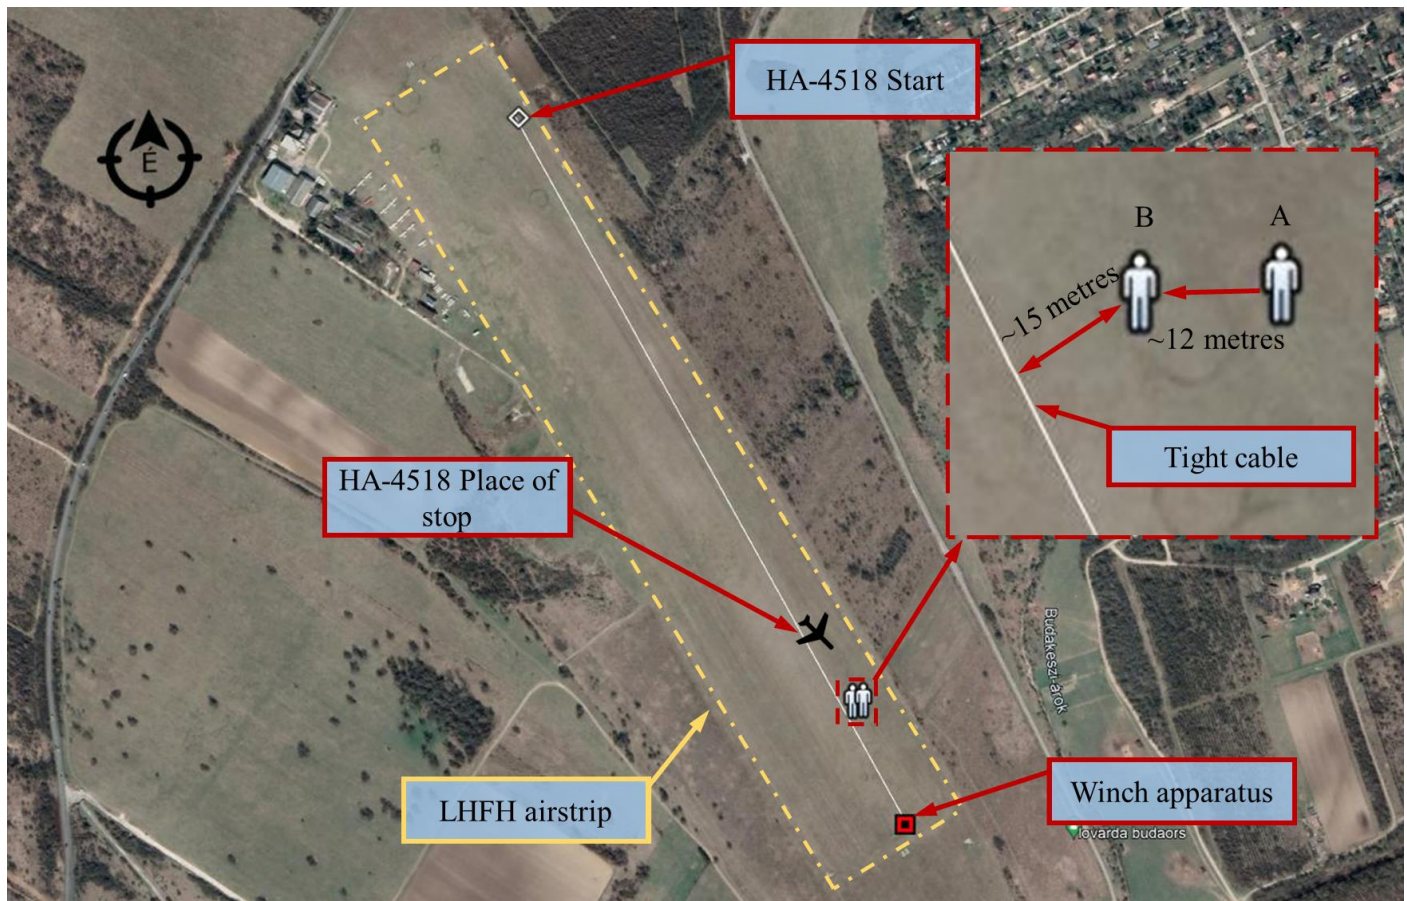
The IC obtained the important coordinates (Figure 2) at the scene as follows:

- the location of the winch apparatus and the people involved in the flight operations were determined (as points A and B in Figure 2) on the basis of the winch operator's report;
 - Point A: where the people involved in the flight operations were staying before start of the winch launch;
 - Point B: position of the same people when the winch launch was stopped;
- the starting and stopping points of the aircraft were determined using the OGN tracker⁴;
- the position of the aircraft as found during the incident site investigation (the same spot where the aircraft had come to rest after landing) was recorded.

Figure 2: The scene of the incident

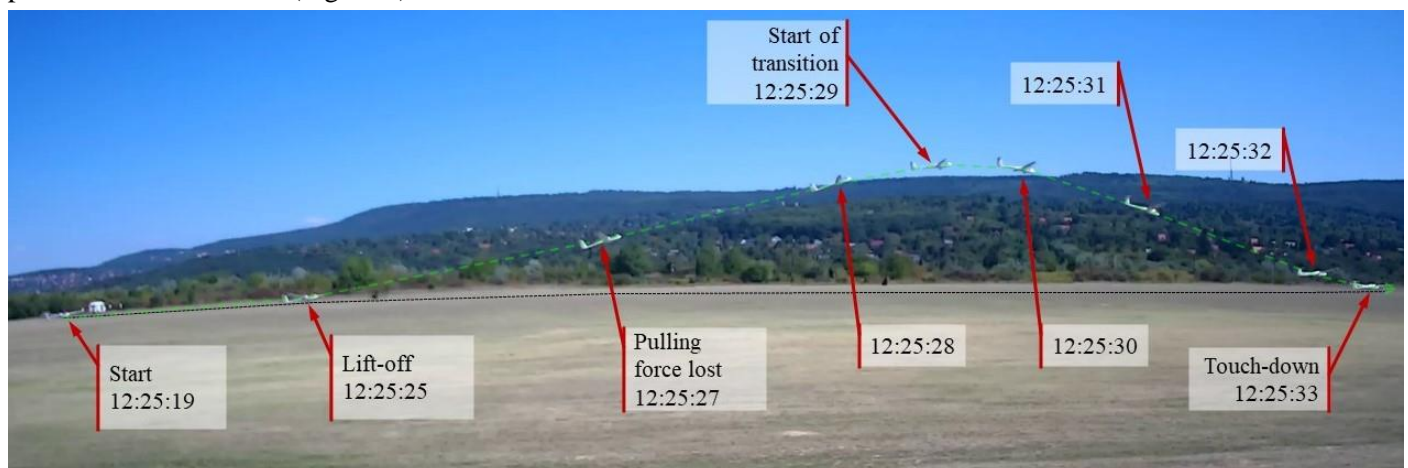
The IC made a series of images from the time-stamped frames of the security camera recording; it depicts the flight path of the aircraft well (Figure 3).

Figure 3 – The flight path of the aircraft (Source of picture: security camera recording)
