FINAL REPORT

Mooney M20K, HA-JDZ

Budaörs Airfield (LHBS), 9 May 2022

2022-0533-4

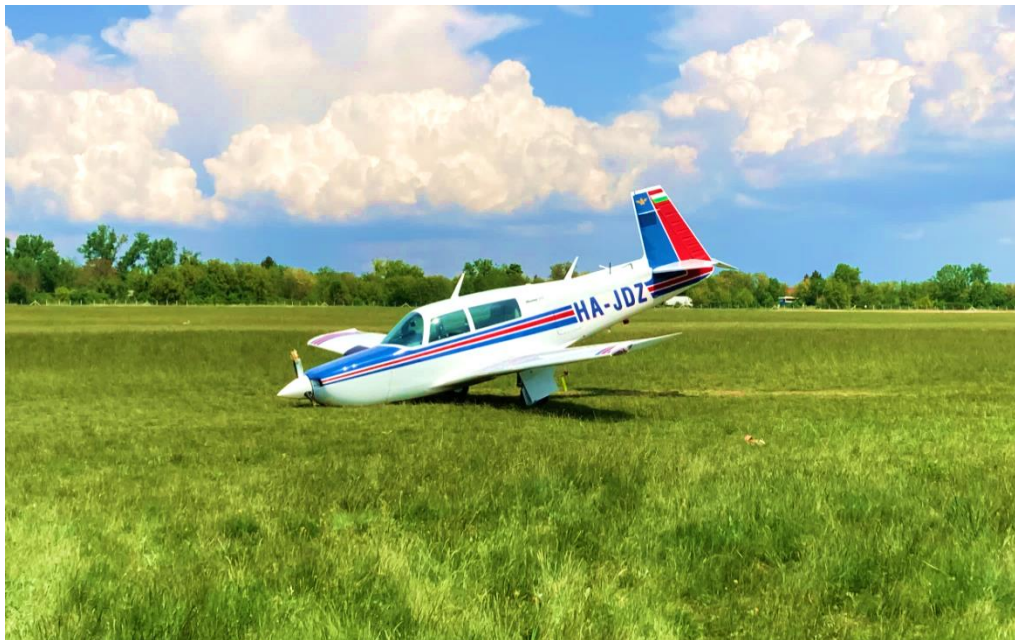
Figure 1. The position of the aircraft when the IC arrived on the site.
