MINISTRY OF
TECHNOLOGY AND INDUSTRY
TRANSPORTATION SAFETY BUREAU

FINAL REPORT

DG-202-17, PH-699
Mátranovák, Hungary
14 May 2022

Accident
2022-0569-4

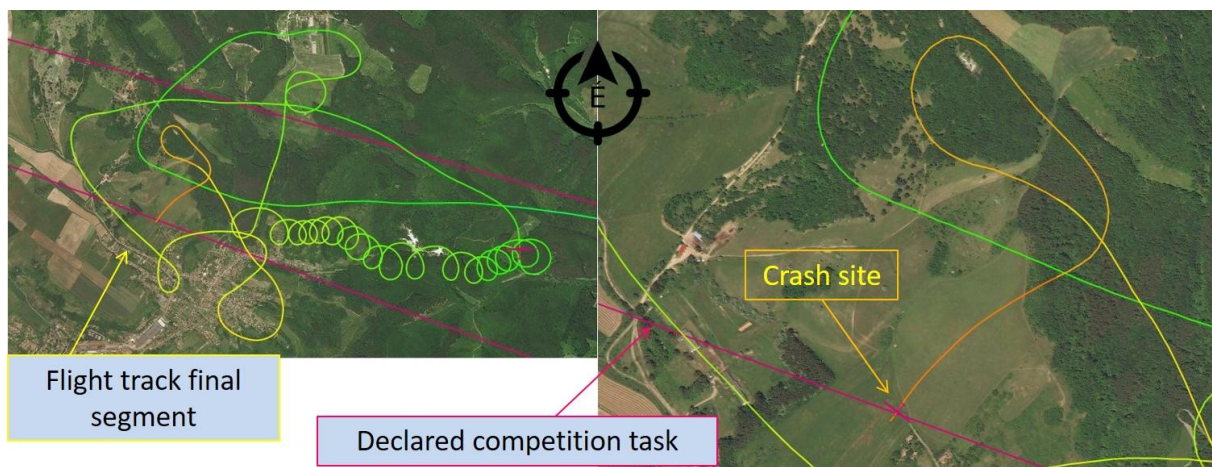
The recorded flight IGC-data show a 3 to 6 m/s wind, varying between 270 and 278 degrees in the last few minutes of the flight, as displayed in the pictures below.

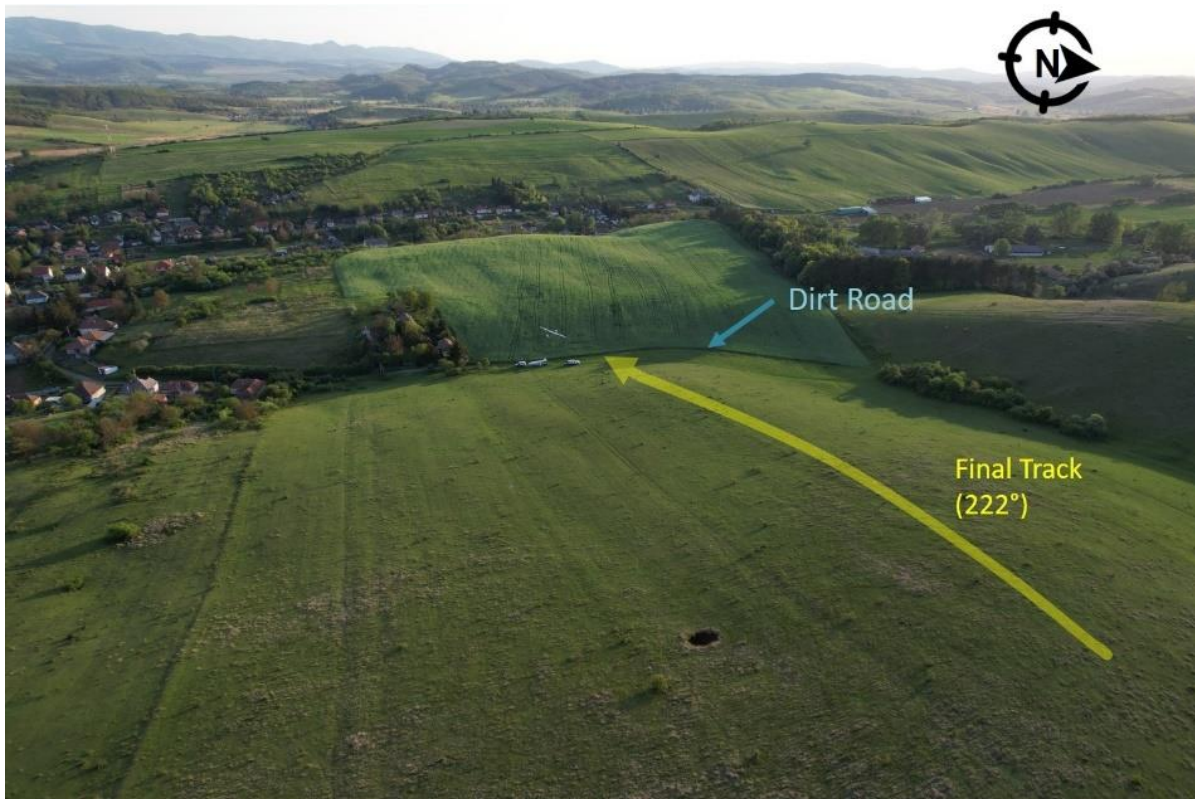
The final segment of the flight preceding the landing was over a sloping pasture of about 11 degrees of decline, bordered by a dirt road at its far end on the southwest. Across the road there was a crop field of 40 to 50 cm tall green wheat. This field started in a rampant acclivity of a significant, 22-degree gradient that further on renounced into a milder upslope, as shown in the picture. The impact site was on the initial, steep section of the wheat field, about 20 meters from the dirt road, at coordinates N48°02'35.7", E19°58'31.4".

Note: At the time this photo was taken, the sun was already setting, so the shadows cast on the ground enhance the terrain features and the sharp changes of the topography. At the time of the accident the sun was at 60 degrees high, much higher than in the photo, and these terrain features were much less conspicuous for the pilot.

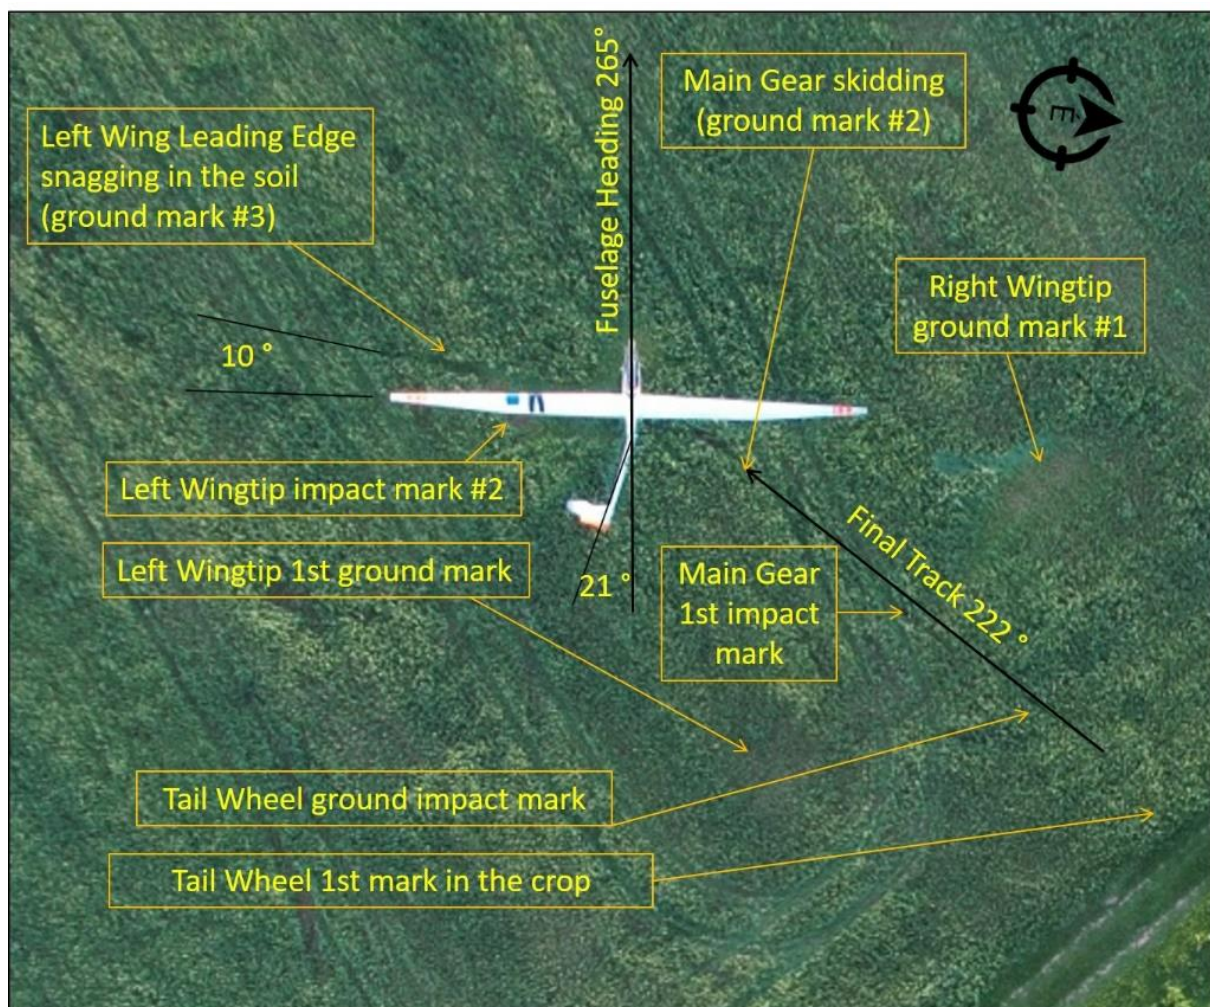
As a result of the series of forces acting on the fuselage during the impact, the laminated fiberglass empennage broke clean off the hull at about 30 centimeters behind the wings' trailing edge, with only the elevator rods and rudder cables linking the separating parts. The carbon-fiber reinforced left side flap succumbed to the left wing's dynamic fore-and-aft oscillation forces and buckled on impact near the left wing root. The removable add-on wingtip got stuck in place on the left side, effectively resisting all removal efforts on the spot.

By the marks recorded on the ground, the tail wheel touched down first, followed by the main wheel, while both wingtips flapped all the way down against the ground. The left wing only mowed the wheat stems at ground level, while the right wing left a hard ground impact mark in addition, revealing that the wings were not quite level on touchdown. The resulting increased drag on the right side gave the fuselage a right turning momentum as it was bouncing off in a left rolling and down pitching attitude. On the next ground impact the left wingtip slammed into the ground, together with the main wheel skidding left, while the nose also came down hard, scraping on the ground.

The left wing bounced off yet again, only to come down once more with its leading edge cutting into the soil. The left wing now, flexing backwards, arrested the last of the aircraft's forward motion. The left wing then sprung back forward and threw the fuselage aft, while twisting it about 10 degrees back left at the same time. As a result of the rapidly changing, excessive torsional forces, the empennage separated and came to a rest, tilting left.
