| Aircraft | Type | PZL 101/A, Gawron |
| | Registration | HA-SBG |
| Occurrence | Date and Time | 05. June, 2022, 18:06 LT <sup>1</sup> |
| | Location | Farkashegy airfield (LHFH) |

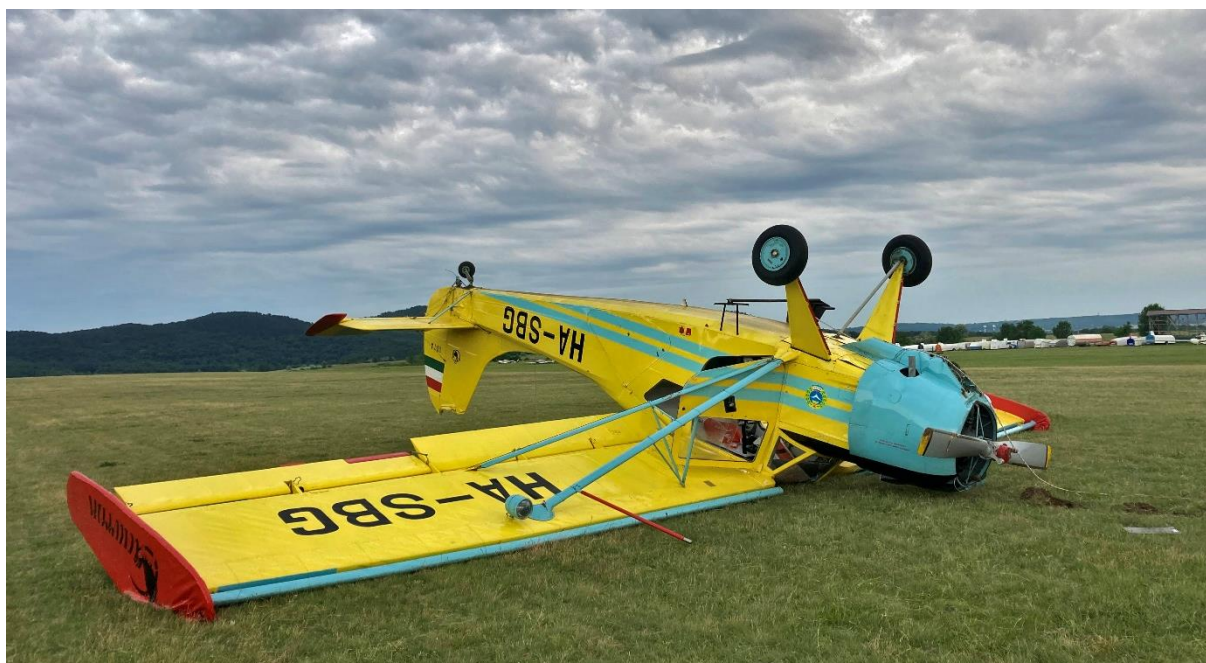
On 5th June, 2022 at 18:06 LT a PZL-101/A Gawron aircraft (HA-SBG) landed at Farkashegy airfield (LHFH) and turned over and stopped upside down on the runway during the roll after touch down. The pilot was taken to hospital with minor injuries, the aircraft was damaged in the incident.

The Investigation Committee (hereinafter: IC) attributed the direct cause of the incident to the excessive braking force used by the Pilot to stop the aircraft. The shorter runway due to the non-runway direction landing, the high position of the aircraft's center of gravity, the dynamic operation of the air brake and the pilot's lack of landing experience with the type also contributed to the incident.

Figure 1: the aircraft after the event

During its safety investigation, the IC concluded that the direct cause of the incident was that the Pilot applied too much brake force to stop the aircraft, which led to the overturning of the aircraft.
