# FINAL REPORT

Zlin Z-326 Tréner, HA-TRT  
Szeged Airport (LHUD), 13 June, 2022

Serious Incident  
2022-0719-4

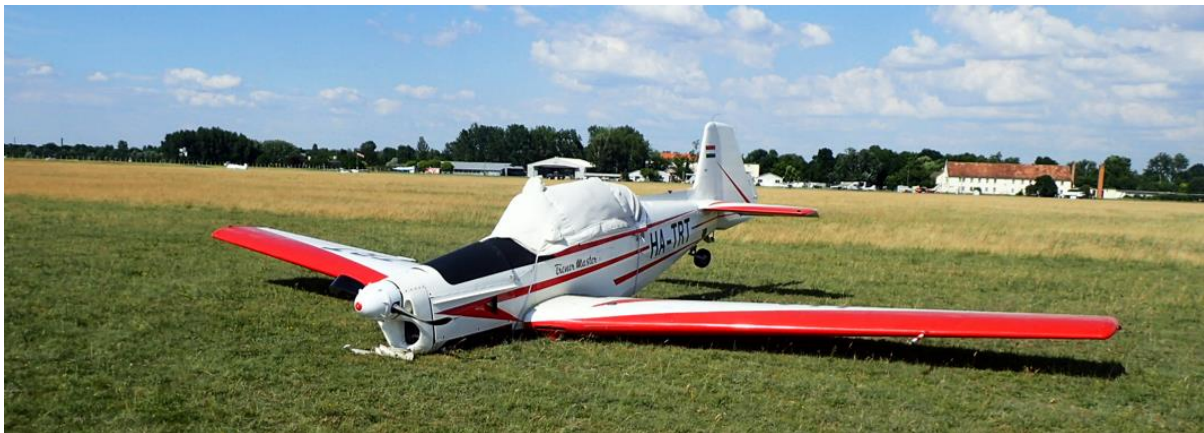
The pilot of the mishap aircraft planned his take off from the grass strip Runway 34. In the initial phase of the take off – at about 4-6 meters – the aircraft started to descend and impacted terrain. It came to rest after a 60 m skid on the ground.

The Investigation Committee (hereinafter: IC) attributed the direct cause of the serious incident to the pilot's loss of situational awareness at a critically low altitude during take-off.

Figure 1: The mishap aircraft after the incident

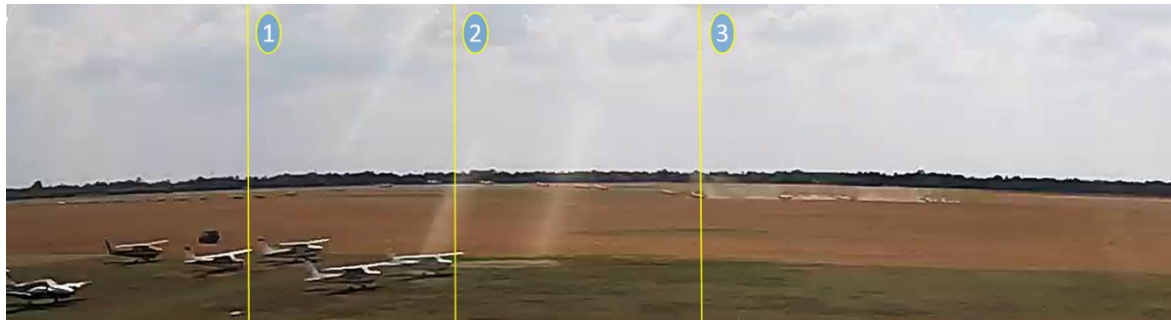
2. Figure: The flight path of the mishap aircraft based on the surveillance camera  
1: Take-off, 2: Highest point of the flight, 3: Impact with terrain

The highly experienced pilot arrived at Szeged airport that day to complete the last flight of his flying career. After performing the pre-flight check, the pilot and his passenger boarded the aircraft and taxied onto the grass runway 34. The pilot recalled starting the takeoff roll 300-350 meters from the threshold of the runway in moderately strong, gusty north-westerly wind after carrying out the pre-takeoff checklist. Based on the evidence by the surveillance camera, the plane accelerated for 15 seconds before takeoff, and after climbing for 3-4 seconds reached the peak of its flight path (height of 4-6 meters above ground level). The aircraft began to descend from this position, and after 5 seconds it collided with the ground at a flat angle with its propeller, belly and gears not fully retracted. After a skid of about 60 meters the aircraft turned approximately 90 degrees to the left with respect to the axis of runway 34 and came to rest at the coordinates N46°14'58" E020°05'34".

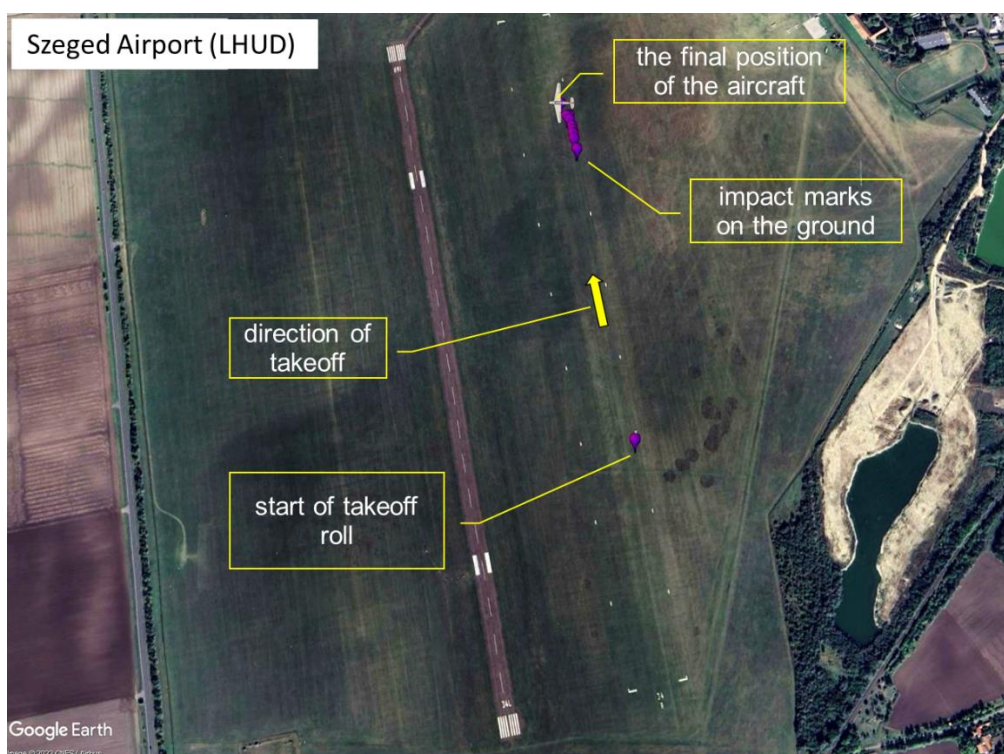
Figure 3: Traces observed at the scene
