FINAL REPORT

P2002-JF, HA-TEF

Gödöllő Airport (LHGD), 20/05/2023

2023-0574-4

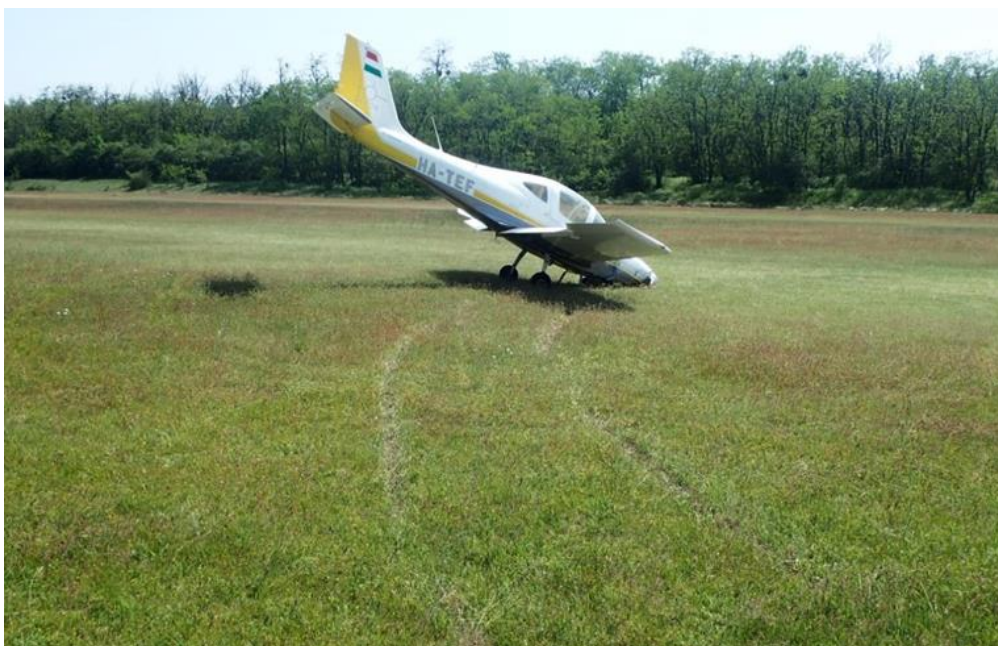
The pilot involved in the incident landed the Tecnam P2002-JF aircraft, registration mark HA-TEF, on runway 13 of Gödöllő airport after a cross-country flight of more than 3 hours. After landing, however, the pilot lost control of the aircraft and, after a relatively high-speed left and then right turn, the aircraft came to a stop on the right side of the runway at the same time as the nose of the aircraft broke off.

Figure 1: The aircraft at the occurrence site

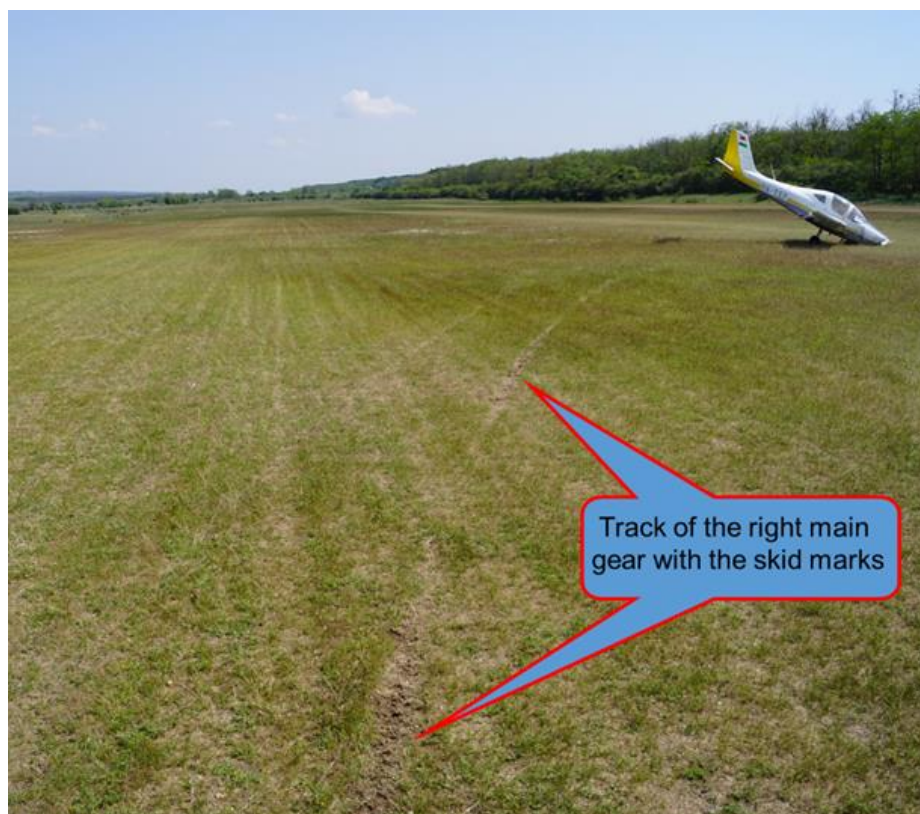
Figure 2: Trace of the aircraft's right main landing gear
