# FINAL REPORT

Zenit-290 parachute (Z06290028)

Nyíregyháza Airport (LHNY), 08 July, 2023

2023-0888-4

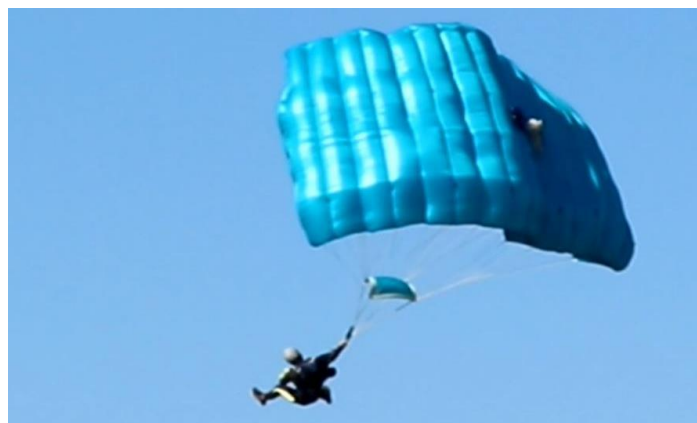
The parachutist involved in the accident was a student making his second jump of the day from 1,500 meters. He exited the aircraft second, immediately followed by his instructor who jumped third. During the deployment sequence after exiting the aircraft, the student's right hand became entangled and trapped in the harness, which led to a severe deformation of the otherwise inflated main parachute. As a result, the canopy entered a rapid left-hand spin (*Figure 1*).

The Investigation Committee (hereinafter "IC") concluded that the direct cause of the accident was the student's inability to manage the critical situation for unknown reasons. The IC identified the student's improper body position during exit as a contributing and triggering factor to the accident. The IC found no grounds to issue a safety recommendation.

*Figure 1. (Source of the image: eyewitness video recording)*

Video footage recorded by the Instructor shows that he removed the pilot parachute from its pocket and released it after the Student exited the aircraft. After exiting, the Student failed to assume a symmetrical, arched, stable body position and rotated to the right into the deploying parachute. His right hand became trapped between the two deploying risers and was wrapped by the harness during deployment. As a result, the left-side lines were significantly shortened, causing the otherwise inflated main canopy to become severely deformed and enter a rapid, left-hand spin (*Figure 1*).
