FINAL REPORT

Socata Morane MS-893 E, HA-VEF
Kecskéd airfield (LHKD), 04 May, 2024

Serious Incident
2024-0612-4

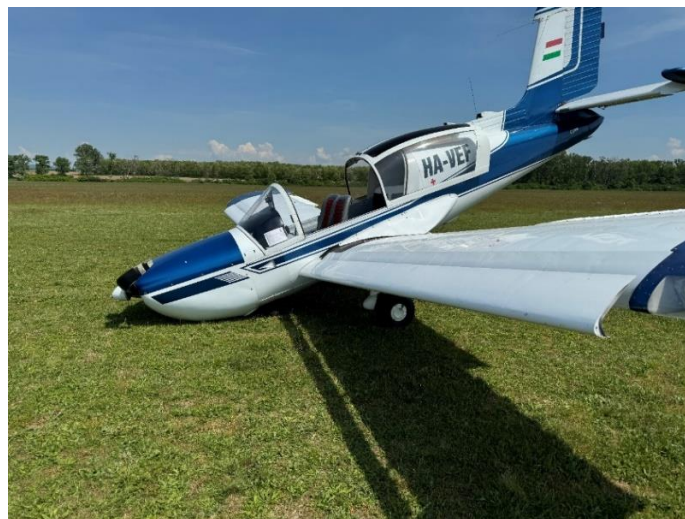
Figure 1. The HA-VEF aircraft (source: the Pilot)
