Bundesstelle für Seeunfalluntersuchung

Federal Bureau of Maritime Casualty Investigation

ECDIS; a grounding avoidance tool? EMAIF 5; 30th - 31st March 2009 Jörg Kaufmann

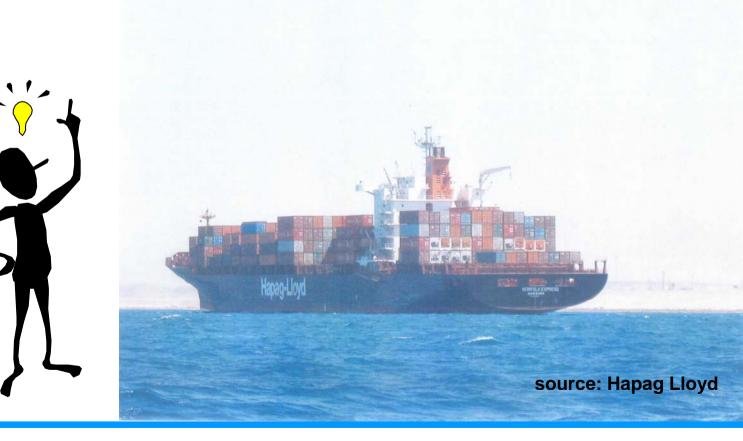
in the Gulf of Suez; May 08; no EC on board

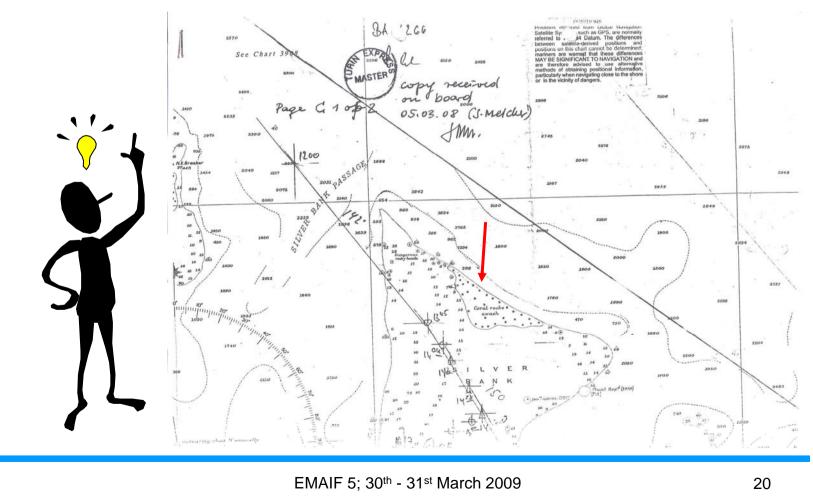
On February 29th, 2008 the container vessel "Turin Express" departed at 06:00 hrs lt from Savannah and commenced her sea passage at 09:30 lt.

The vessel's destination was Caucedo, Dominican Republic, with estimated time of arrival March, 3rd, 06:00 hrs lt.

A voyage plan from Pilot to Pilot had been prepared by the Navigation Officer as done before. The vessel headed for the Mona Passage with the intention to continue with the coastal voyage to the port of destination.

Unfortunately the Navigation Officer altered the track of previous voyages closer to the east coast of Hispaniola, passing the center of the Silver Bank, the center to avoid charted reefs in the northeasterly edge of the bank, considering the passage safe and free of underwater reefs.

During his watch the Duty Officer entered the bank and followed the route until a nearby research vessel contacted him by VHF, given warnings about dangerous reefs with the advice to alter the couse by 10 degrees to starboard for a safe passage to which I agreed. Course had been set to 150 degrees and the vessel continued on her passage with the 2nd Officer on duty, assisted by the 3rd Mate. Speed was about 17.5 kts.

When the Duty Officer detected discoloured water close to the port bow, he altered the course to starboard, reduced the speed and called me.

When I arrived on the bridge the vessel hit with her bulbous bow an underwater coral reef and the vessel was shaking and she listed for few seconds to port.

in the Caribbean Sea; March 08; no EC on board

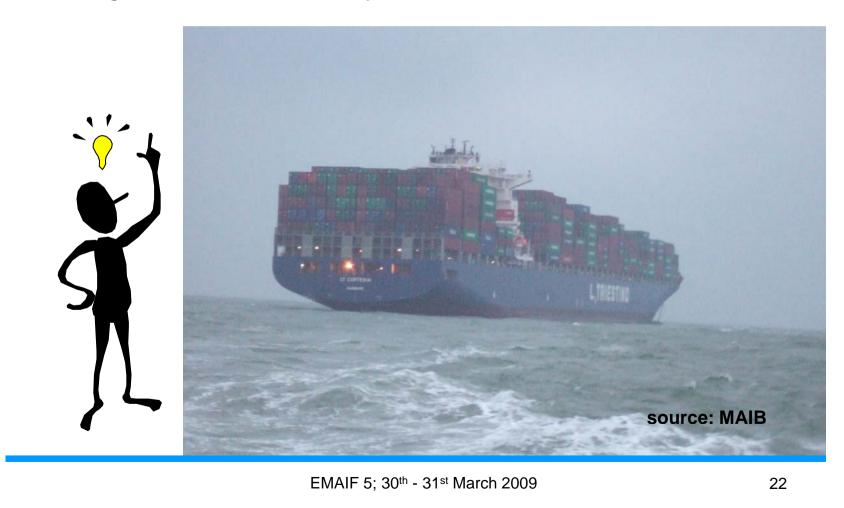
in the English Channel; January 08; ECS on board

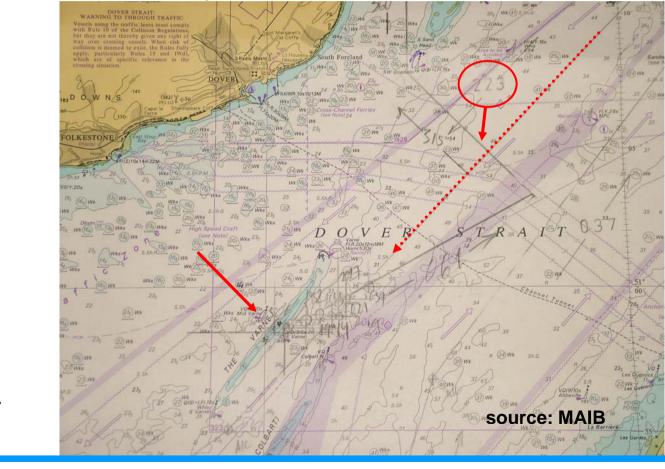
in the English Channel; January 08; nautical chart

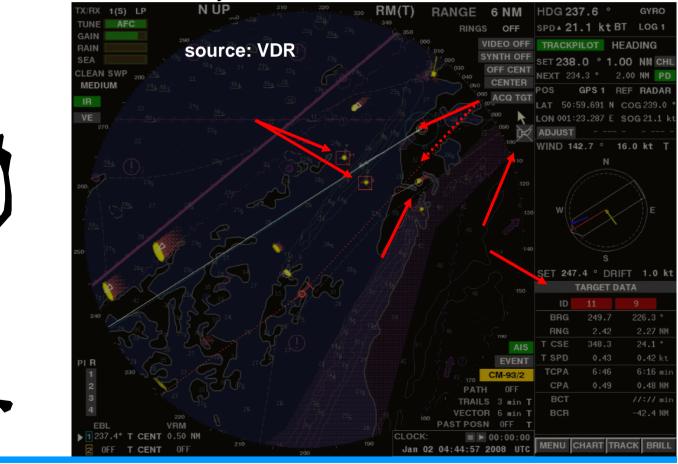
in the English Channel; January 08; Radar / ECS; t ~ -10 min.

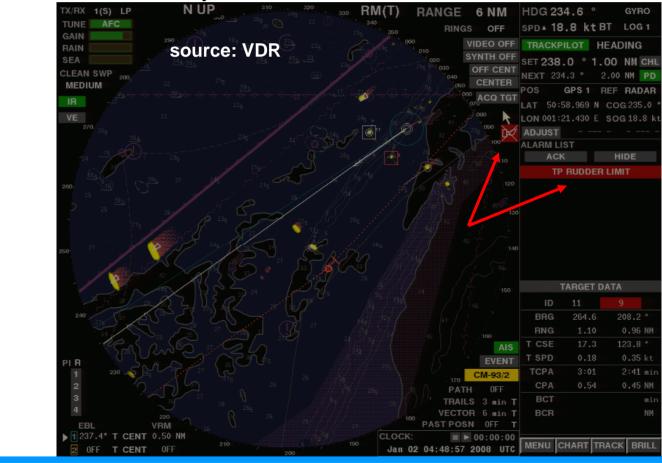
in the English Channel; January 08; Radar / ECS; t ~ -6 min.

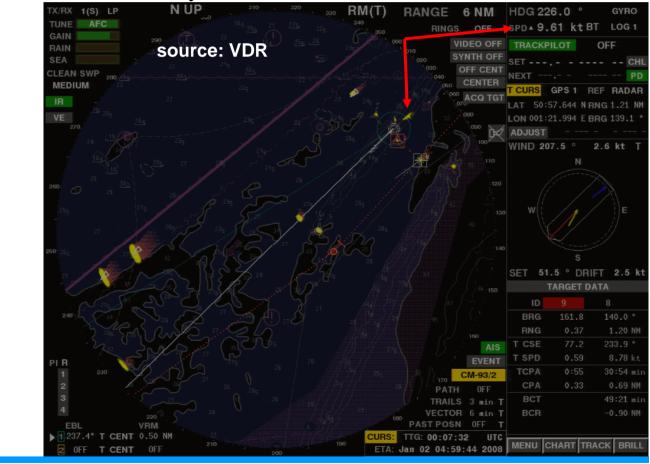
in the English Channel; January 08; Radar / ECS; t ~ +5 min.
