MV NATISSA

An unlucky
River sea trader

A CHAPTER OF ACCIDENTS

E- MAIF 30-31 march 2009 – BUDAPEST

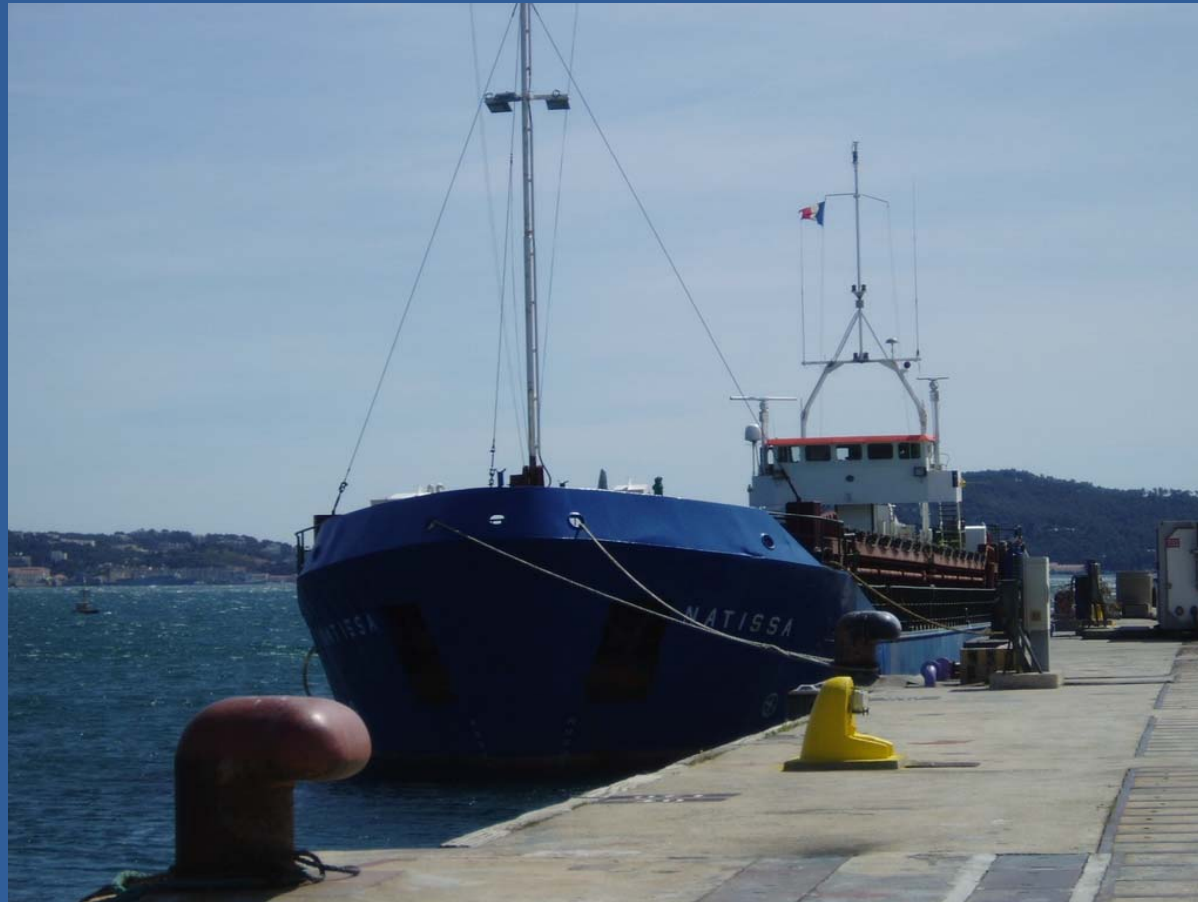
NATISSA GROUNDED ON 31st MARCH 2008

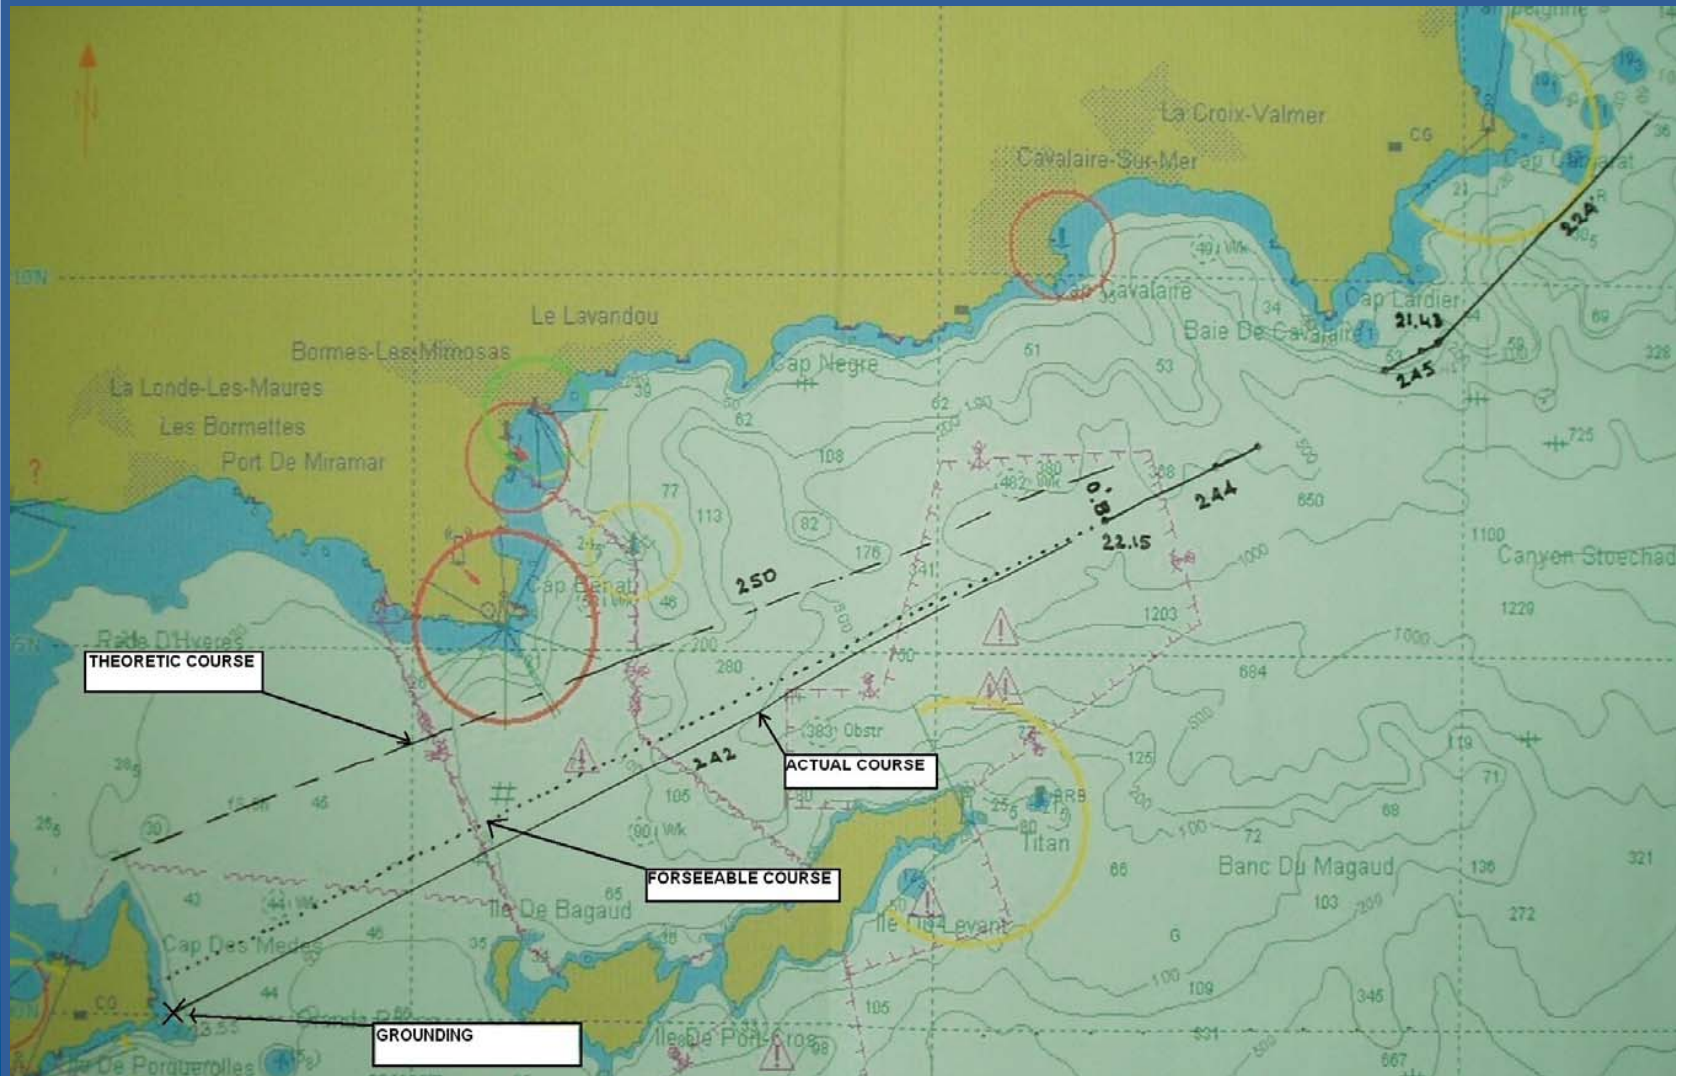
RECONSTITUTION

- Captain is alone on watch in the dark
- From 21:43 (last reported position) and 23:55, his attention is monopolized by computer work
- The CMG is not 250 as planned but 242, because northerly wind and Ligure stream (SW # 0,5 knots).

- A number of contributing factors have been identified :
 - lack of attention to navigation in a coastal zone between land and islands
 - lack of lookout
 - absence of a second sailor on bridge
 - routine

- Insure that two people are on watch in dark periods
- Insure that during watch, priority is given to watch keeping and attention to navigation
- Complete crew if necessary and insure that crew knows working organisation

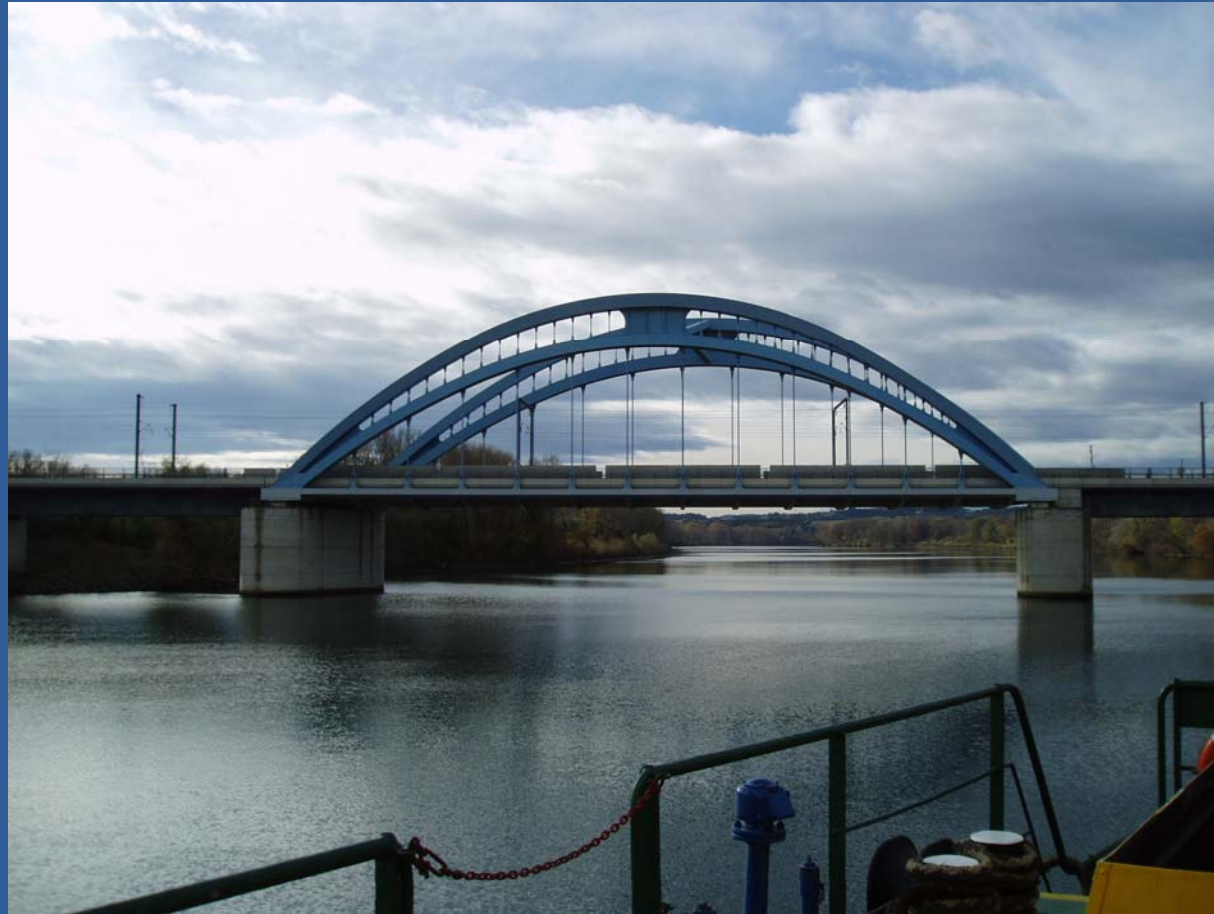
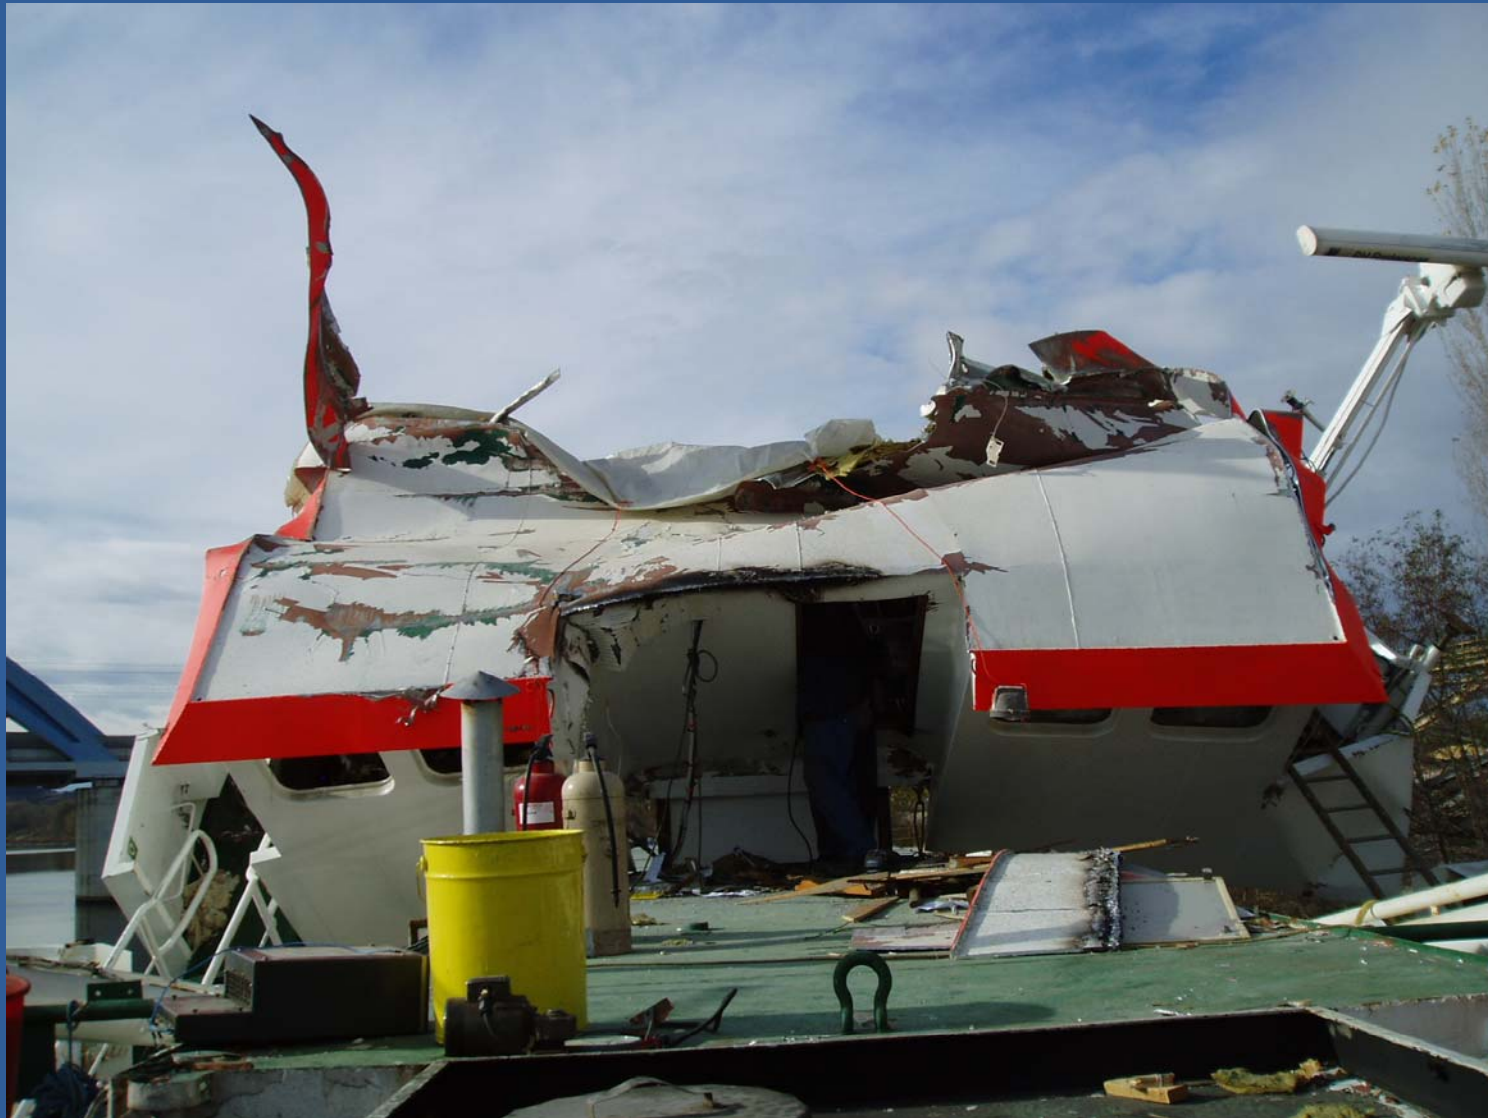
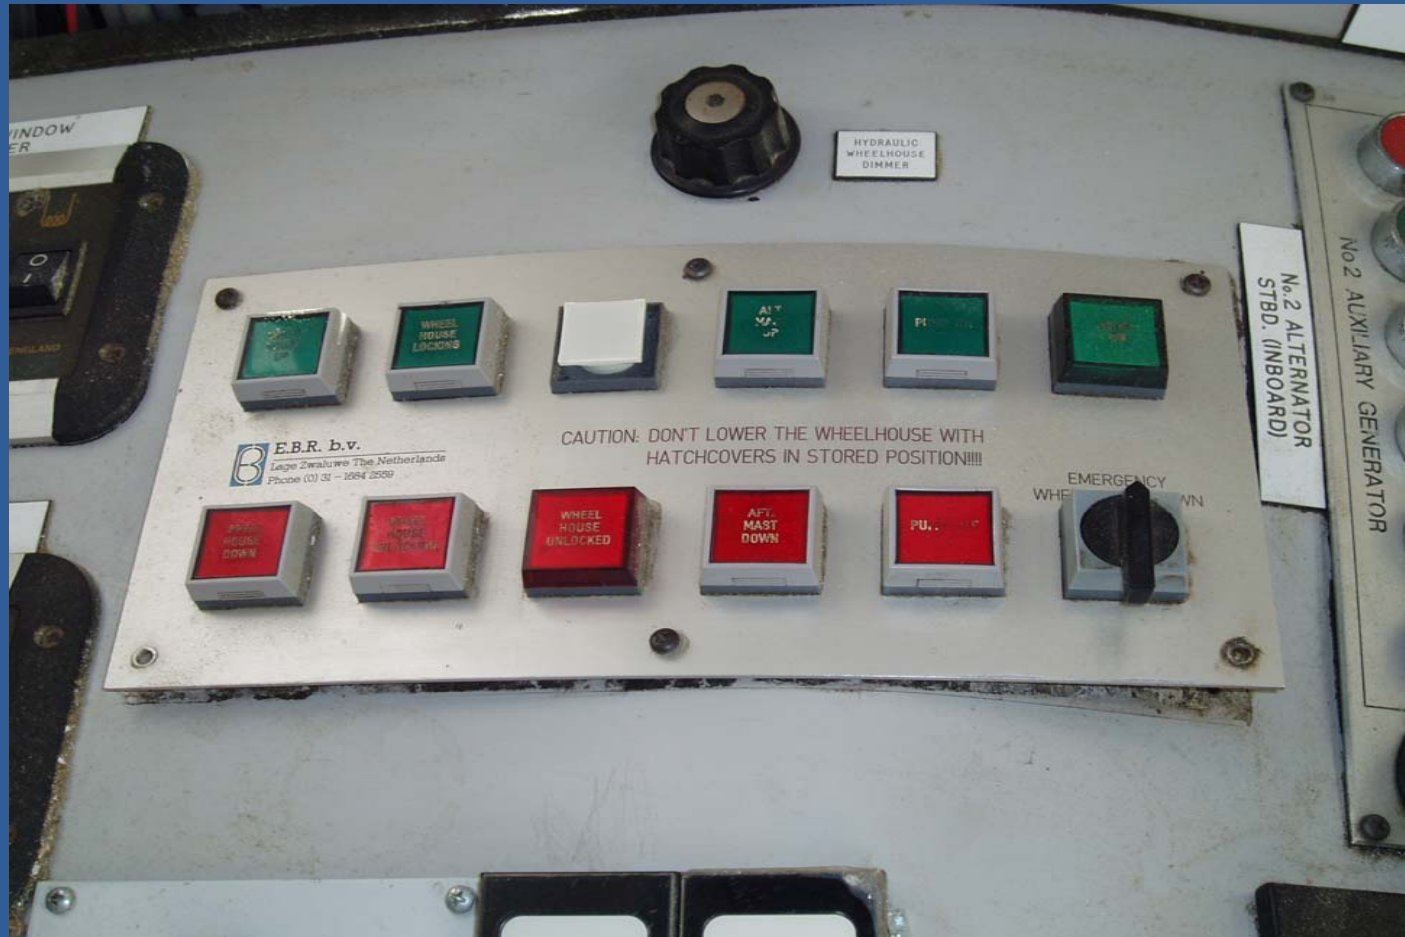
2) COLLISION WITH A RAILWAY BRIDGE (LE RHONE RIVER) on november 2008

OOW just forgot to lower the wheelhouse before passing the railway bridge !

Wheelhouse was destroyed...
