Collision of Eurocity train No. 108 with an obstacle (fallen bridge structure) in Studenka station

The Rail Safety Inspection Office

Accident basic data

Date and time: 8th August 2008, 10:30:27

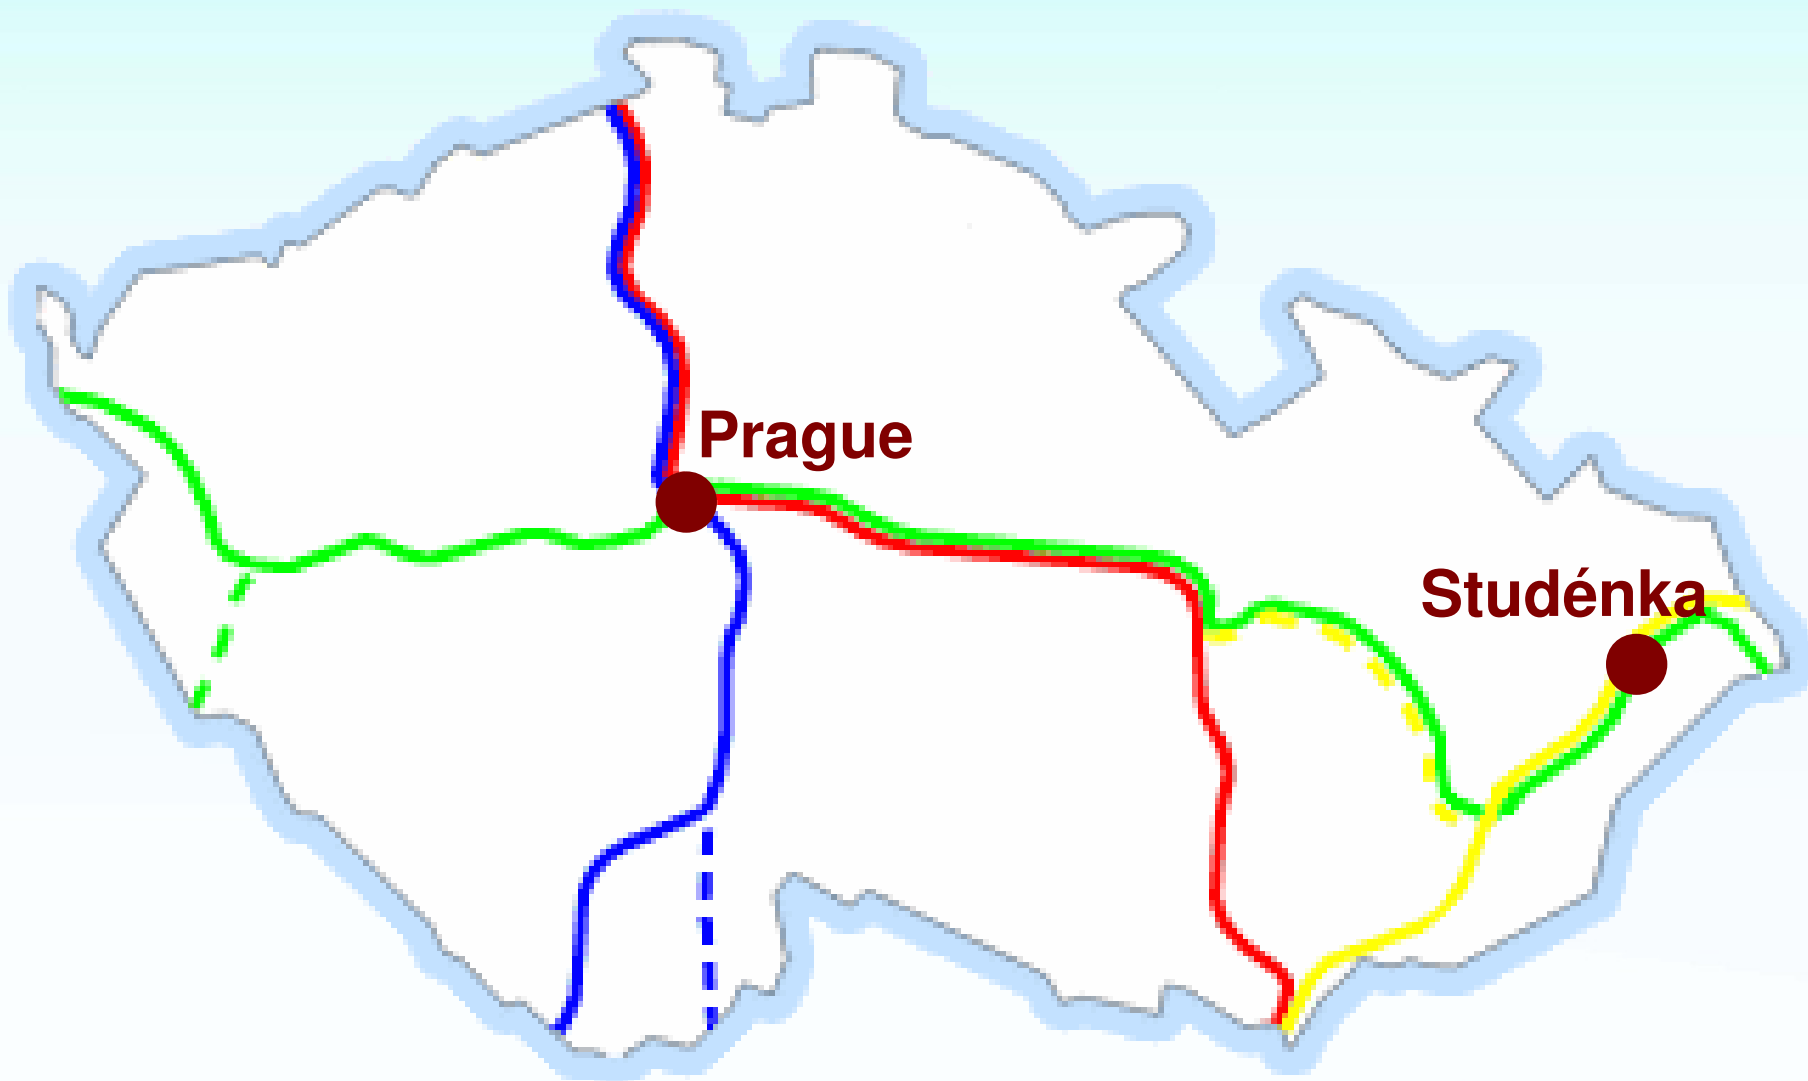
Accident site

A road bridge above the station collapsed just in front of approaching Eurocity train No. 108. The train collided with the ruins of the bridge and derailed. 4 derailed carriages consequently collided with a stationary goods train, causing derailment of 3 wagons of the goods train.

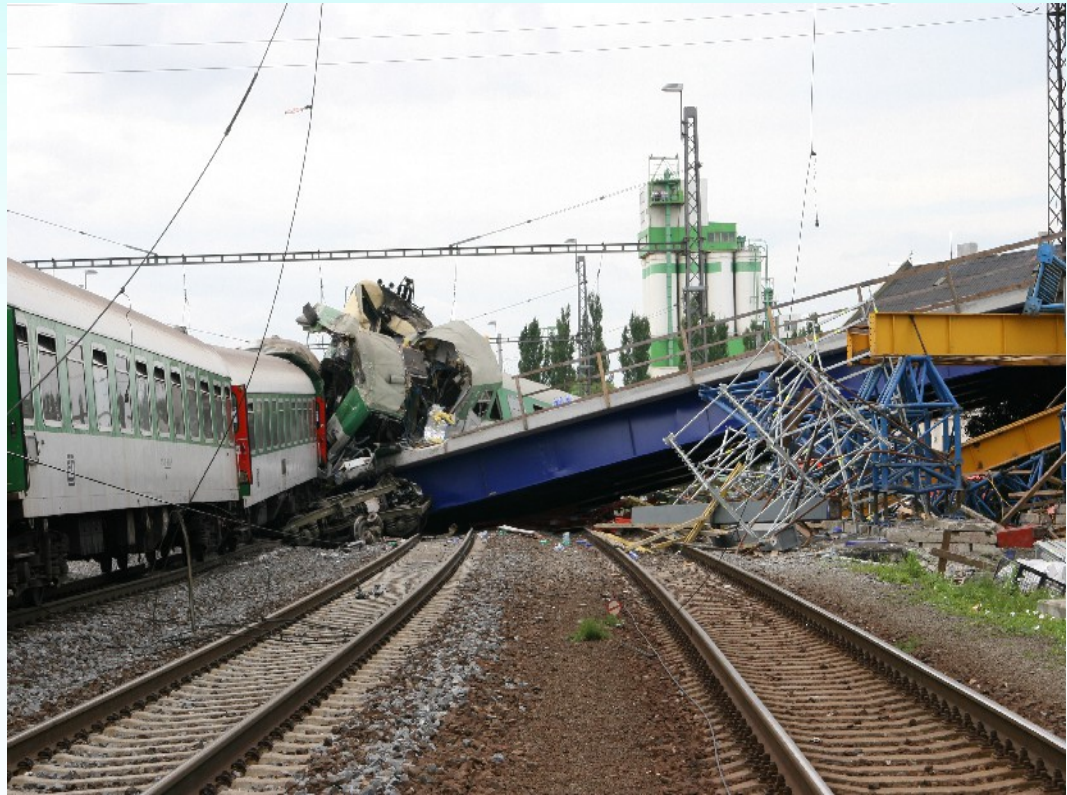
Road bridge

- above the tracks
- the bridge was under the reconstruction
- should be replaced
- steel concrete bridge construction weighing 500 t

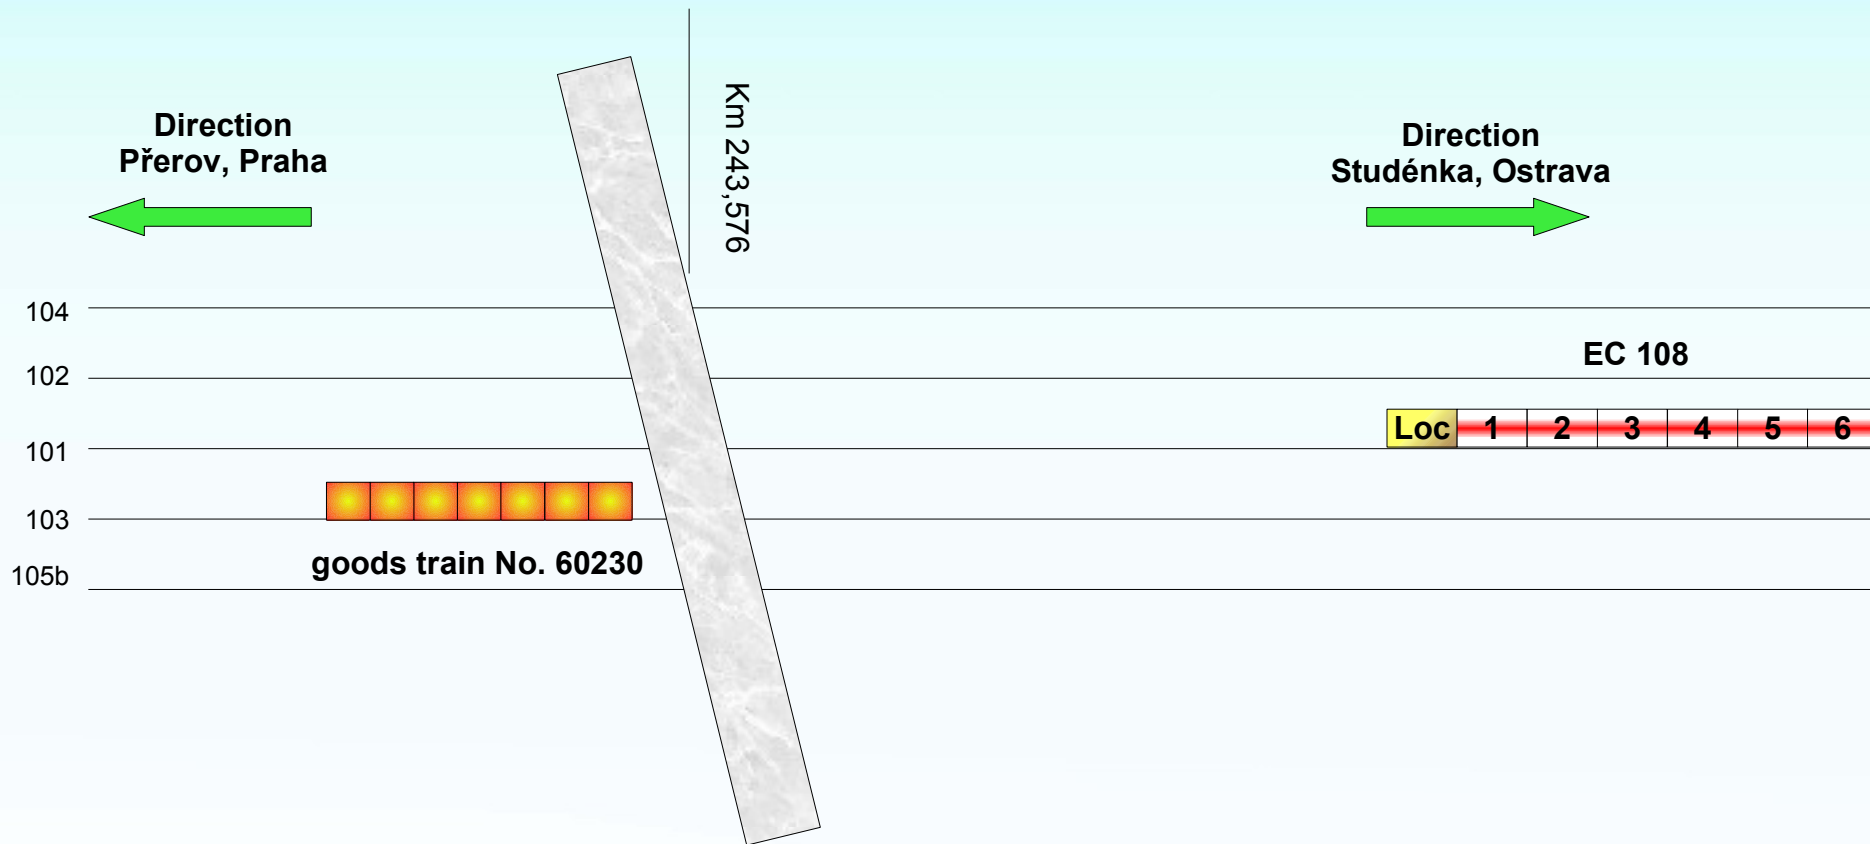
Situation before the accident

Loc: Locomotive (151 018-9)

1 – 6: first 6 carriages behind the locomotive

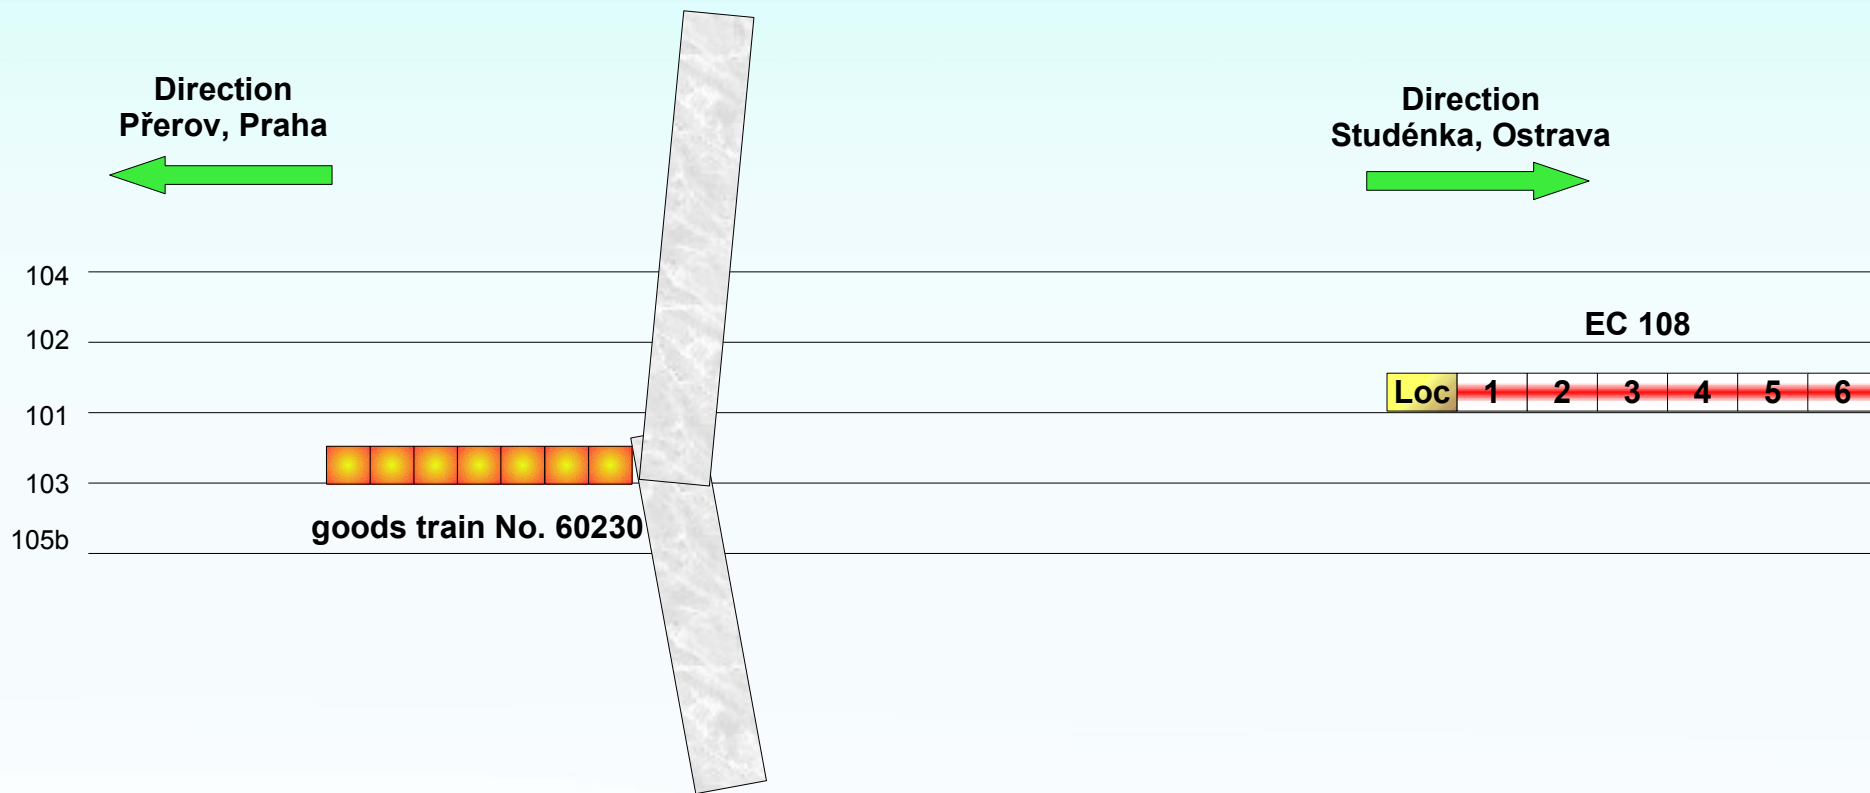
Chronology of the accident – 10:30:08

- bridge construction falls down
- EC train is **638 m** from the bridge at speed of **134 km/h**
- time to collision is **19s**
- the engine driver notices the bridge structure falling down

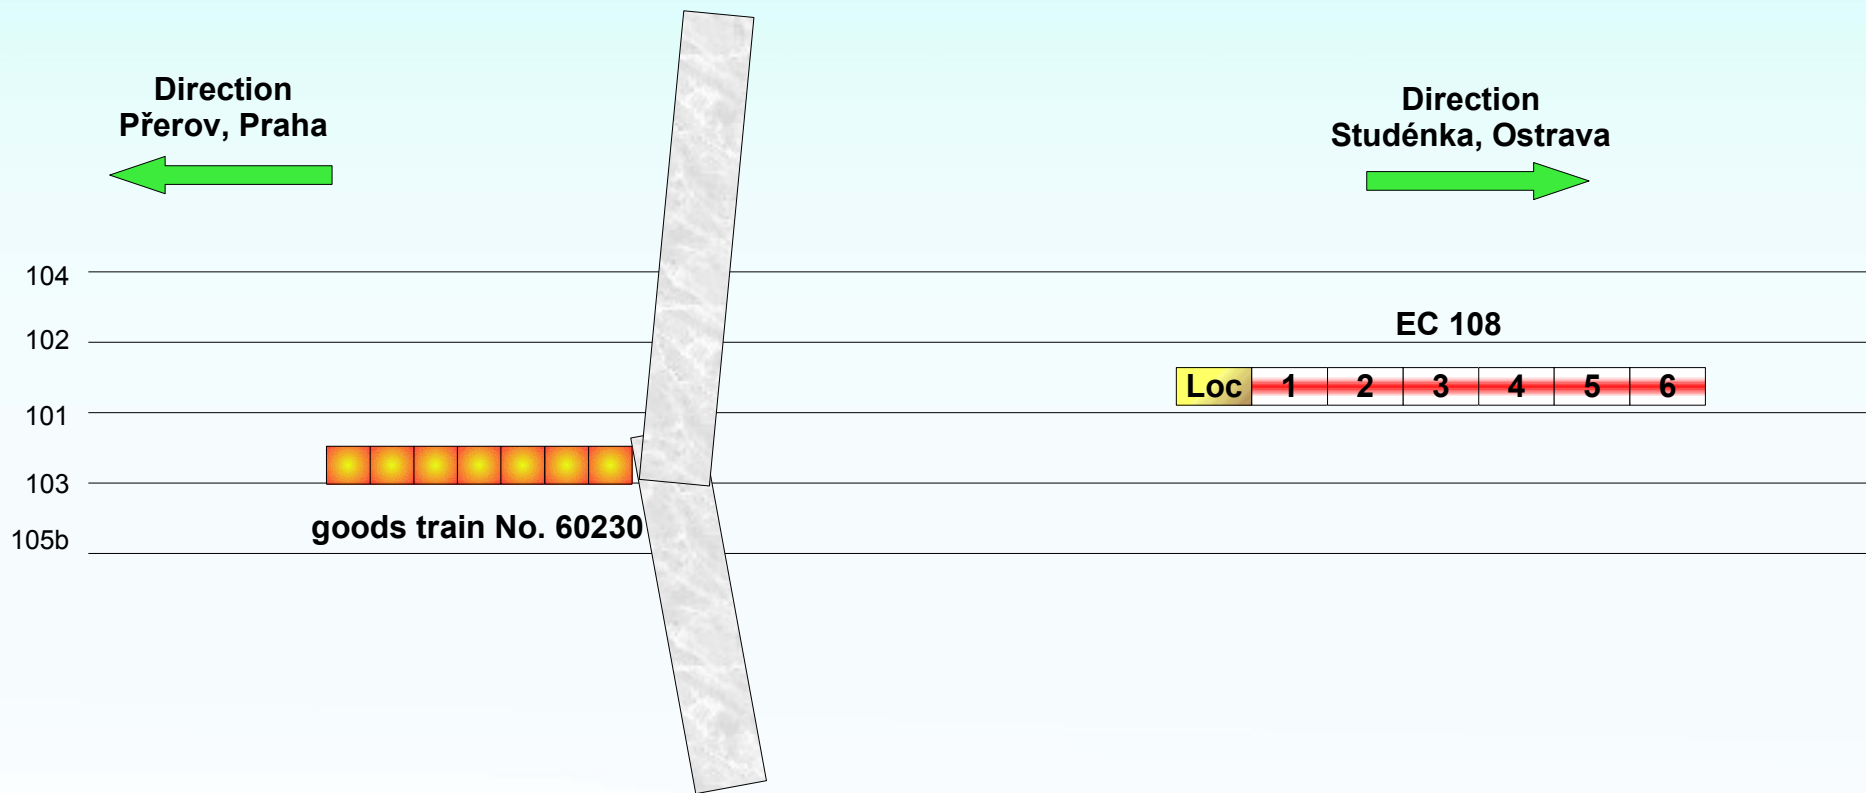
Chronology of the accident – 10:30:13

- emergency brake was applied
- EC train is **452 m** from the bridge at speed of **133 km/h**
- time to collision is **14s**
- the engine driver escapes to the engine room

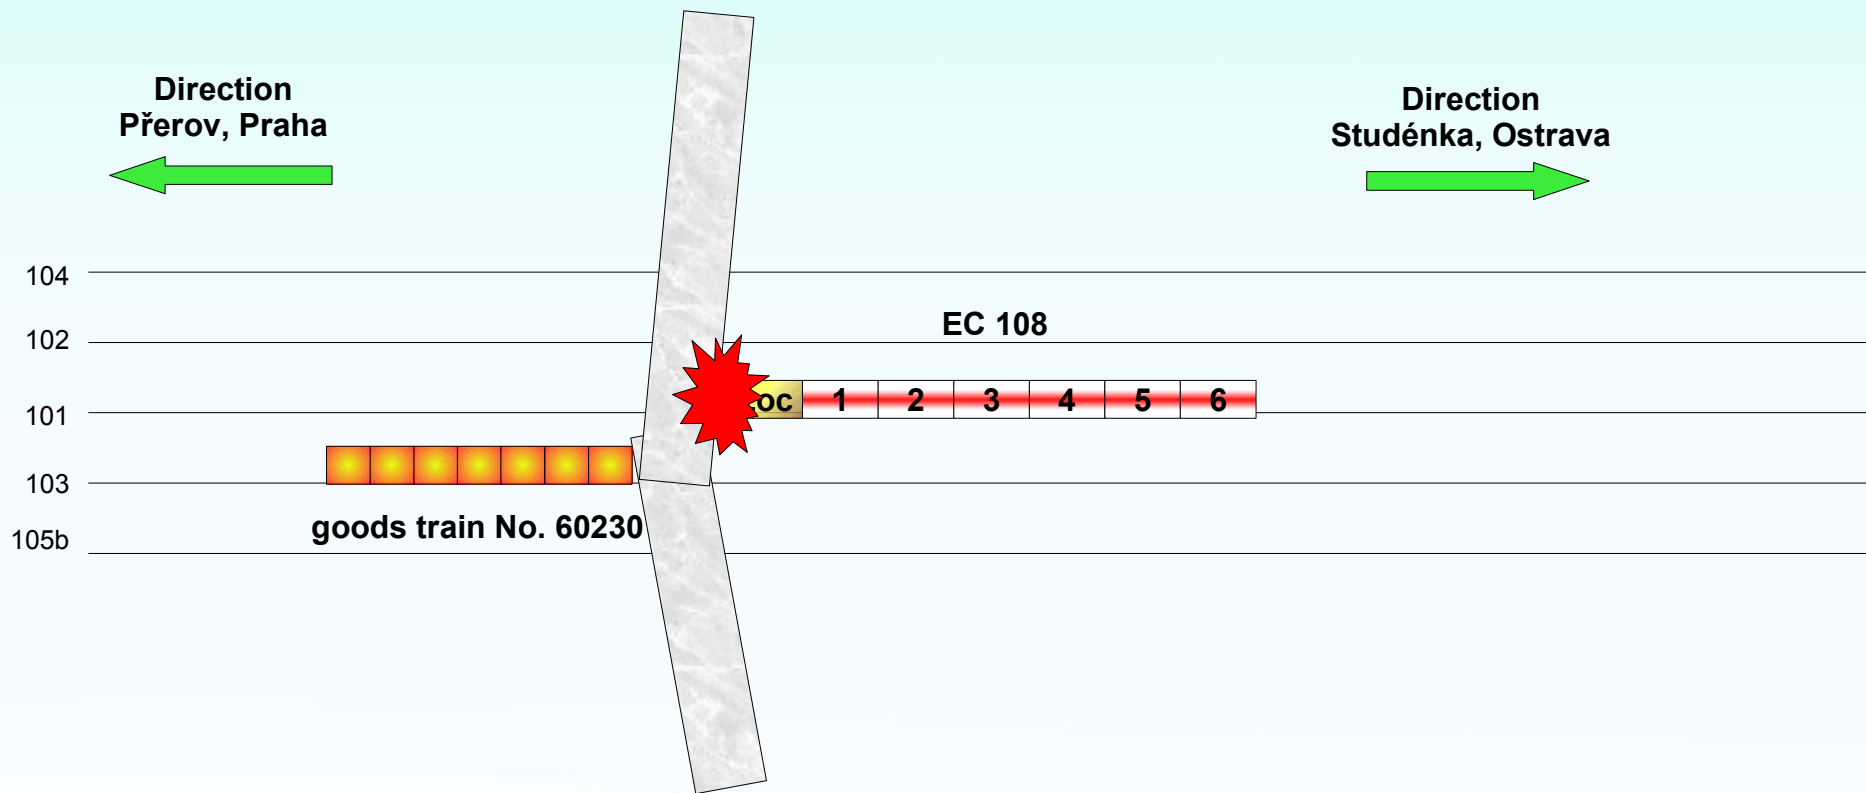
Chronology of the accident – 10:30:27

- moment of the collision
- impact speed is **90 km/h**
- the train pushes the construction ahead for 33 m

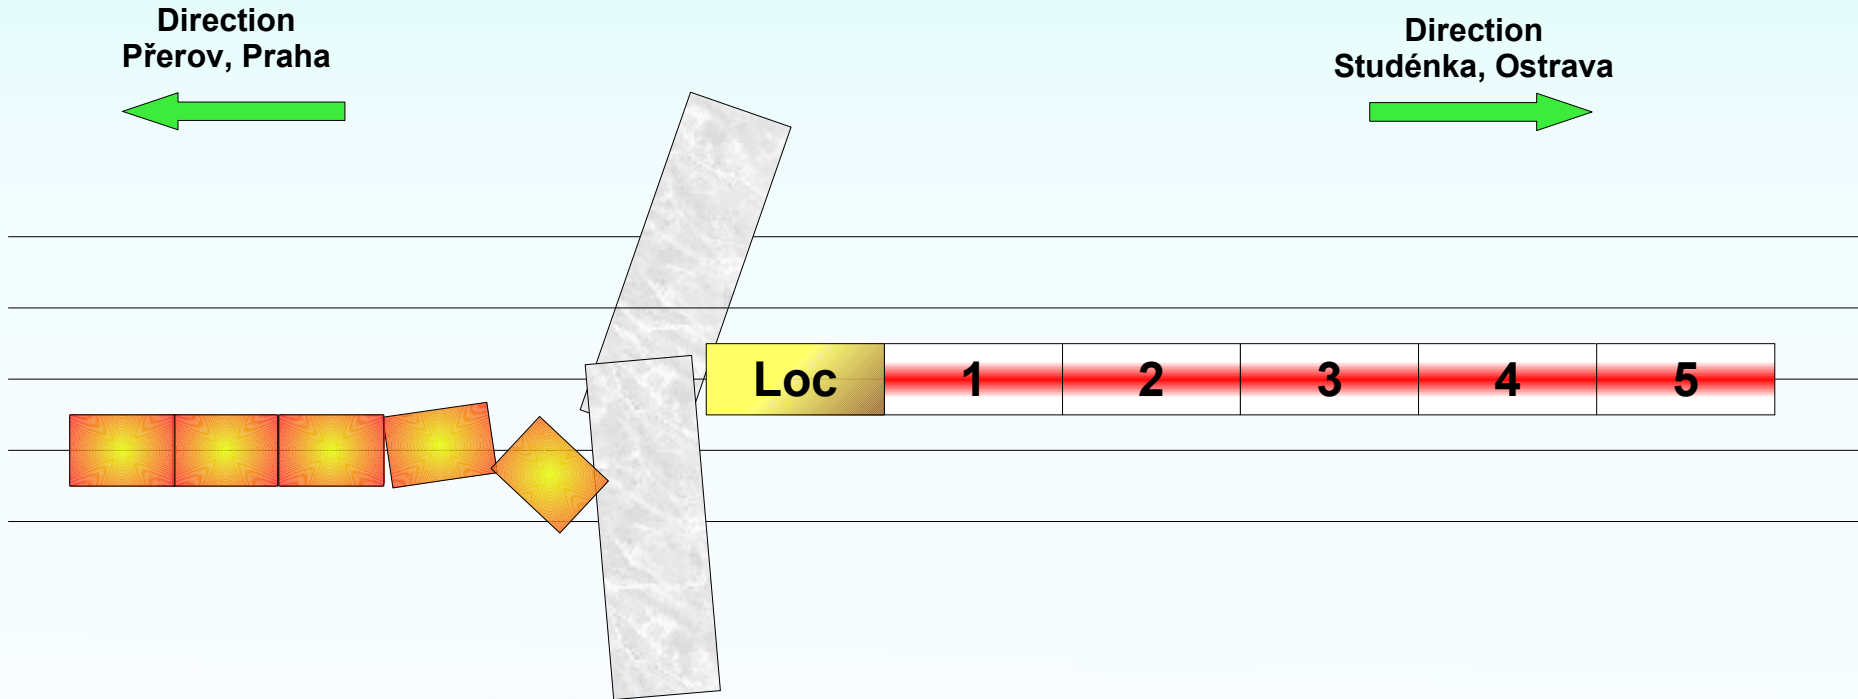
Dynamic process of the accident

- the locomotive pushes the bridge construction ahead
- bridge construction collides with rear part of goods train

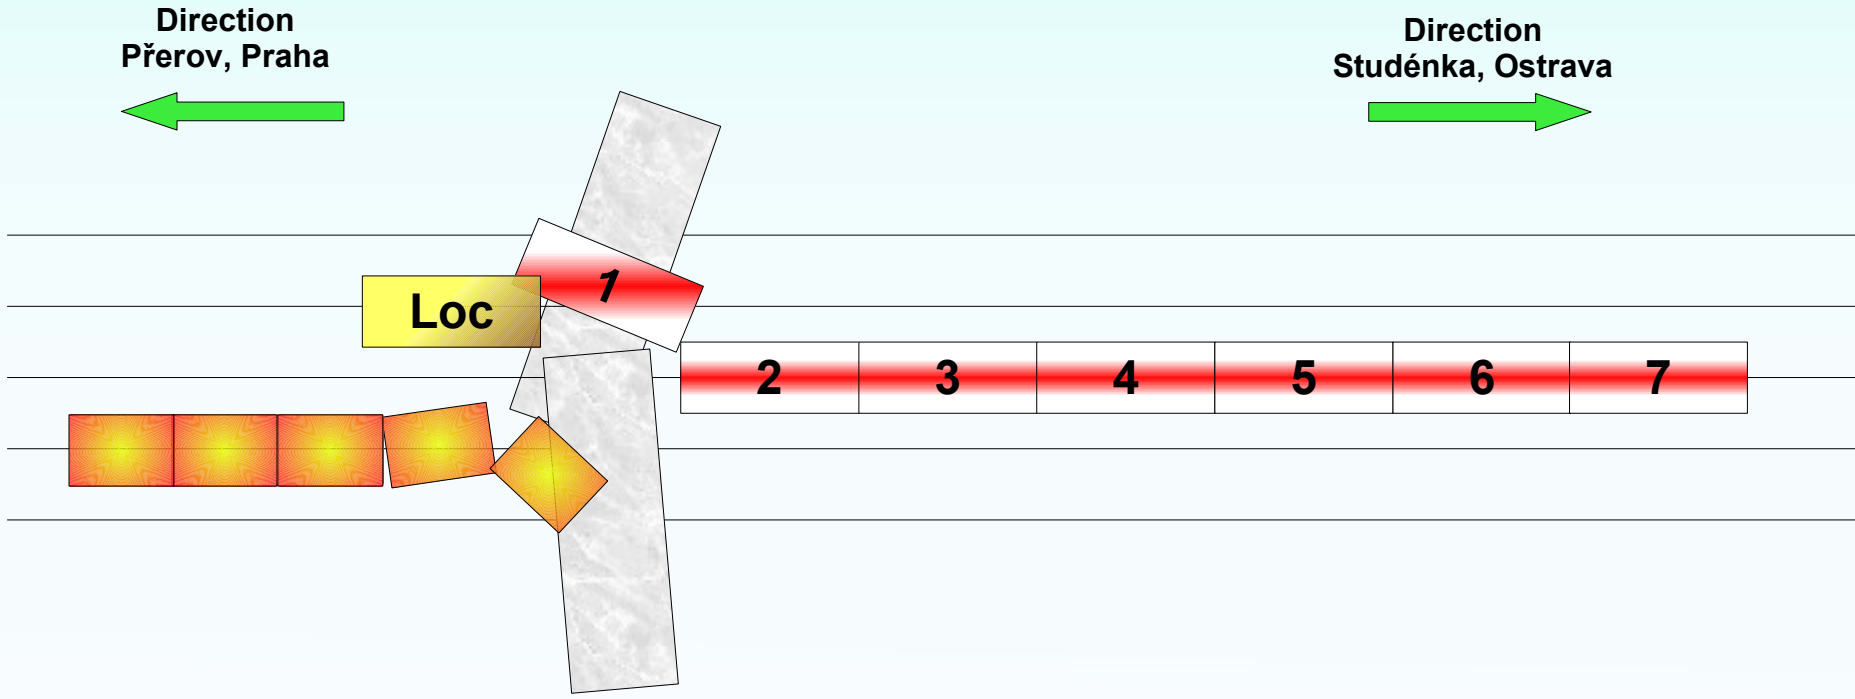
Dynamic process of the accident

→ the locomotive continues over the bridge construction

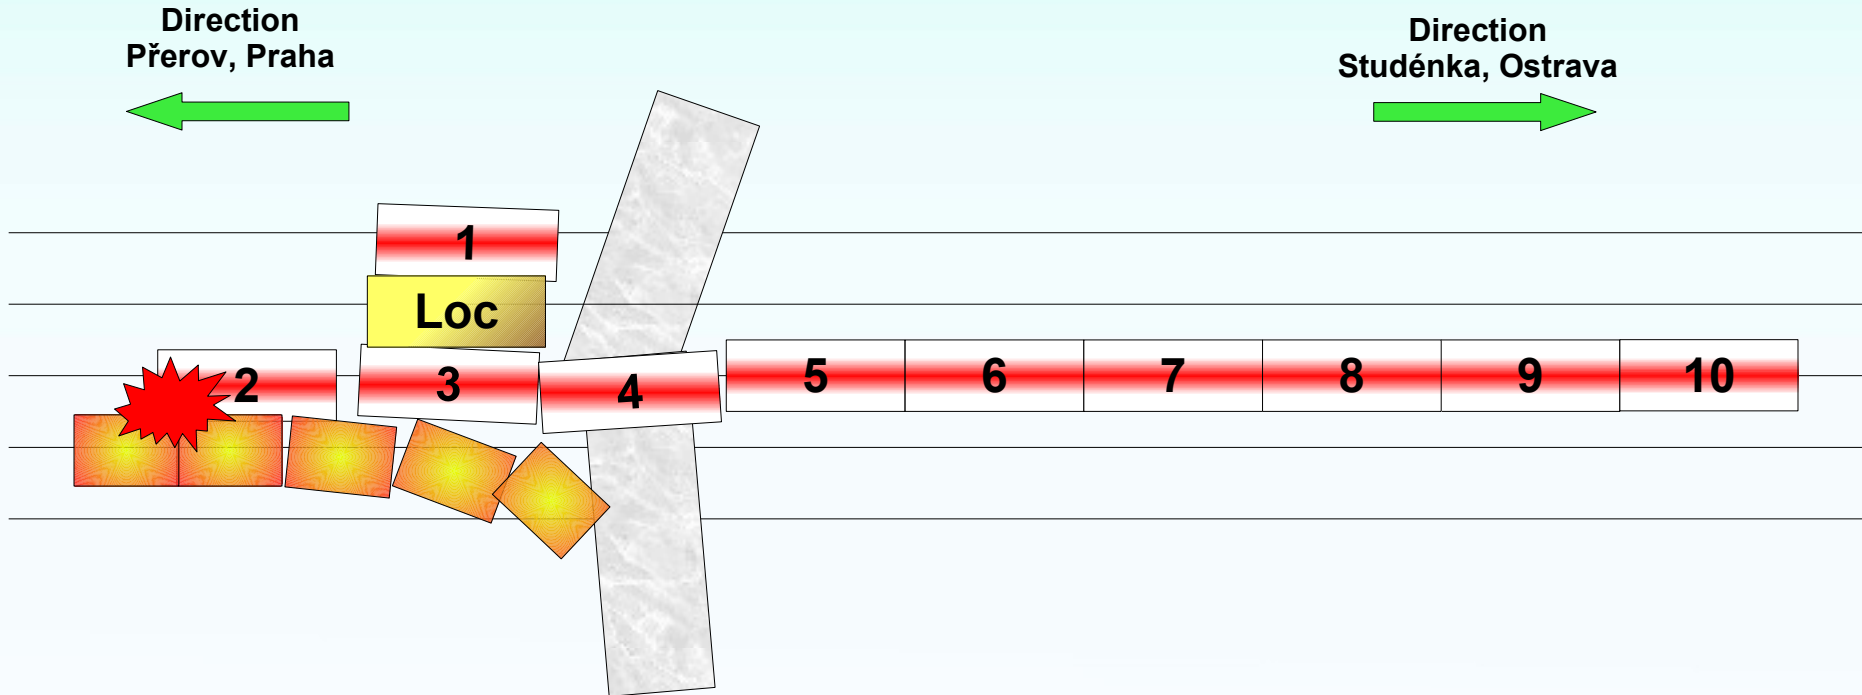
Dynamic process of the accident

- carriages jumped over the bridge construction
- carriage No. 2 collided with 2 wagons of goods train

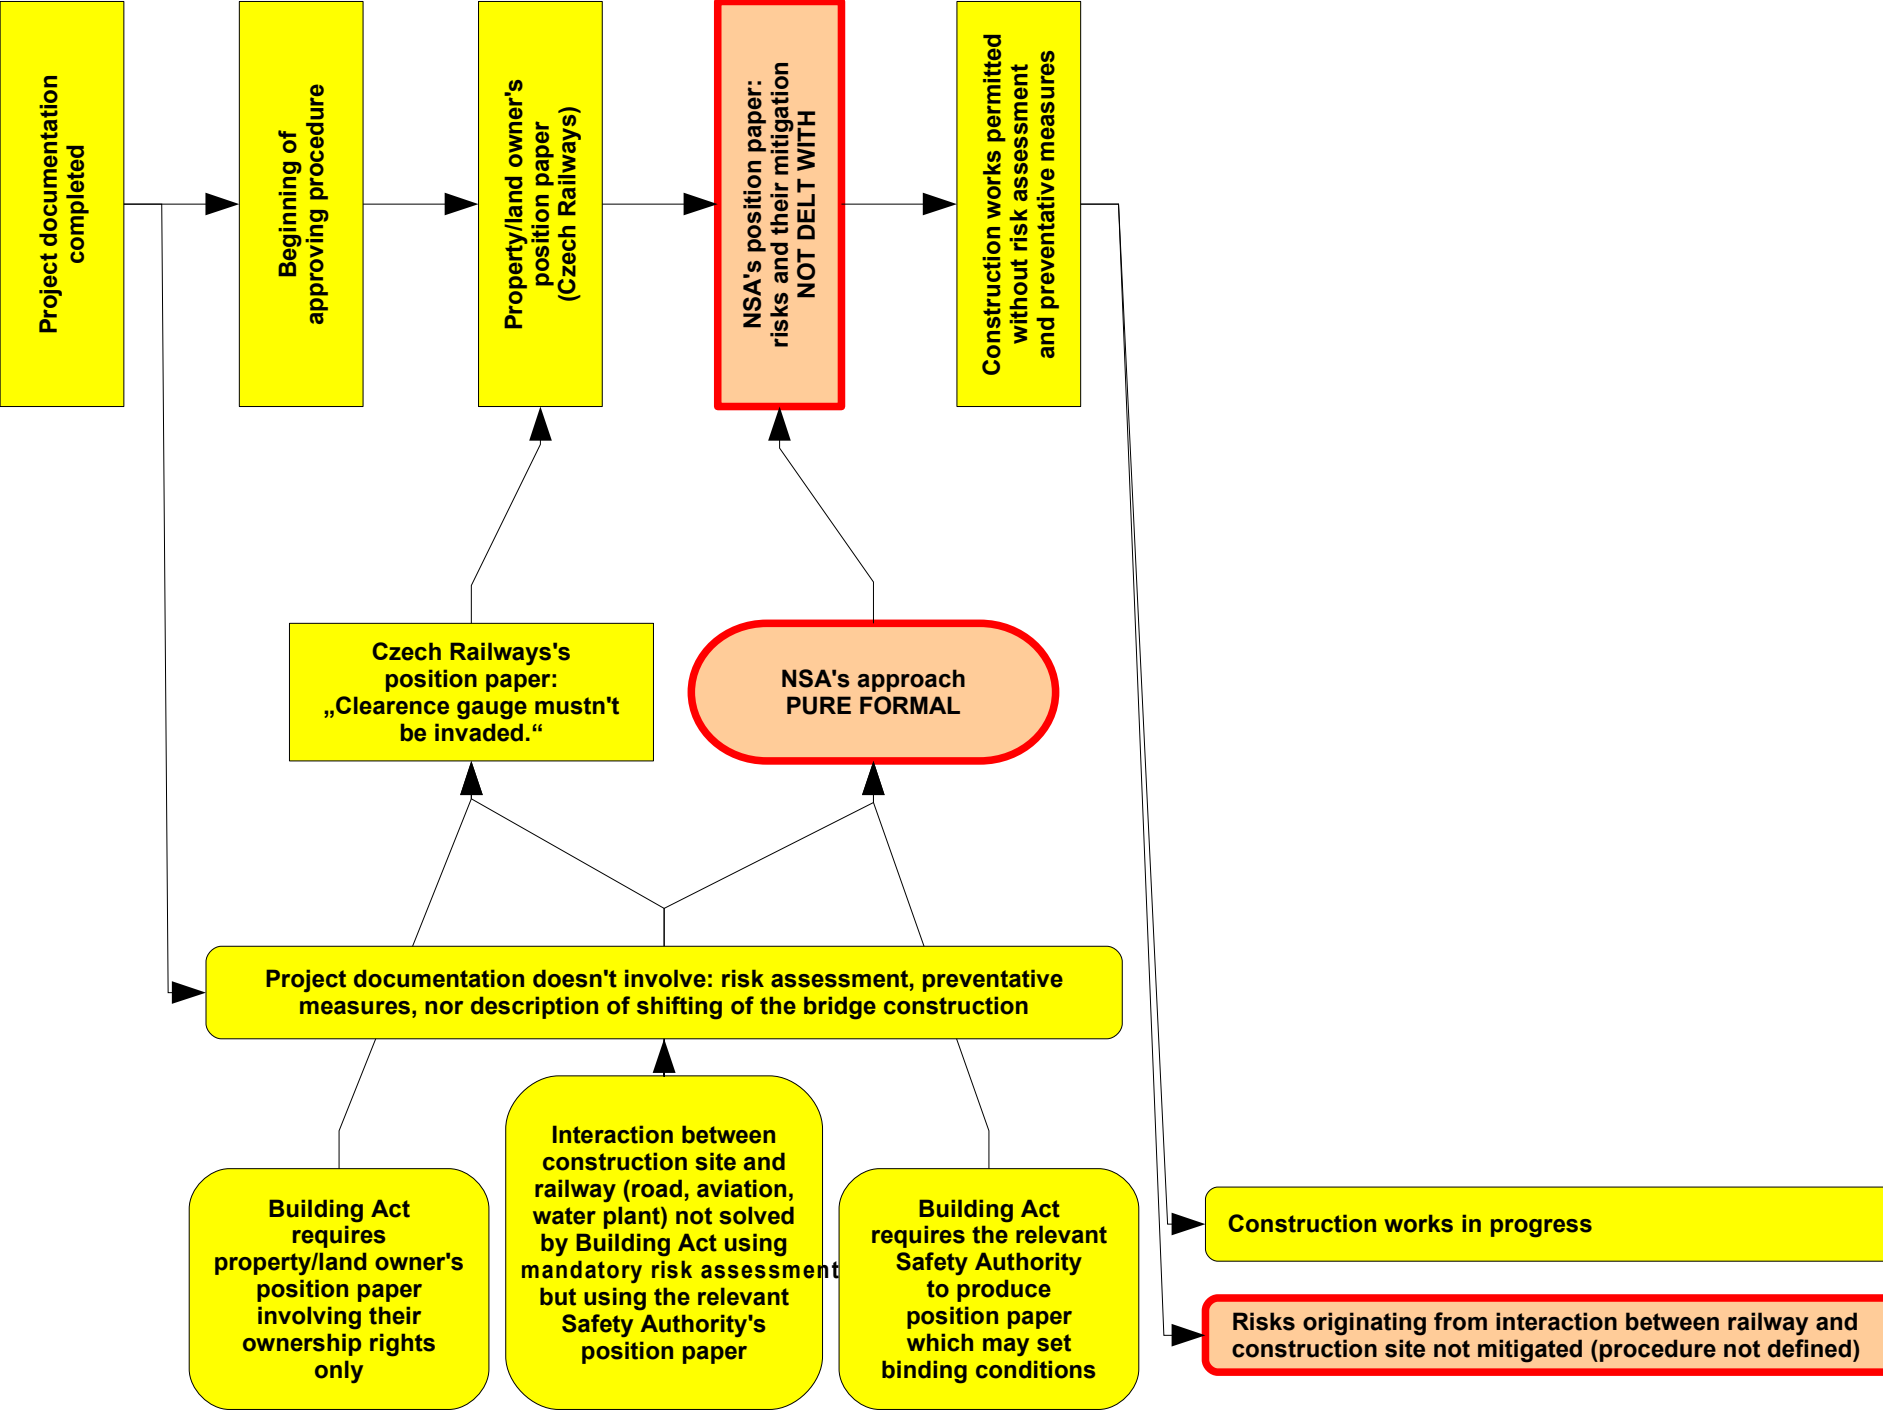
Accidental process

Unsafe condition of the bridge construction

Real braking effort 137%
Reported br. effort 144%

Track speed 150 km/h not reduced

Risks originating from interaction between railway and construction site not mitigated (procedure not defined)
