FINAL REPORT

2006-254-4

SERIOUS INCIDENT

**F-PIFS
SOUBRANE ACRO 200**

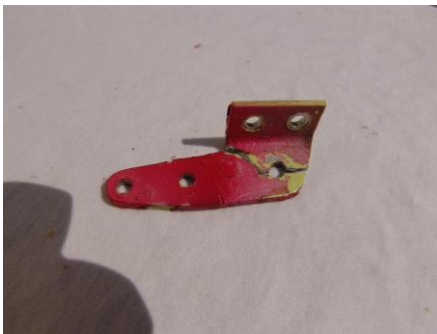
Bracket right eyelet fracture

The other eyelet shows dent marks similar to those visible on eyelet 1. The leg with one bore is broken, the missing part took away with it the lower half of the material. This fracture was also caused by tension combined with bending. (In more practical terms, the lower part of the eyelet leg was torn off.) The fracture surface is similar to those of the eyelet 1.

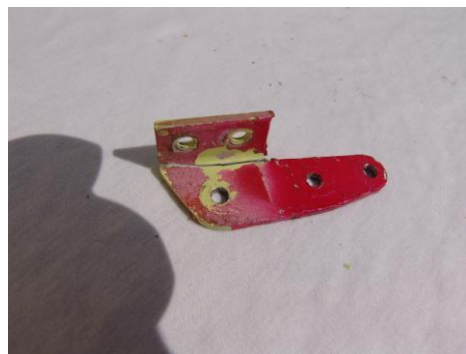
Bracket left eyelet fracture at its base

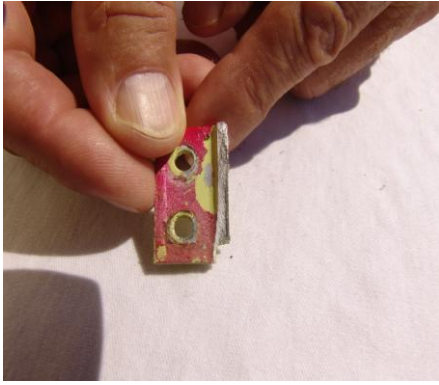
Fracture surface of left eyelet

The fracture surface shows a stringy texture, characteristic to extrusion. The whole surface is crystalline except for at the ends where shiny parts resulted from tensile load.

The fracture was caused mostly by tension combined with bending (a slight contraction is visible).

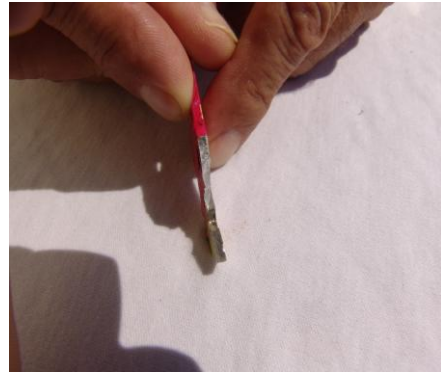
Grainy structure (dynamic fracture)

The center bracket's fracture surface has a grainy, crystalline structure. The reasoning and causes that are detailed in Part 2: Analysis, together with the above fracture surface, prove a dynamic fracture; the possibility of fatigue fracture can be excluded.

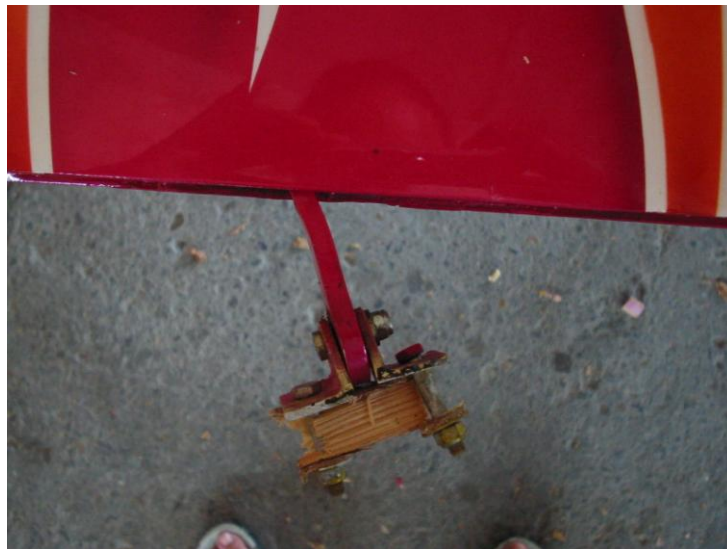
The outer hinge and the aileron spar also show dynamic fracture (see below).

The anchor point of the outer hinge was torn out of the aileron spar

With the fracture of the center joint the connecting flatter-weight was also lost. The system's center of gravity moved behind the rotation axis thus adding the force of inertia of mass to the inducing force. The amplitude of oscillations quickly rose, the shearing force T pulled the outer hinge anchor bolts and washers through the pinewood aileron spar. The aileron was then rotated around the inner hinge joint clockwise (seeing from the tail) and was broken at its weakest part, near the center hinge.

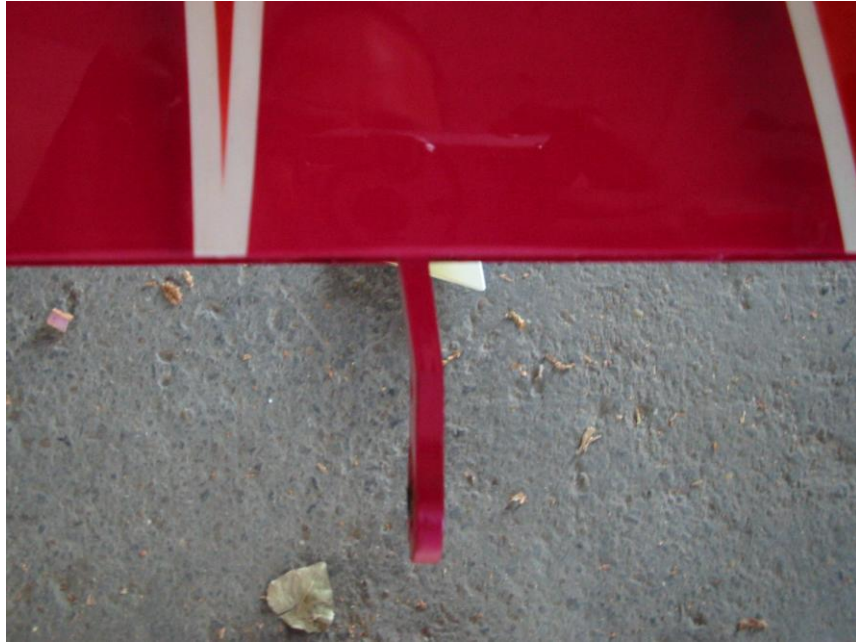
Damaged center hinge

The lower part of the above drawing shows that the center joint is rigid; this is where the momentum M_{cs} and the maximum shearing force T affect. The combination of loads resulted in the fracture of this joint.

2. In the IC's opinion, should the aileron hinges and brackets have been made of aviation steel instead of aluminium alloy, the damage of the aileron could have been prevented. The pilot works as a commercial pilot at an airline, therefore he is probably not an experienced aircraft designer. The designer should have considered the consequences of substituting the steel parts with alloy. What was gained in less weight was lost in strength, because the aviation steel has four times greater rupture strain than the alloy.

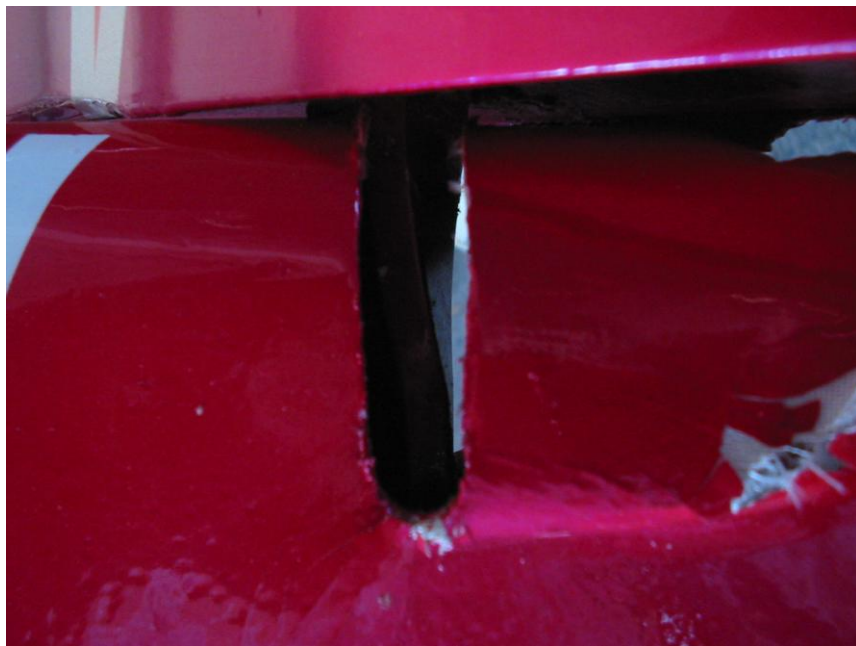
Damaged inner hinge

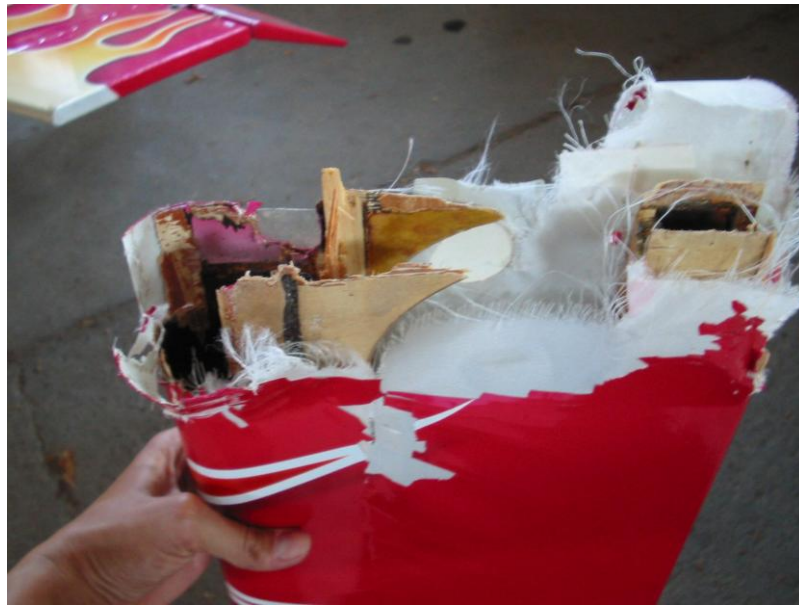
Broken aileron spar

3. The material selection for the aileron spar was unfavorable. Pinewood was used (cross section 40x16 mm), the distance between annual rings was ~3,2 – 3,5 mm that is considered too great; the ideal wood filament distance is 1,4 – 1,8 mm. It is probable, however, that even if the spar is made of stronger wood, it would have not sustained the stress caused by the loss of the flatter weight. In the IC's opinion, instead of standard washers, a 2-mm-thick metallic plate with a size of 35x40 mm should be placed on the spar in order to transfer the shearing force from the hinge to the aileron spar without breaking it.

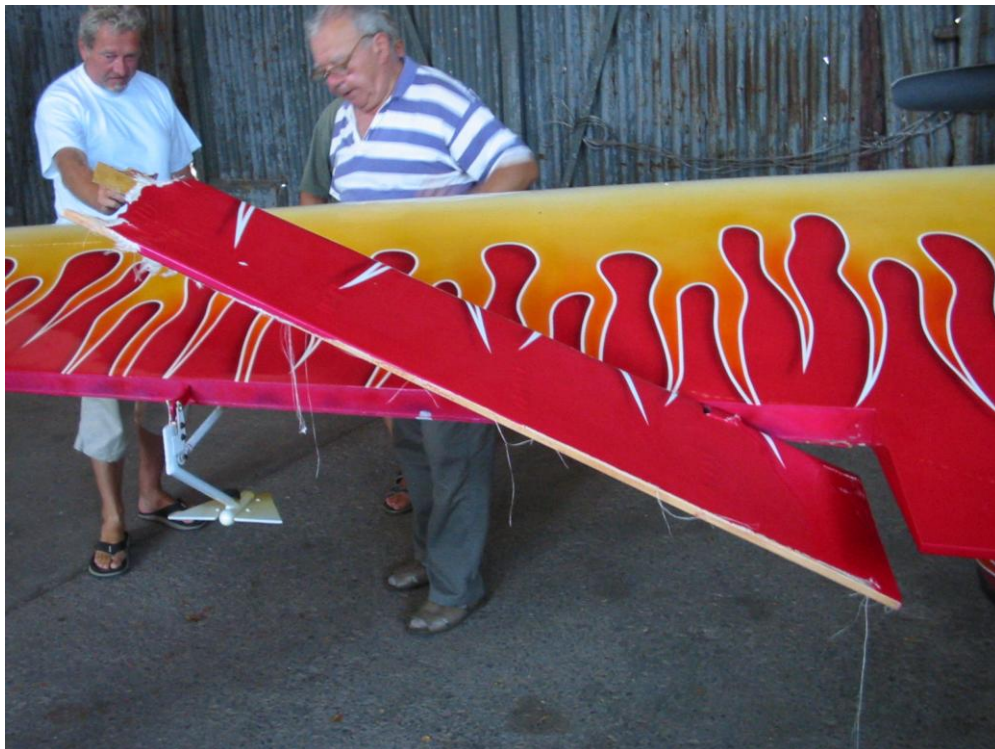
During the pull-up the aerodynamic forces tore the left eyelet of the center aileron bracket, broke the right eyelet at its base, and twisted the center aileron hinge (made of 6-mm-thick alloy) clockwise about 30 degrees. The outer hinge was torn out of the aileron spar, its M4 bolts and M4 washers (Φ 13mm) were simply pulled through the pinewood by the force. Once the outer hinges had been broken, the aerodynamic force broke the aileron spar next to the center hinge and turned the remaining part clockwise. Finally the inner hinge was also twisted. Therefore the left aileron and its three hinges were severely damaged.

The left wing and the remains of the aileron

BA 2006-254_1: The IC recommends the manufacturer to consider the expert opinion expressed in this final report regarding the material of which the aircraft was constructed, thus to use different materials for the construction of the aircraft.

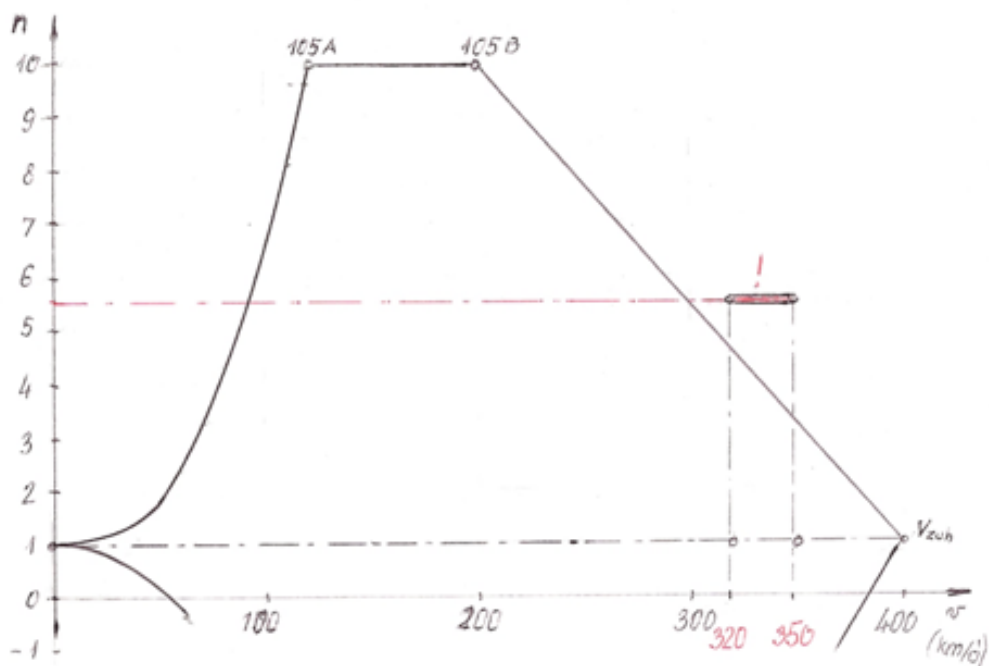
The occurrence was a direct consequence of the pull-up from steep (30 degrees), high-speed (320-350 km/h) descent with a load factor of 5.5 g. The pilot substantially exceeded the speed limits listed in the Flight Manual of the aircraft for pull-up from descent (200 km/h max) as well as for vertical roll (250 km/h max). Therefore, given these speeds and load factor, the load of the aircraft exceeded the limits determined by the Flight Manual (see the velocity- load factor diagram below) that resulted in structural damage.

1. The Flight Manual is very basic and omits several parameters that are very important for the pilot. Moreover, the IC found that the pilot misinterpreted the limitations given in the Flight Manual: he believed that the speed limits were minimal speeds at which the given aerobatic element can still be completed. This misunderstanding explains why he exceeded the speed limits. The IC states that the velocity- load factor diagram should be printed in the Flight Manual of an aircraft made for aerobatics, along with the limitations derived from this diagram.

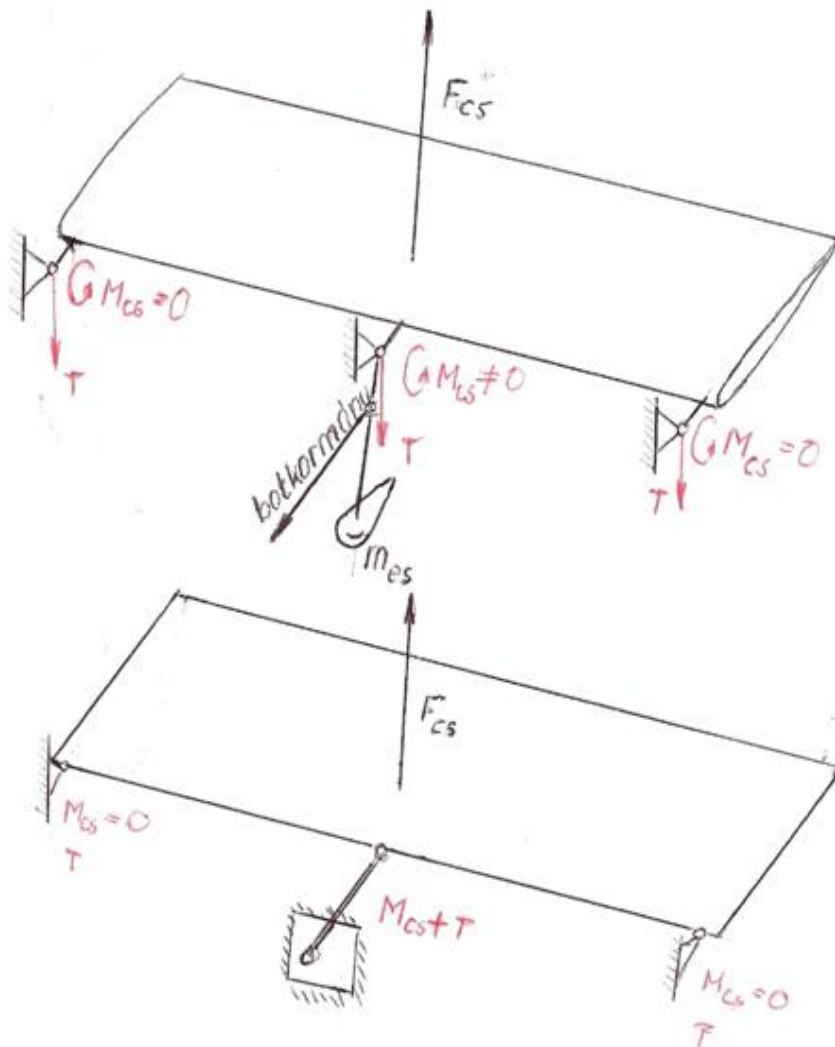
The aileron can be seen as a flat surface anchored to the wing with three hinges. When the aileron is activated, an aerodynamic force F_{cs} is generated. Because the inner and outer hinges are fitted with bearings joints, there is no momentum on those. The center hinge, however, is connected to the aileron pushrod that holds the aileron in the preset angle, therefore a bearings momentum M_{cs} can be calculated; this momentum represents a load on the anchor point of the center hinge.

Moreover, the aerodynamic force generates shearing force T on all three joints. These forces are not equal because they depend on the lift generated by the wing section. Most possibly the greatest shearing force is at the center hinge because there is the maximum of the distributed aerodynamic force.
