FINAL REPORT

**2008-219-4
SERIOUS INCIDENT**

**Ferihegy
27th July 2008**

**Airbus A-320 / Saab-2000
D-AIQB / YR-SBL**

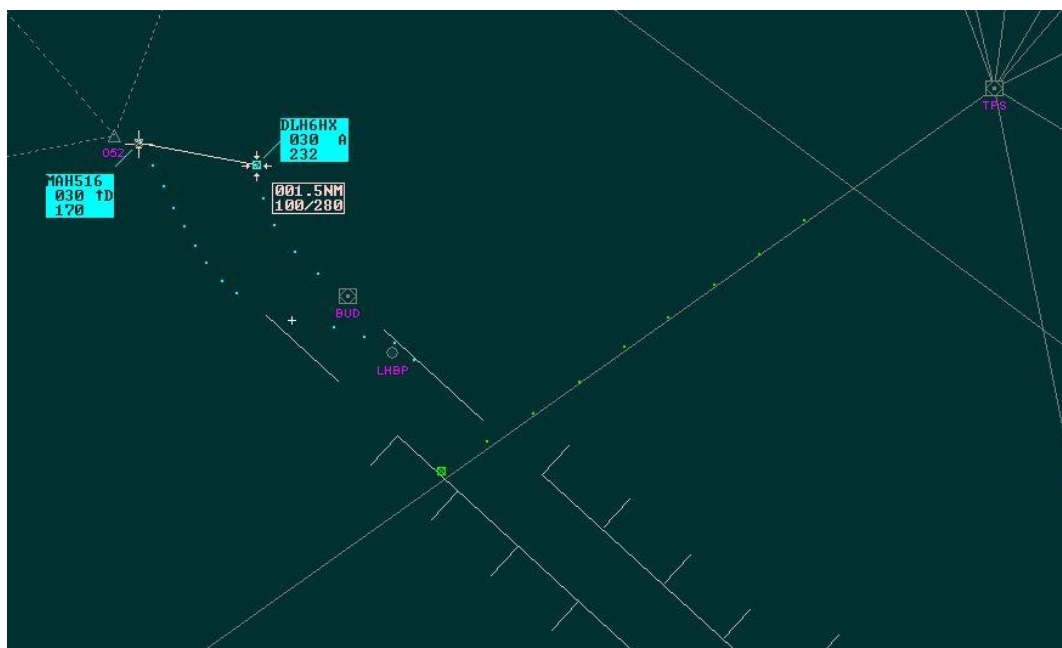
During the incident the 3 NM separation minimum applicable in Budapest TMA airspace was reduced to 1.4 NM at the same altitude. The further flight of the aircrafts ensued without any incident, they landed safely at their destination airports.

Figure 1. The LAN radar shot shows flights DLH6X and MAH516 on the same altitude, 1.5 NM from each other.

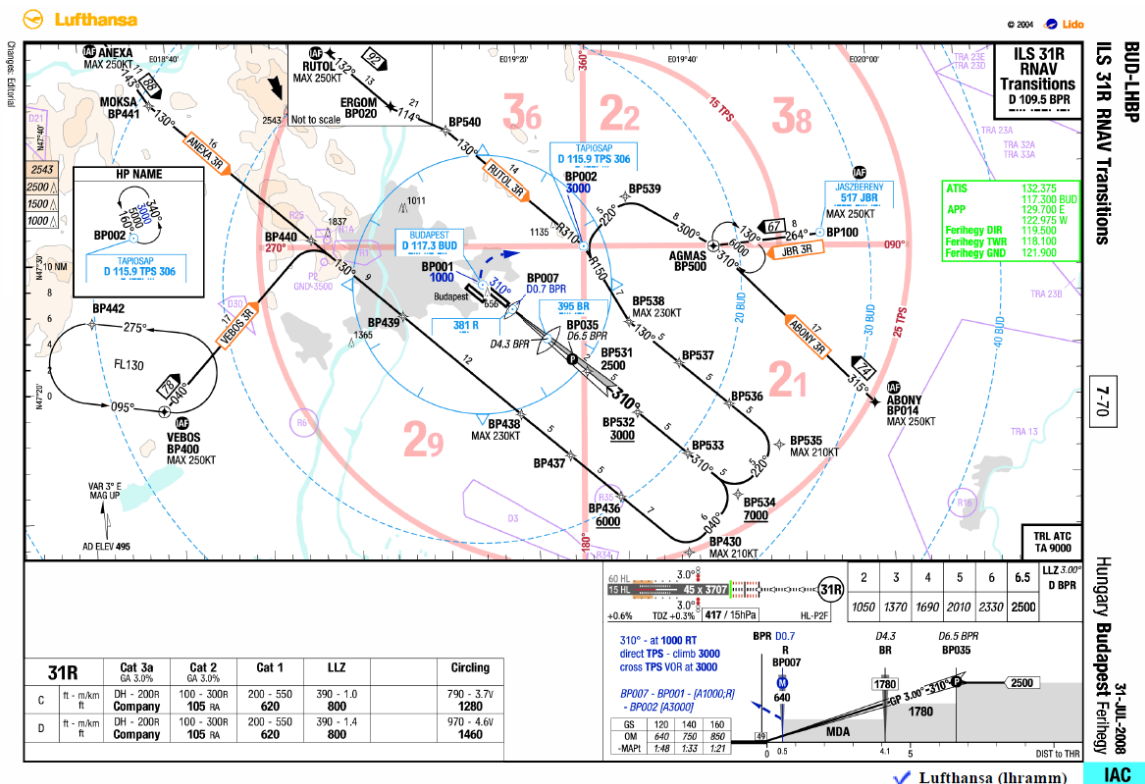
Fig.2. LIDO Chart for the ILS approach of 31R

i.e. flying at 310°, right turn at 1000 feet, climbing to 3000 feet in the direction of TPS, crossing TPS VOR at 3000 feet (Fig. 2).

In the opinion of the IC, the map and the verbal description of the procedure do not match entirely. DLH6X did not follow the missed approach procedure described by the test, i.e. it did not turn right at 1000 feet, but climbed to 3000 feet maintaining the direction of the runway, and kept its direction until passing BUD VOR. Only after passing BUD VOR did it turn to the direction of TPS in the manner it is shown by the map.

The map used by the crew was identical to the current AIP map at the time of the occurrence. HungaroControl issued a decision on 27th August 2008 to correct the misunderstandable figure, the corrective measures were taken. Thus, the AIP

modification published after the incident, valid from 12th March 2009 includes a new map and a modified description on how to carry out the missed approach procedures (see the Appendix).
