KÖZLEKEDÉSBIZTONSÁGI
SZERVEZET

FINAL REPORT
2008-252-4
SERIOUS INCIDENT

Budapest FIR
26th August 2008

Boeing B-757-200 / Airbus A-320
4X-EBU / TC-FBE

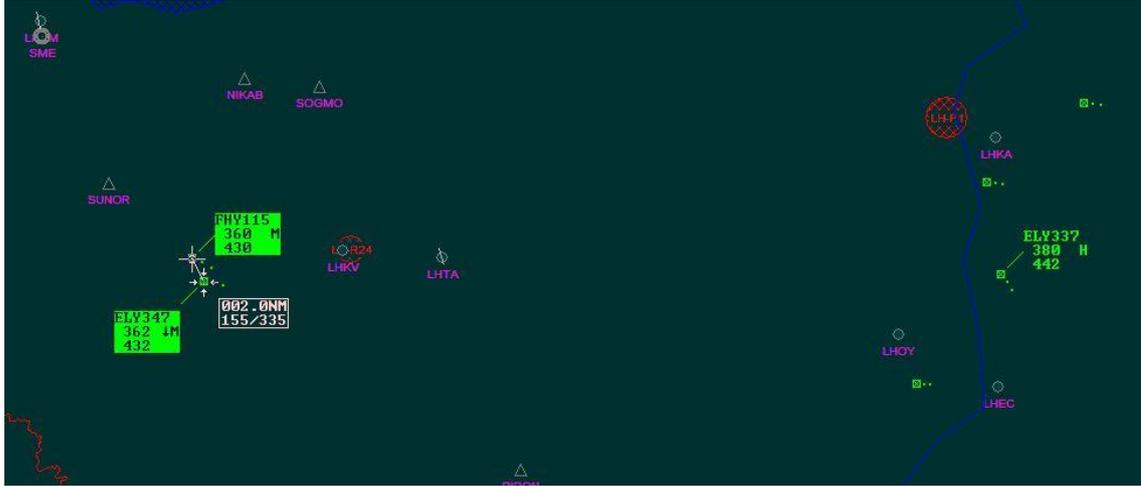
Flight ELY347 descended from FL380 to FL340, and so got in a conflict with flight FHY115 flying below it on FL360.

The smallest separation between the two flights was 2 NMs on the same flight level.

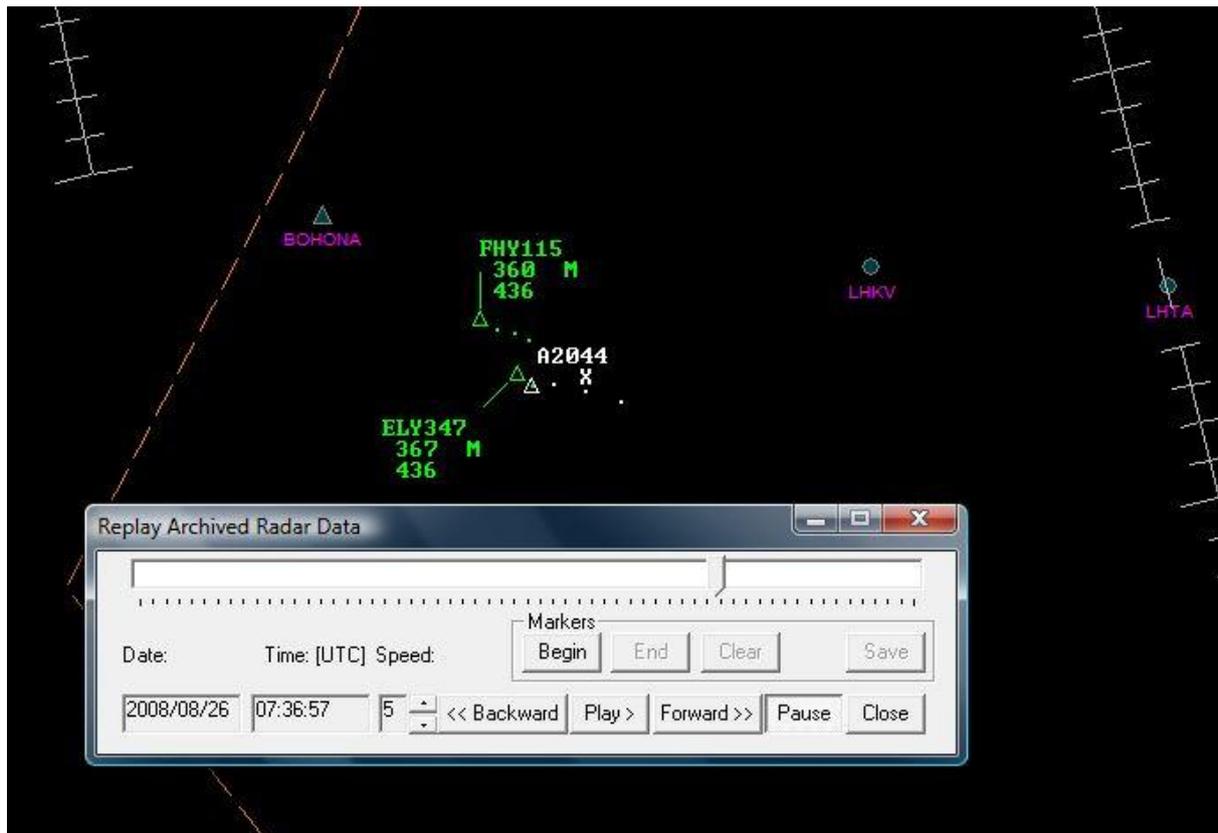
Appendix 1.

Until 07:38:59 ATC was constantly giving permissions and instructions to flight ELY337. These were replied to consistently by ELY347 without giving its call sign. Thus the instruction to descend to FL340 addressed to ELY337 was carried out by ELY347 getting so in conflict with flight FHY115 proceeding in the same direction below it on FL360.

Appendix 1: Position of flights ELY347 and FHY115 when separation ceased to exist
