KÖZLEKEDÉSBIZTONSÁGI  
SZERVEZET  
TRANSPORTATION SAFETY  
BUREAU

**FINAL REPORT**  
**2008-315-4**  
**SERIOUS INCIDENT**  
**Krakow**  
**11 October 2008**  
**Fokker F28 Mk 0070**  
**HA-LME**

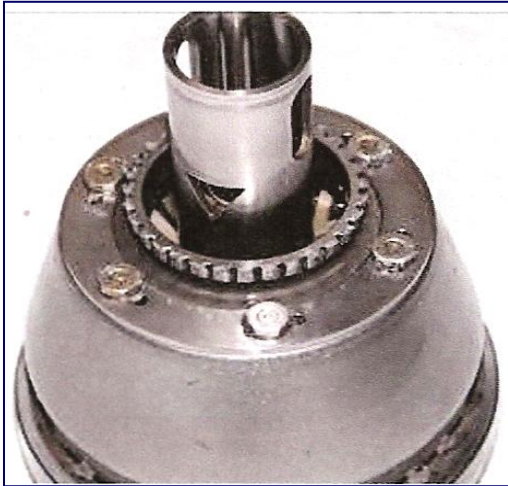
As a response to the request of TSB, the operator sent the Fuel Flow Regulator S/N B2693 for shop visit to Goodrich Engine Control Systems (GECS) in order to reveal the cause of malfunction. In the reports from the shop visit it was established that the gear ring (P/N 771333983) of the fuel control unit was so much worn that the mechanical contact through the driving gear between the pressure drop governor and the speed control governor had been lost.

**Fig. 1.** The worn gear ring

Thus the control unit got into such a boundary condition where the fuel gushed uncontrolled, in big quantities into the engine, independently of the position of the throttle lever, generating the high engine parameters due to which the engine had to be shut down and emergency landing had to be carried out. Figures 1 and 2 show the photos taken during the investigation by GECS. The investigation established that the cause of high degree wearing was the fact that the equipment was operated much longer without “midlife reworks” and overhaul than the operating time recommended by the manufacturer.

- **BA 2008-315-4\_01:** The IC recommends NTA AD to control, using its powers of authority, whether the flying hours data of the CASC512 Fuel Flow Regulators mounted on the TAY 620-15/20 engines of Fokker 70 type airplanes operated by Malév Zrt. fulfil the requirements of document GOODRICH CMP 052.
- **BA 2008-315-4\_02:** The IC recommends NTA AD in possession of the data resulting from the control described in paragraph BA 2008-315\_01, to carry out the measures necessary to terminate the situation endangering flight safety without delay.

Maintenance Programme” in line with the recommendations of document „EMP Tay 620-15 for Fokker 70 & 100 Operators” (RM 1581 issue 6. 26 November 2007) issued by Rolls-Royce Deutschland Ltd & Co KG. Regarding Chapter 4. ”ON-WING MAINTENANCE” of the above mentioned document, besides the jobs required by Fokker MPD, the modification shall extend to the so-called „RR tasks” as well. The modified „Malév Fokker 70 Maintenance Programme” shall be submitted to NTA AD for approval.

- **BA 2008-315-4\_04:** The IC recommends Malév Zrt. to include in Chapter “Component Limitation” of “Malév Fokker 70 Maintenance Programme” the “soft time” engine auxiliary equipment and maintenance tasks from document RR „EMP Tay 620-15 for Fokker 70 & 100 Operators” together with their from/until “soft time” values.

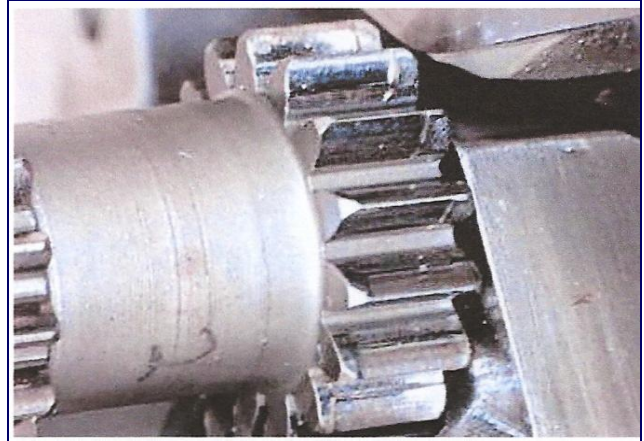
**Fig. 2.** The planet gear
