TRANSPORTATION SAFETY
BUREAU

FINAL REPORT

2009-229-4P AVIATION INCIDENT

Piper Cherokee Arrow PA 28R 201

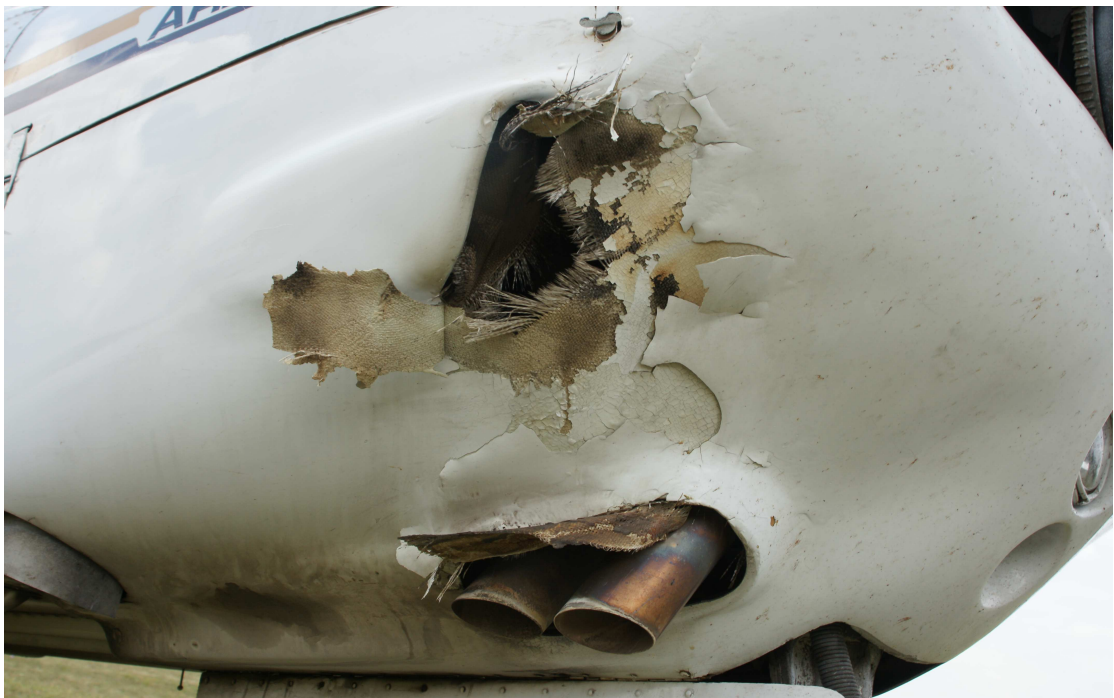
The exhaust pipe got separated from the right front cylinder of the engine. As a result, the hot exhaust burned out the epoxy of the engine cowling made of composite, and created a hole in it. The damage can be repaired.

The IC believes that the fracture of the exhaust pipe was a result of material fatigue caused by extended vibration and dynamic loading of the tube. Hairline cracks developed, and at a point the cracks gave way to a fracture. The separated piece of the pipe was free of corrosion and burning marks. Two 2-cm long fresh fractures were visible on the perimeter of the pipe. The IC established that the engine temperature readings were high due to the exhaust gas which got inside the engine bay. The IC did not find oil leak marks on the propeller or in the engine bay. There was no measurable oil consumption. After the repair the aircraft was tested on the ground as well as in flight. The oil system was found fully functional in the course of the tests, therefore the reported oil pressure problem could not be confirmed.

The incident was caused by the fracture of the exhaust pipe as a result of metal fatigue.
