TRANSPORTATION SAFETY
BUREAU

FINAL REPORT

2010-004-4P
Serious incident

Fokker 100
HB-JVE

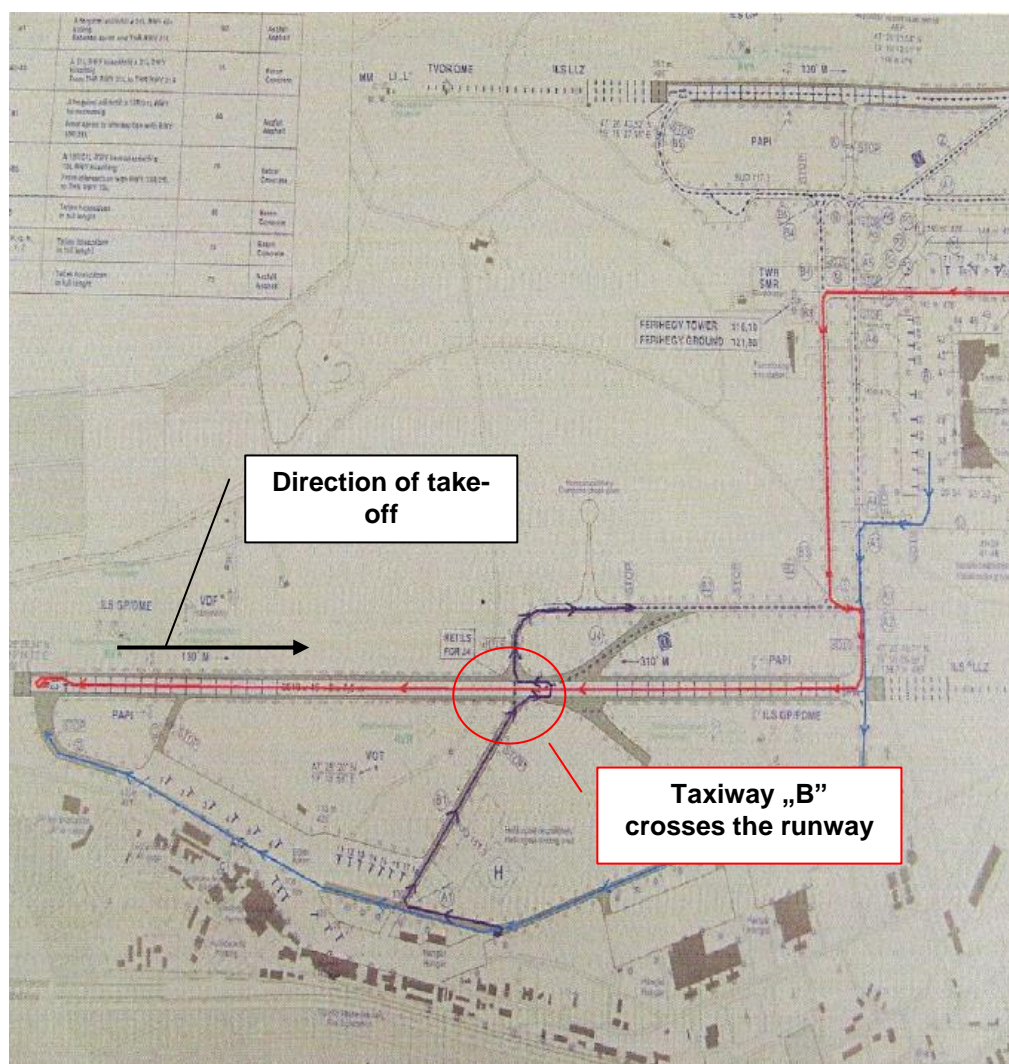
Fig. 1.

Line of movement of flight SWR225A (red), of the snow clearing vehicle line (violet) and of flight ELY366 (blue)
