**KÖZLEKEDÉSBIZTONSÁGI  
SZERVEZET**

# **FINAL REPORT**

**2010-202-4P  
INCIDENT**

**BOEING 737-600  
HA-LOE**

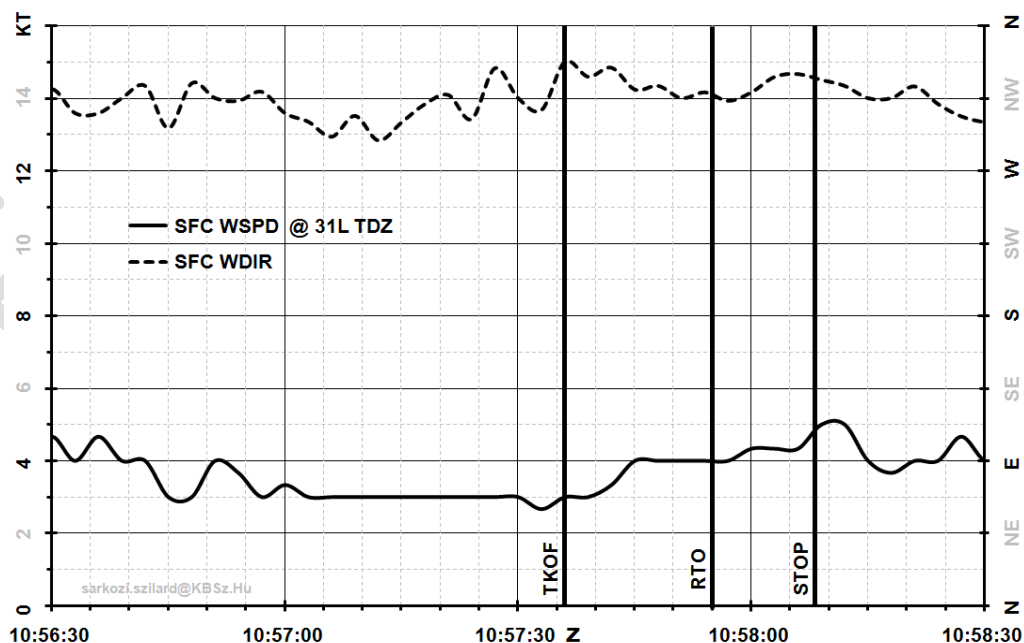
The occurrence took place at daylight in good visibility, with no mentionable weather phenomena present. There was only fair wind, 3-5 kts, including gusts, from NW, smooth, which was ideal for take-off from 31L. Just prior to the take-off a 3-knot wind was registered from NW-NNW. (A slight turbulence of 5 kts could easily be a wake turbulence from the previous aircraft.) It is almost certain that there was no turbulence stronger than the usual daytime thermals present which could have substantial effect on the take-off.

Wind parameters recorded at a place 130 m away from the location of the occurrence

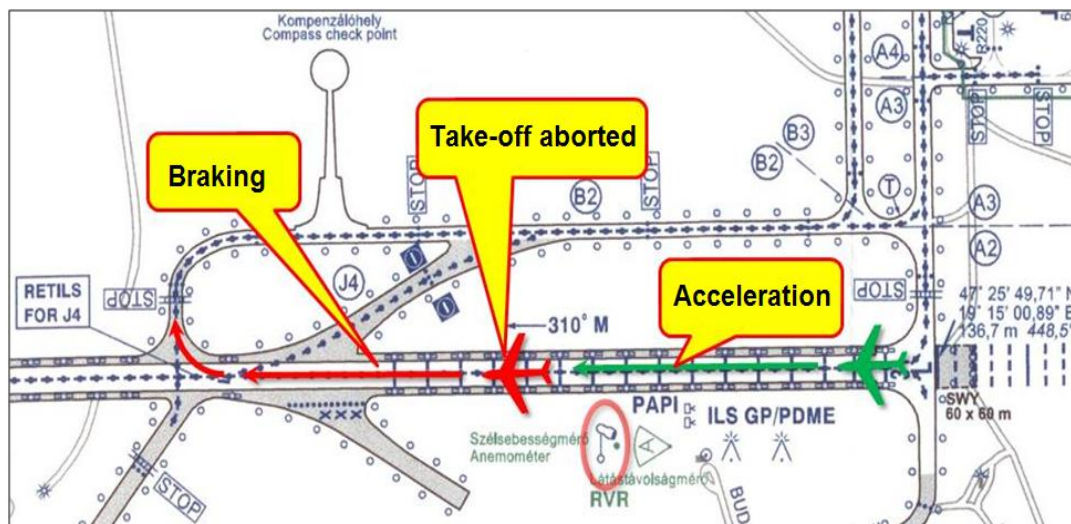
The location of the occurrence. The anemometer marked with a red circle

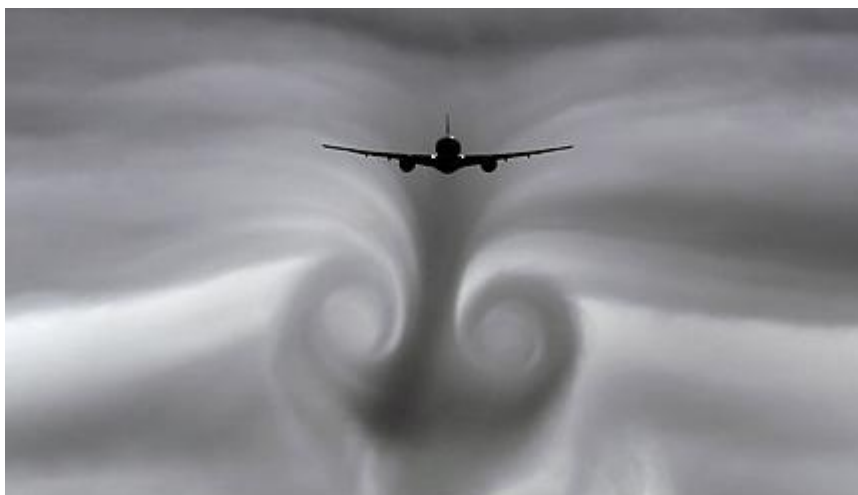
**Wake turbulence (illustration)**

The stagnation of indicated airspeed during take-off as well as the crossing of angle-of-attack vanes one another on the fuselage sides are indicative of an encounter with atmospheric disturbance. It is highly unlikely that such a turbulence is a result of atmospheric disturbances as the air mass was calm at that time. It is more likely that the disturbance was wake turbulence from another B737 aircraft that took off just one minutes and 50 seconds prior to the occurrence aircraft.

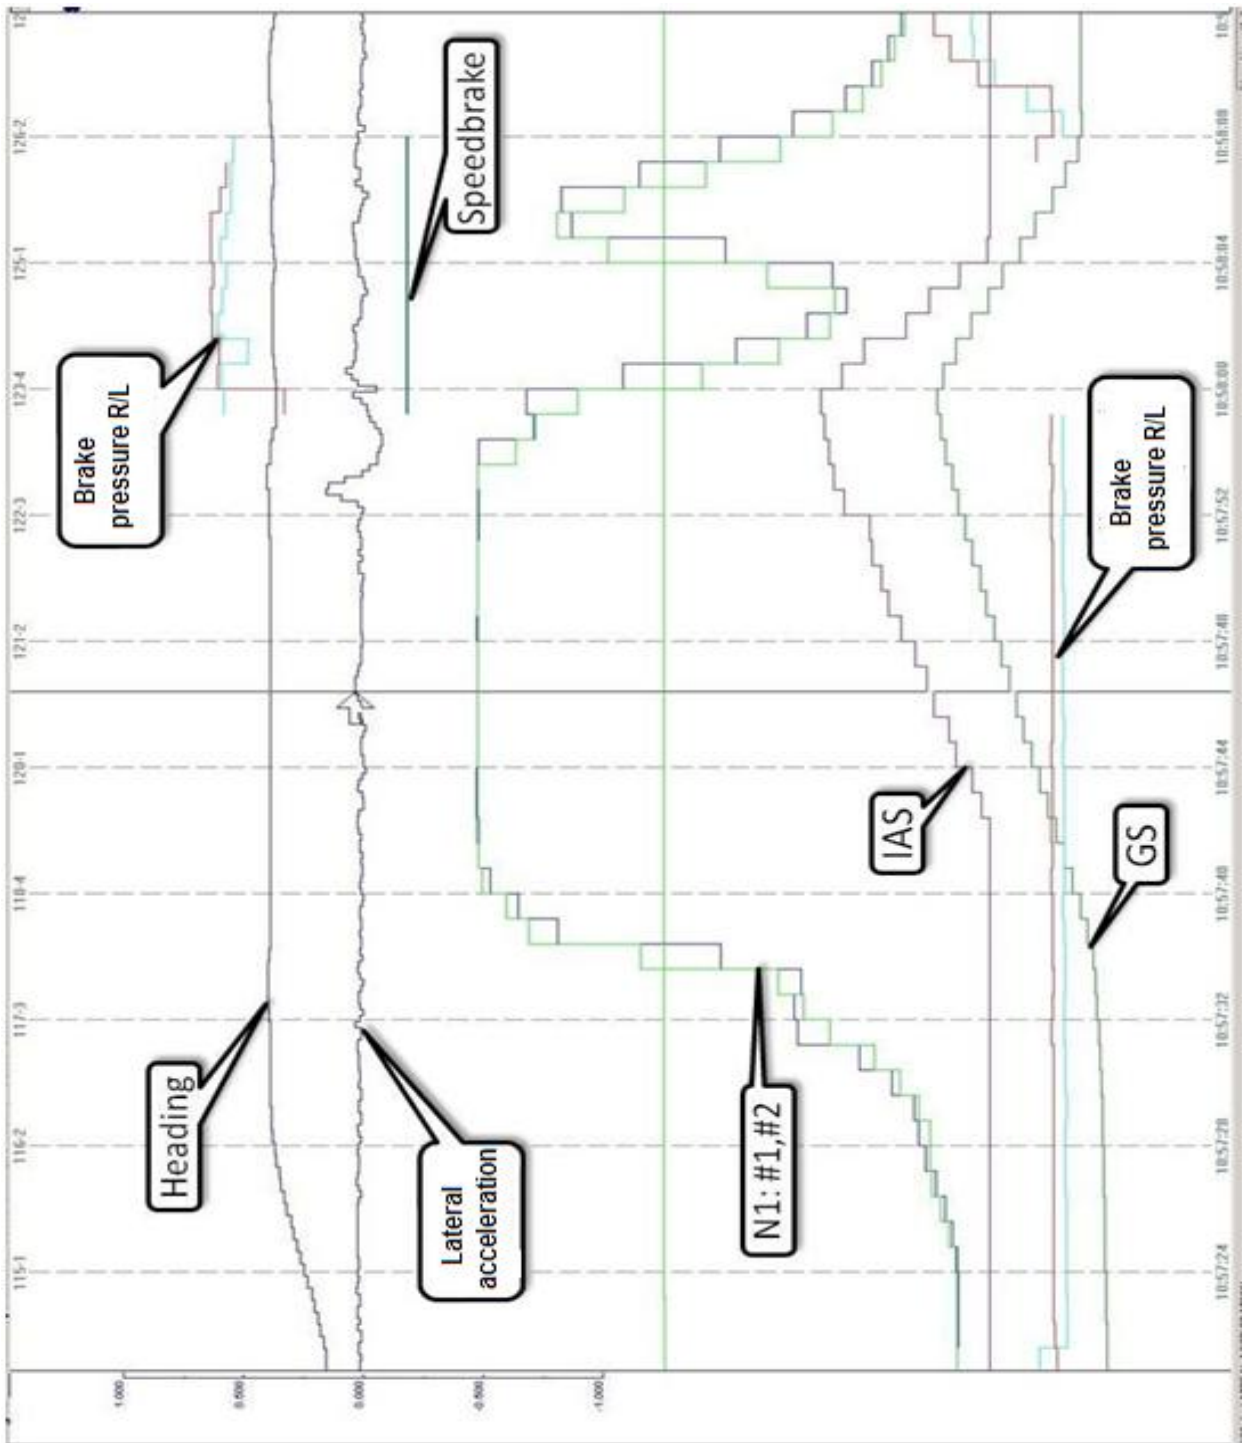
# APPENDIX 2: FDR INFORMATION (1)

The FDR functioned as expected. The evaluation of FDR data was conducted by the MALÉV Flight Safety Office and the Boeing Customer Support. The data showed that the engines, the aerodynamic and wheel brakes worked in full symmetry (see Appendix 2). Prior to the abort there was a lateral jolt of 0.16 g to the right while at the same time the rudder was in the position of 7.6 degrees to the left. Also at this moment the yaw-damper moved the rudder 3 degrees to left (with its maximum movement) while the pilots added an extra 2.6 degrees of pedal which equates to about 5-6 degrees of rudder. The yaw-damper then responded to the change in yaw rate and moved to its full right position of 3 degrees while the recorded acceleration shifted to 0.08 g to the left in 2 seconds. The recorded headings paired with the acceleration values were 311 degrees and 307 degrees accordingly. The data showed that after these lateral acceleration and heading changes the yaw-damper made oscillations inversely proportional to the yaw rate (per design) that slowly diminished (see Appendix 4). At the moment of the first lateral jolt the indicated airspeed stagnated while the angle-of-attack vanes registered values of opposite direction (see Appendix 3).

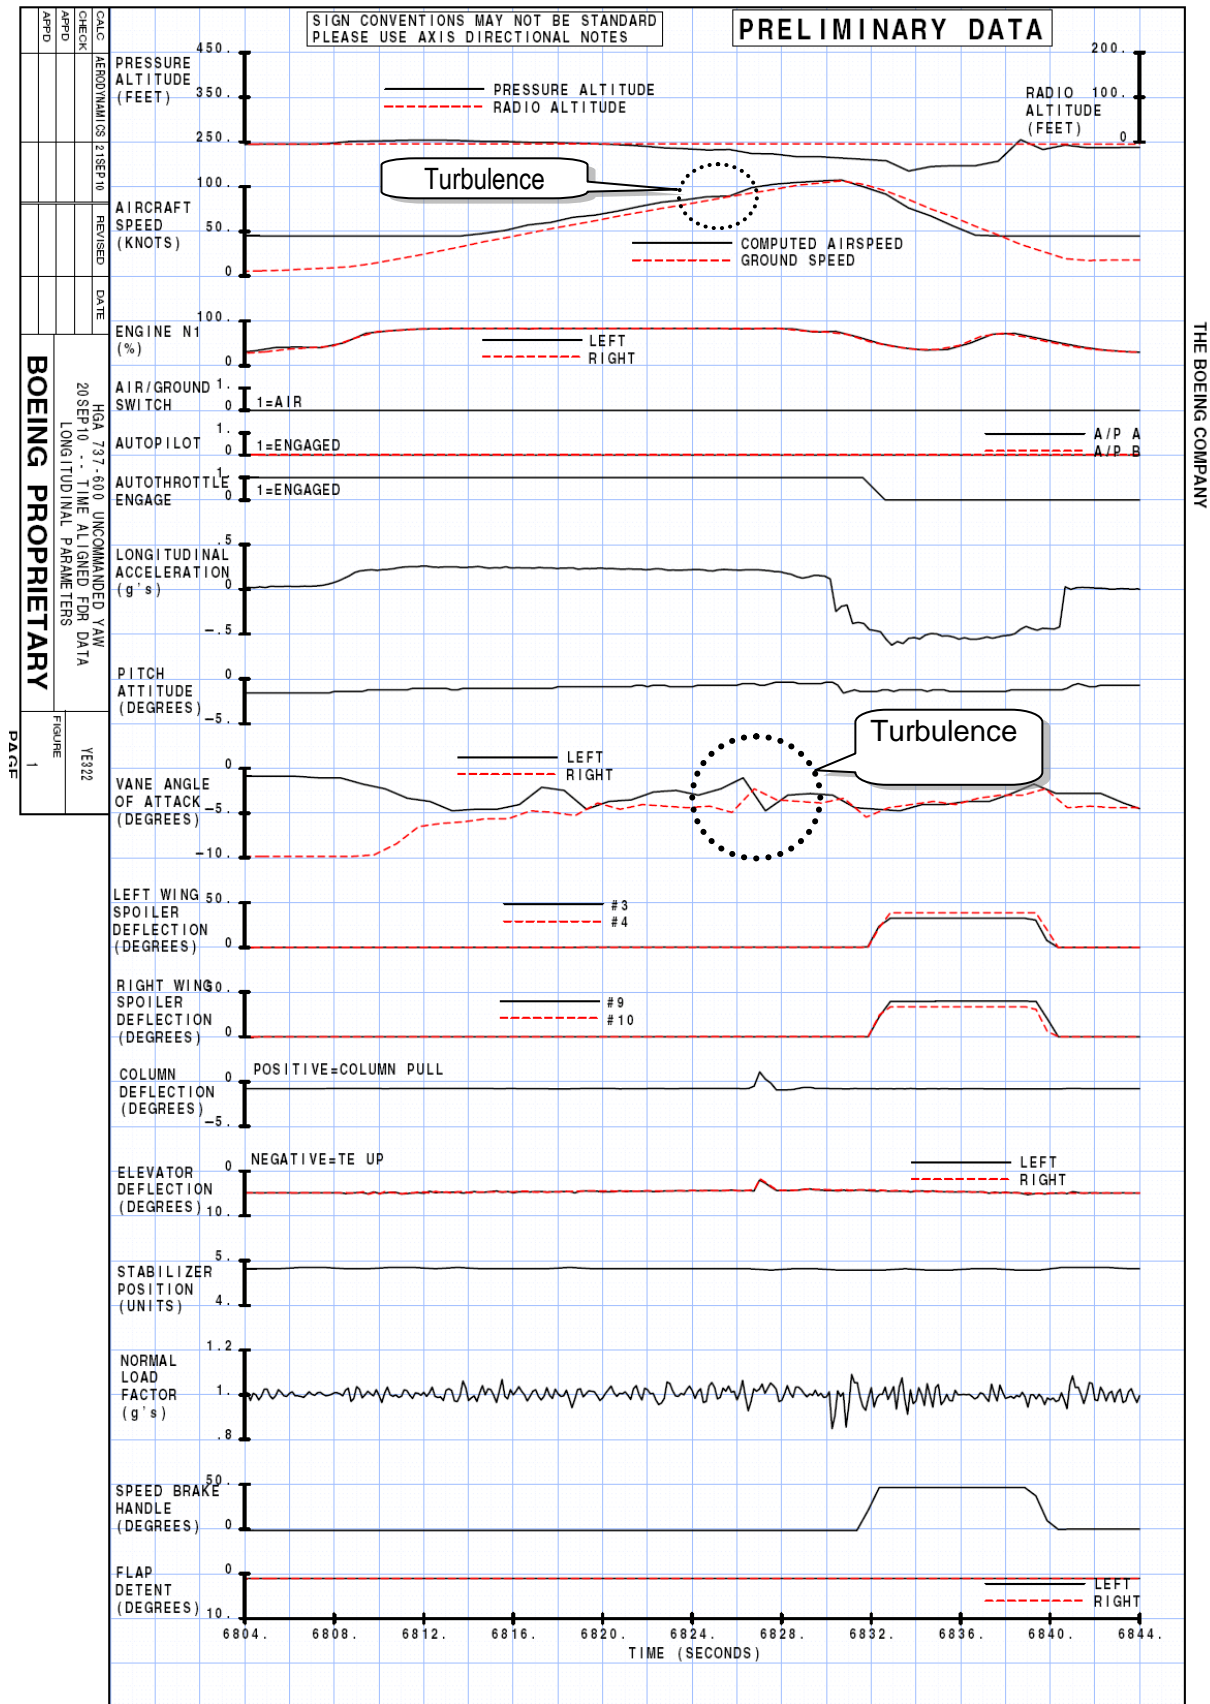
### APPENDIX 3: FDR INFORMATION (2)

4. Ref /E/ FDR data plots are attached to this message. The following is a summary of our analysis and review of the FDR data submitted by HGA:  
 The data show the airplane experienced a lateral acceleration of approximately .15 g's to the right around time 6827 seconds. Coincident with the lateral acceleration spike, left rudder was commanded by the crew, as evidenced by the rudder pedal moving to the left synchronously with the rudder position. This is a normal correction for an acceleration and yaw to the right.  
 Just prior to the acceleration to the right, between times 6824 and 6826 seconds, a stagnation in airspeed was observed. Also, around the time of the spike in lateral acceleration, oscillations in vane angle of attack were noted, with the left and right vanes crossing over one another. These characteristics are indicative of an encounter with atmospheric disturbance, most likely a wind gust or wake turbulence. This disturbance was the cause of the airplane yaw to the right, and the airplane operated as expected.

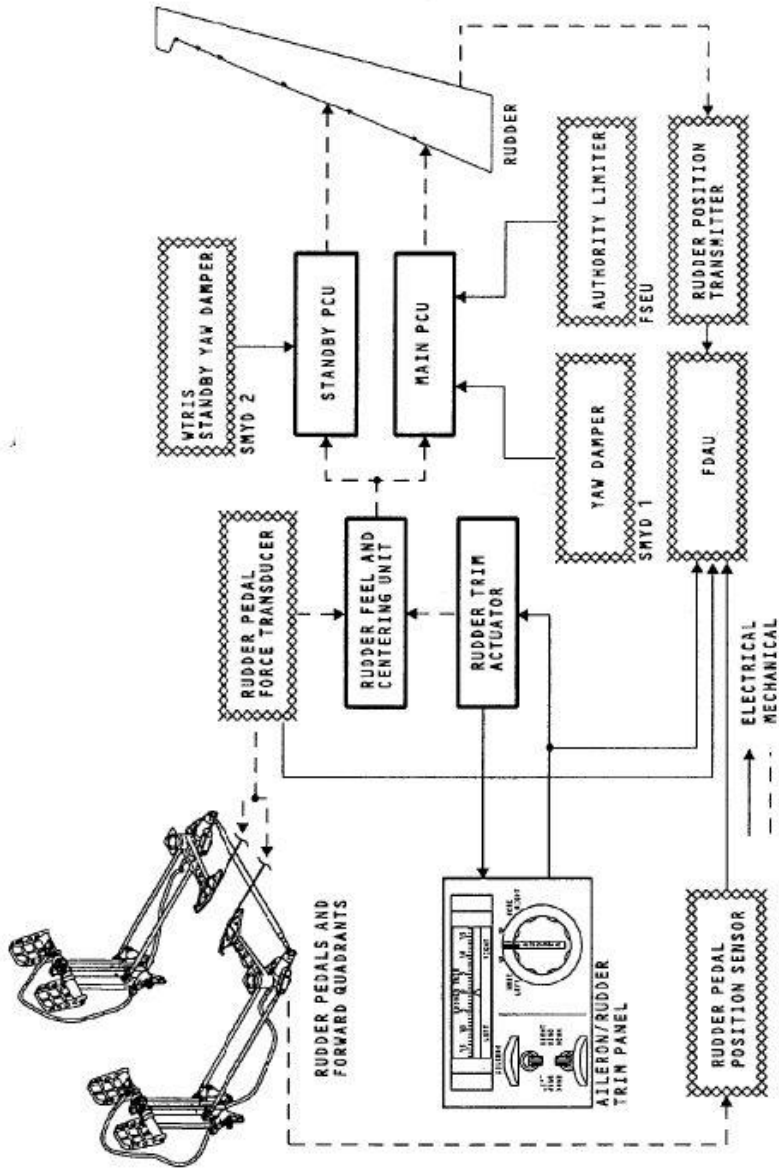
APPENDIX 5: General schematics of rudder control

A schematic drawing of rudder control system of the aircraft can be found in Appendix 5. The rudder is controlled by the pedals and the automatic yaw-damper system. Any of these controls can independently move the rudder surface. If the two controls work in the same direction, their effect is summarised. The functioning of the yaw-damper does not have any effect on the pedals therefore its operation cannot be noticed directly by the pilots.
