**TRANSPORTATION SAFETY
BUREAU**

FINAL REPORT
2011-269-4P
SERIOUS INCIDENT
LHBP
14.11.2011.
Boeing 737-800
VP-BNG

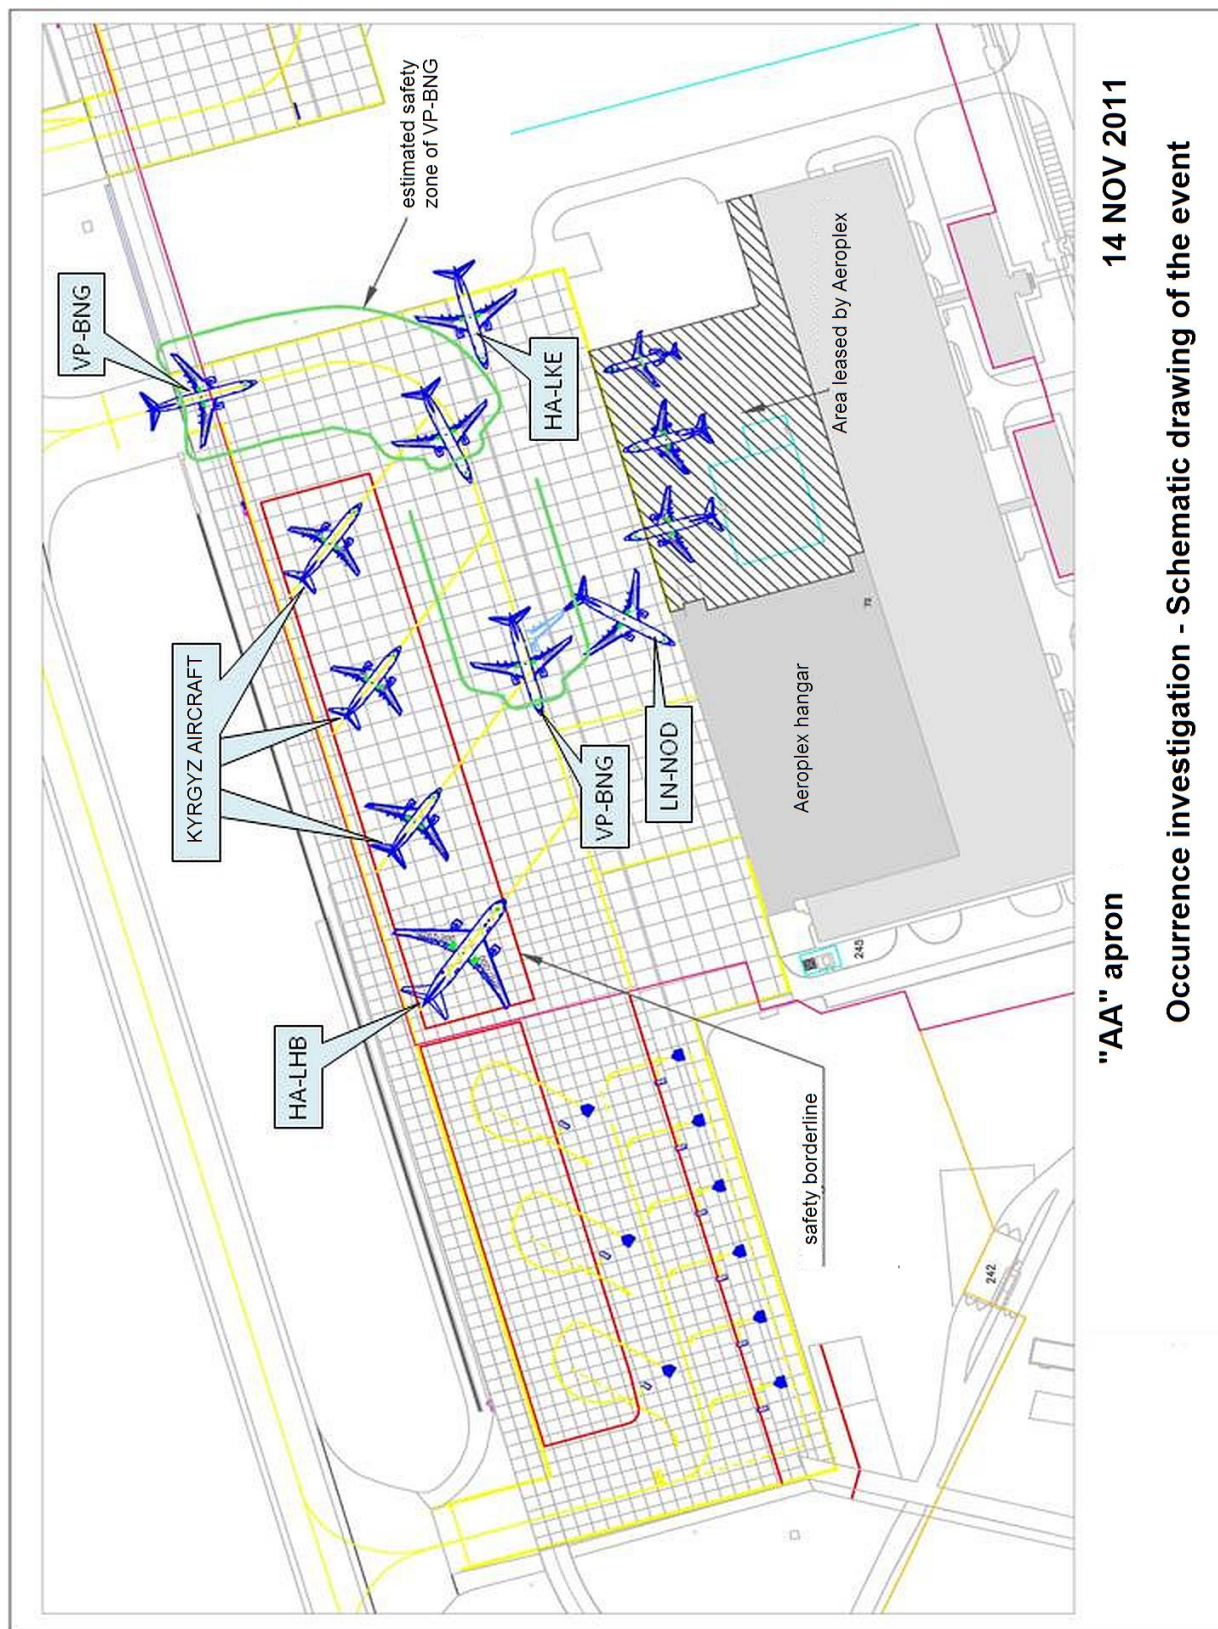
The aircraft collided into the right horizontal stabiliser of a parked aircraft (registration LN-NOD, B737-800, referred to as LN-NOD thereafter) with its left winglet while taxiing on the ACE AA. The pilots noticed the collision, stopped the aircraft and shut down the engines.

The left winglet of VP-BNG sustained serious damage and had to be replaced.

The RH horizontal stabiliser of LN-NOD sustained repairable damage.

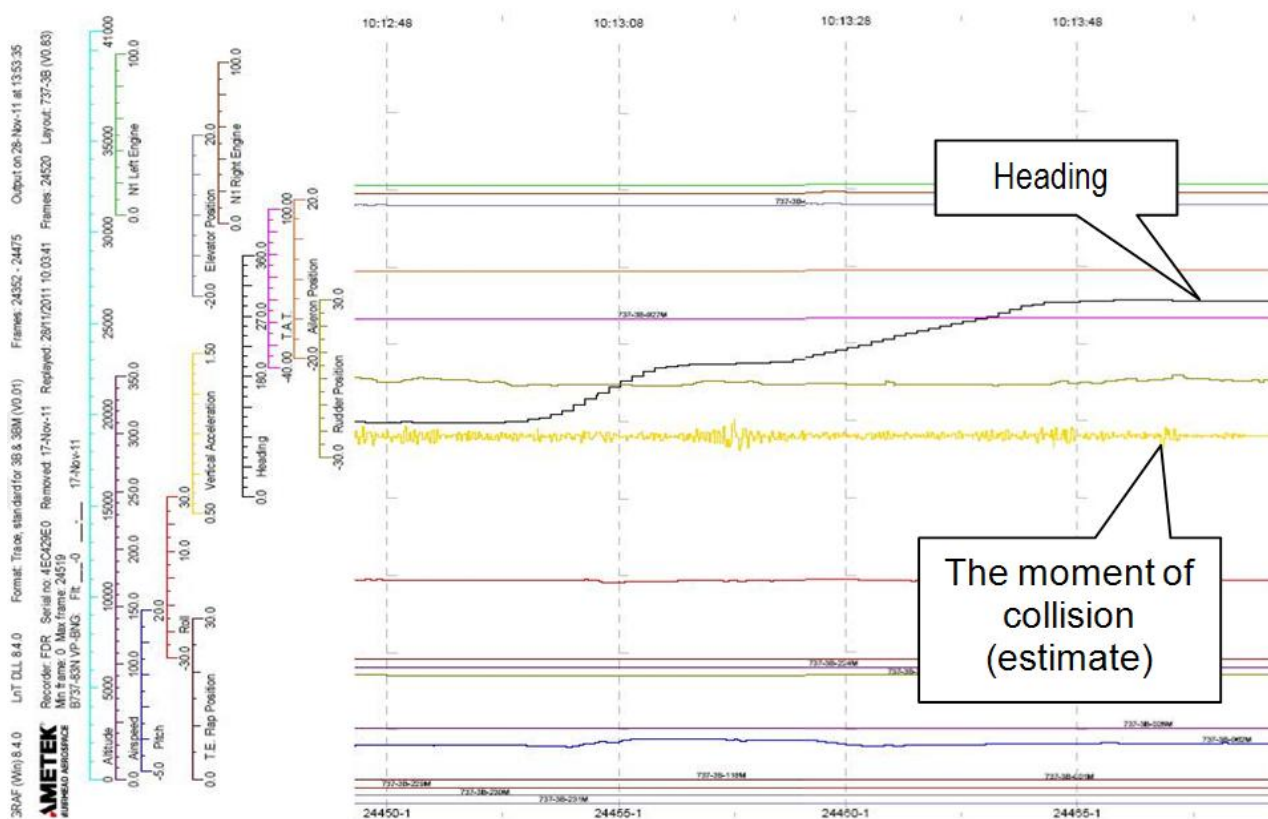
FDR data of the marshalling

Based on objective information – FDR and CCTV recordings – it was established that the aircraft did not change direction after the second right turn. It was also established that the AOO's statement - according to which the aircraft initially followed the marshaller car but later it deviated to the left and this deviation led to the collision with another aircraft - is unsupported by the facts.
