TRANSPORTATION SAFETY  
BUREAU

## **FINAL REPORT**

### **2011-272-4P SERIOUS AVIATION INCIDENT**

**Boeing 737-800  
HA-LOK**

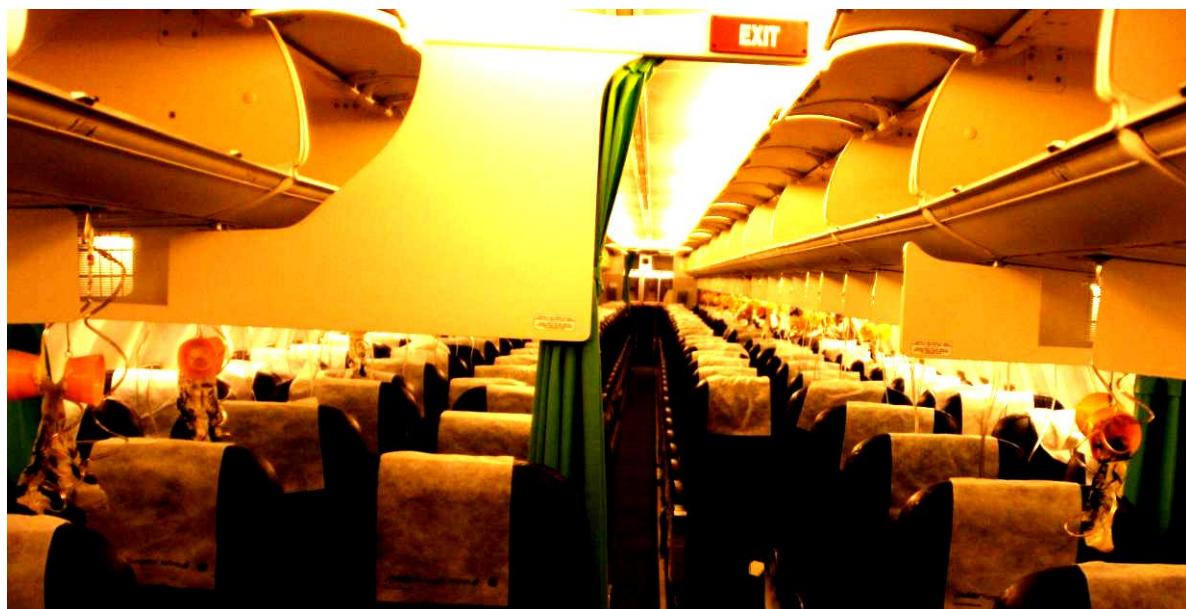
***The cabin of the aircraft with the deployed oxygen masks, after it has landed and the passengers have disembarked***

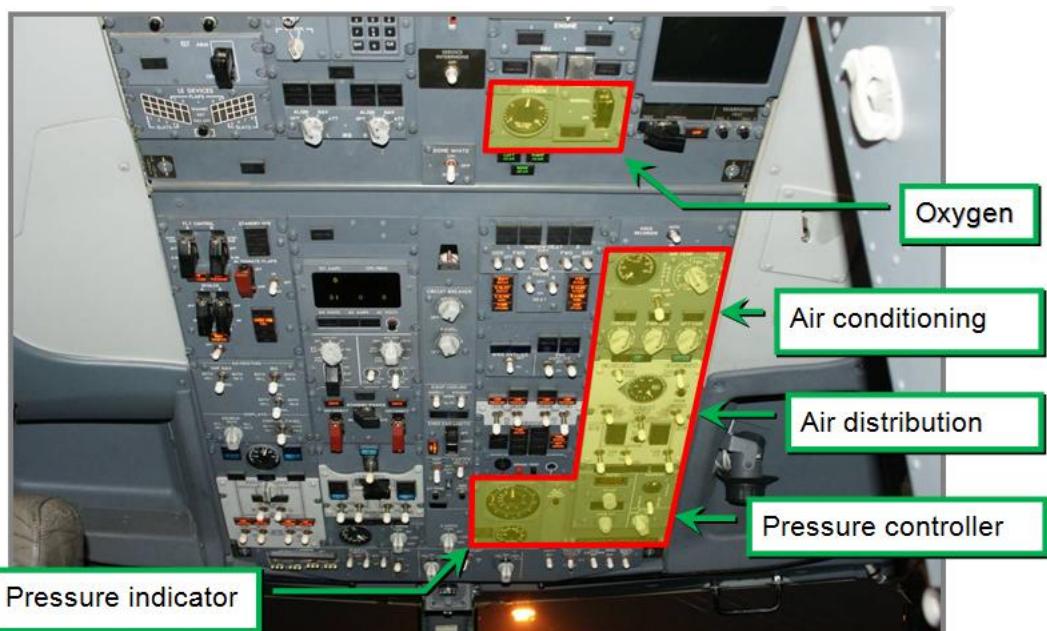
**Panels of air conditioning, air distribution, pressure control and oxygen systems of the aircraft at the overhead control panel**

In the present case, the first officer failed to turn on the "Pack" switches of air conditioning during the before taxi procedure, which have to be always switched off in the course of engine start, since it is the pressurized air which provides energy for the starting turbines to spin up the engines. Although the before and after take-off checklists were read out, some of the questions included were answered without the crew assuring the exact position of the levers and switches. Consequently, the crew was not aware of the air conditioning equipment being switched off.

TSB recommends the Federal Aviation Administration and the European Aviation Safety Agency to consider using an alerting annunciation on the Boeing 737 aircraft, which would indicate to the pilots that air conditioning is not on.

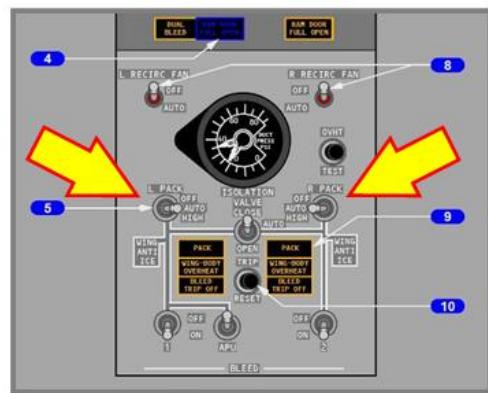
**Air distribution panel:**

**⑤ Switches of the air conditioning system (indicated by the arrows)**

**⑥ Switches of the recirculation fans**

**④ and ⑨ Displays**

- After engine start, the crew failed to turn the “Pack” switches of the air conditioning system from the “OFF” position to the “AUTO” position.
- The failure to turn on air conditioning was also not recognized while reading out the checklists.

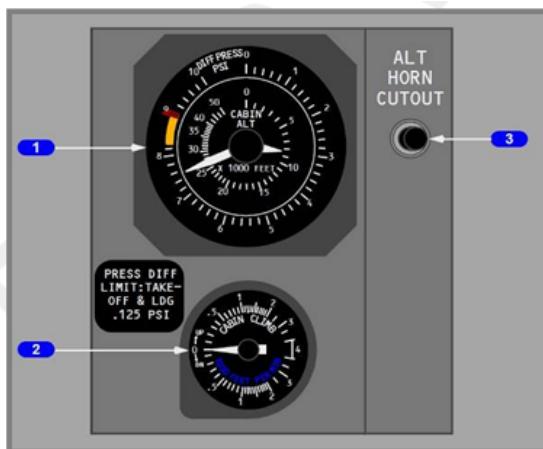
**Parts of the air pressure panel:**

**① Cabin altitude and differential pressure indicator**

**② Cabin climb indicator showing the course and speed of pressure change**

**③ Horn off switch**

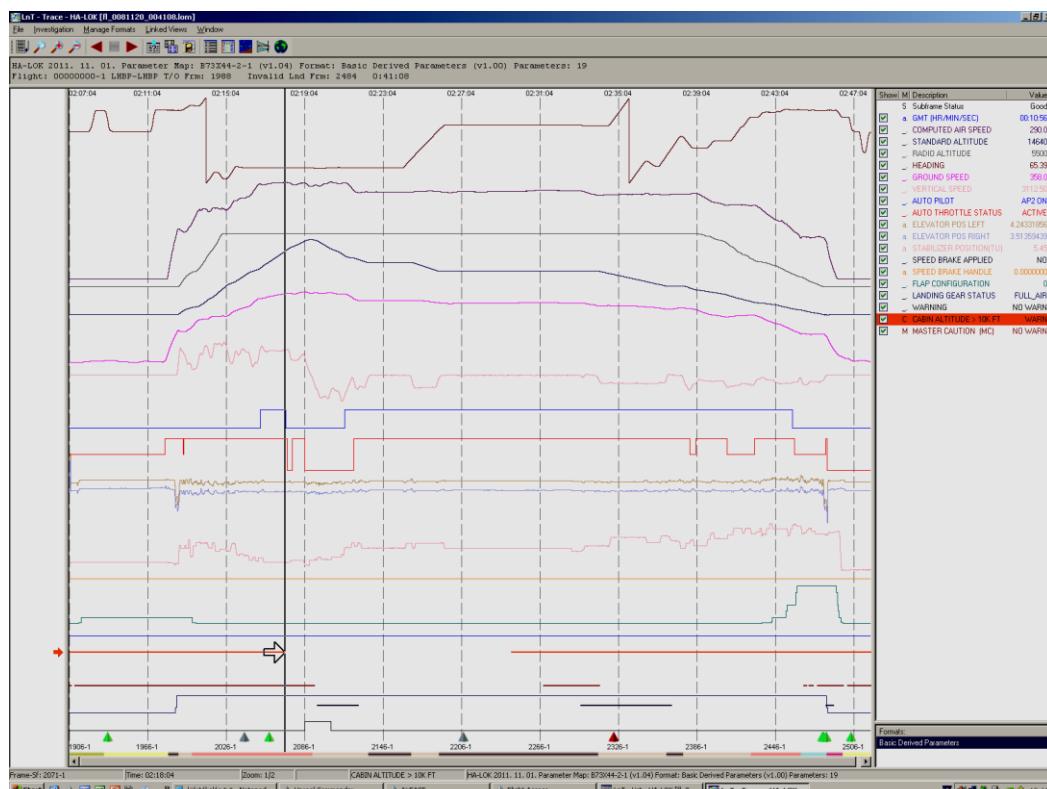
Reconstructing the sequence of events was made difficult by the fact that the flight data recorder does not record the instantaneous data of cabin pressure / cabin altitude.

**Graphic display of all the relevant information recorded by the flight data recorder regarding the whole length of the flight**

TSB recommends the International Civil Aviation Organization to consider extending the data obligatorily recorded by the accident data recorder of the aircrafts to include the momentary value of cabin pressure.

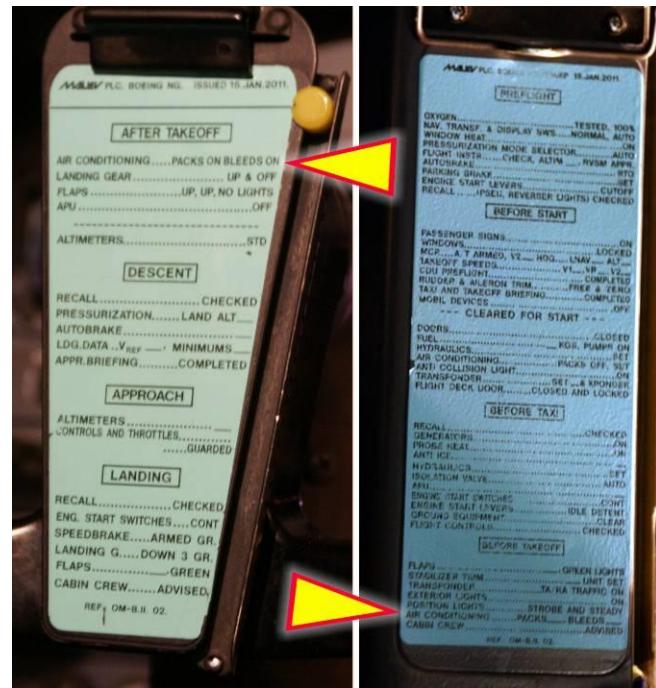
**„Normal“ checklists displayed in the cockpit  
(the line relevant to air conditioning are indicated  
in the before and after takeoff checklists)**
