TRANSPORTATION SAFETY
BUREAU

FINAL REPORT
2012-324-4P
SERIOUS INCIDENT
LHCC
07/10/2012
AIRBUS A319
G-EZDU

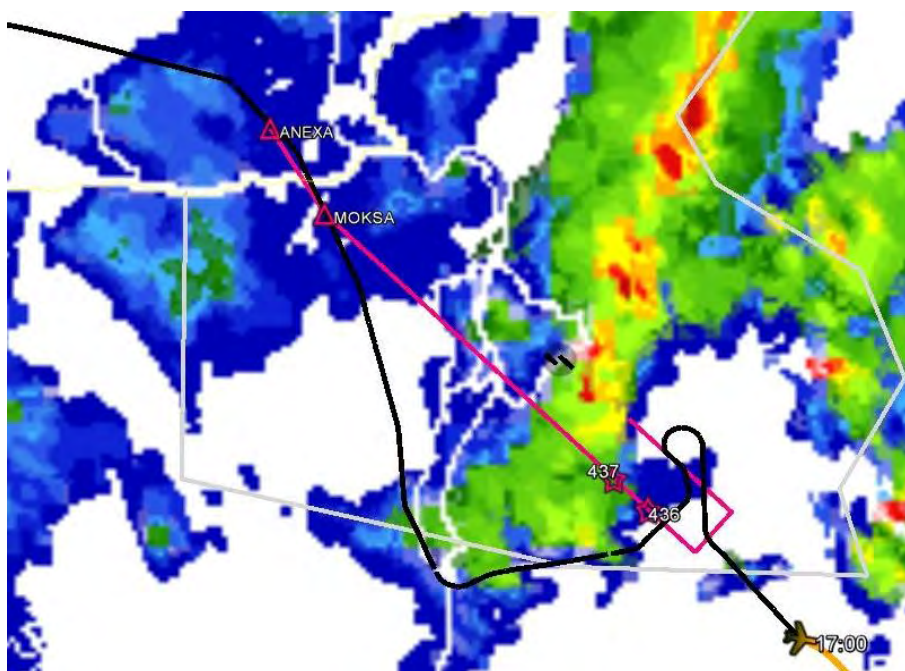
Figure 4

The aircraft had the chance to go round the squall line only by drawing away by 20 nm from the approach procedure to SW direction, in a wider gap between two squall cells, which required crossing the southern boundary of the terminal control area (**Figure 4**). (Two flights arriving beforehand evaded the squall line exactly in the same way.) But then, when the aircraft returned to the final of Runway 31R, it faced one of the most active clusters of the squall line which was just over the airport, and thus the aircraft was again cut from the runway and thus from landing.

The flight path [*in black*] between the showers and thunderstorms [*yellow-red spots*], with highlighting those sections [*orange colour and time points*] which the aircraft flew when the background radar images were taken; and the standard arrival procedure [*purple*] and the boundary of the terminal control area [*in grey*]

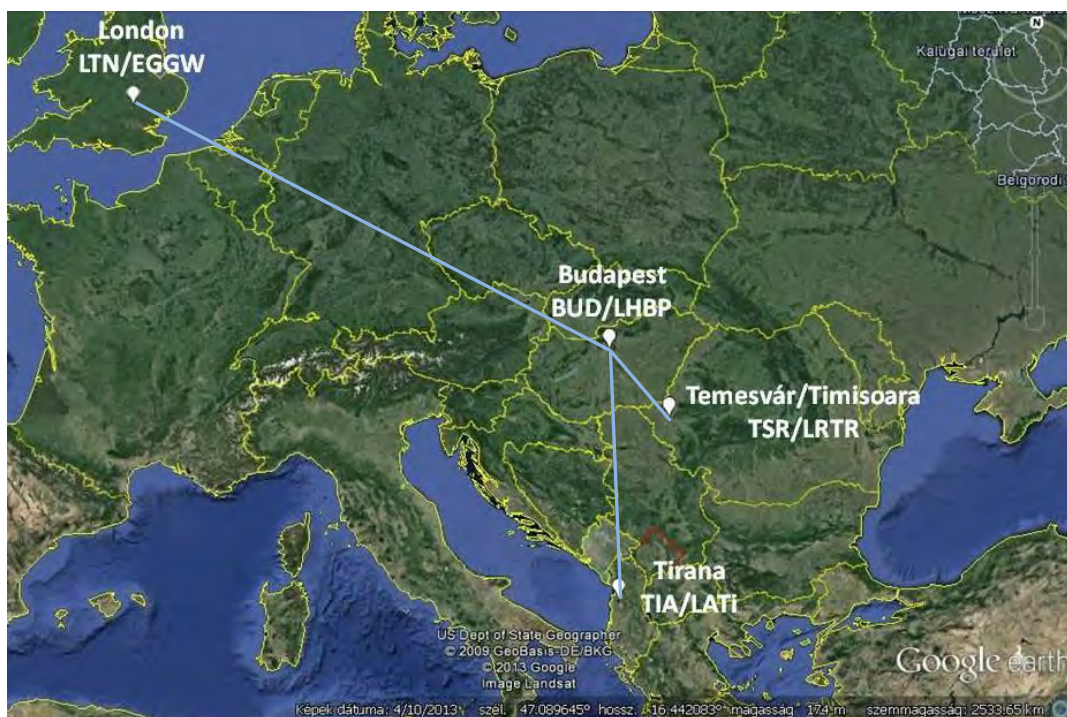
Figure 5

point that the commander decided to land at an aerodrome which is nearby, has favourable weather conditions, and accessible by avoiding the squall line. When re-planning the route, the crew communicated to the air traffic control that they selected Tirana as alternate aerodrome (**Figure 5**), and in 4 minutes they reported Fuel Mayday to the air traffic controller.
