TRANSPORTATION SAFETY
BUREAU OF HUNGARY

FINAL REPORT

**2013-151-4P
ACCIDENT**

**Nimbus 3 / 24.5
OE-5310**

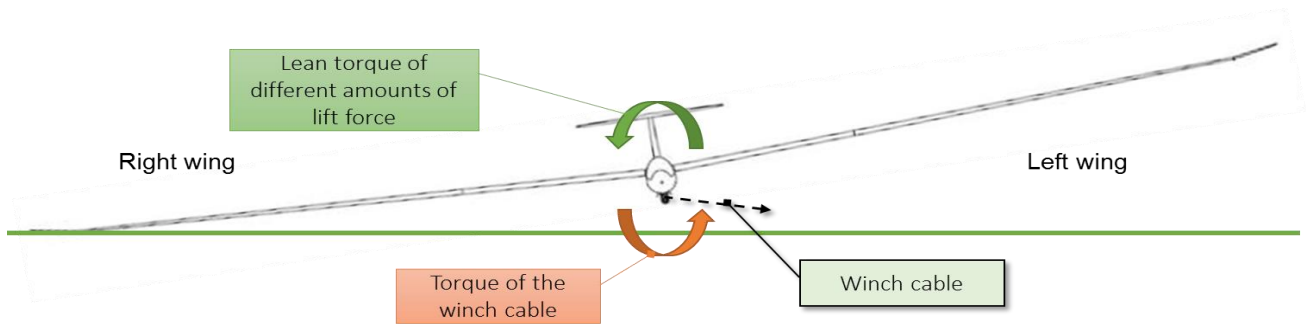
Figure 1

According to the position of the IC, a slight wind gust or turbulence may also have caused the right wing to drop (**Figure 1**). However, some more factors may also have contributed to the event indirectly.

When the aircraft turned away from the intended direction, the winch cable formed an angle with the longitudinal axis that was identical with the angle of the turn, which resulted in an additional lean torque (**Figure 1**).

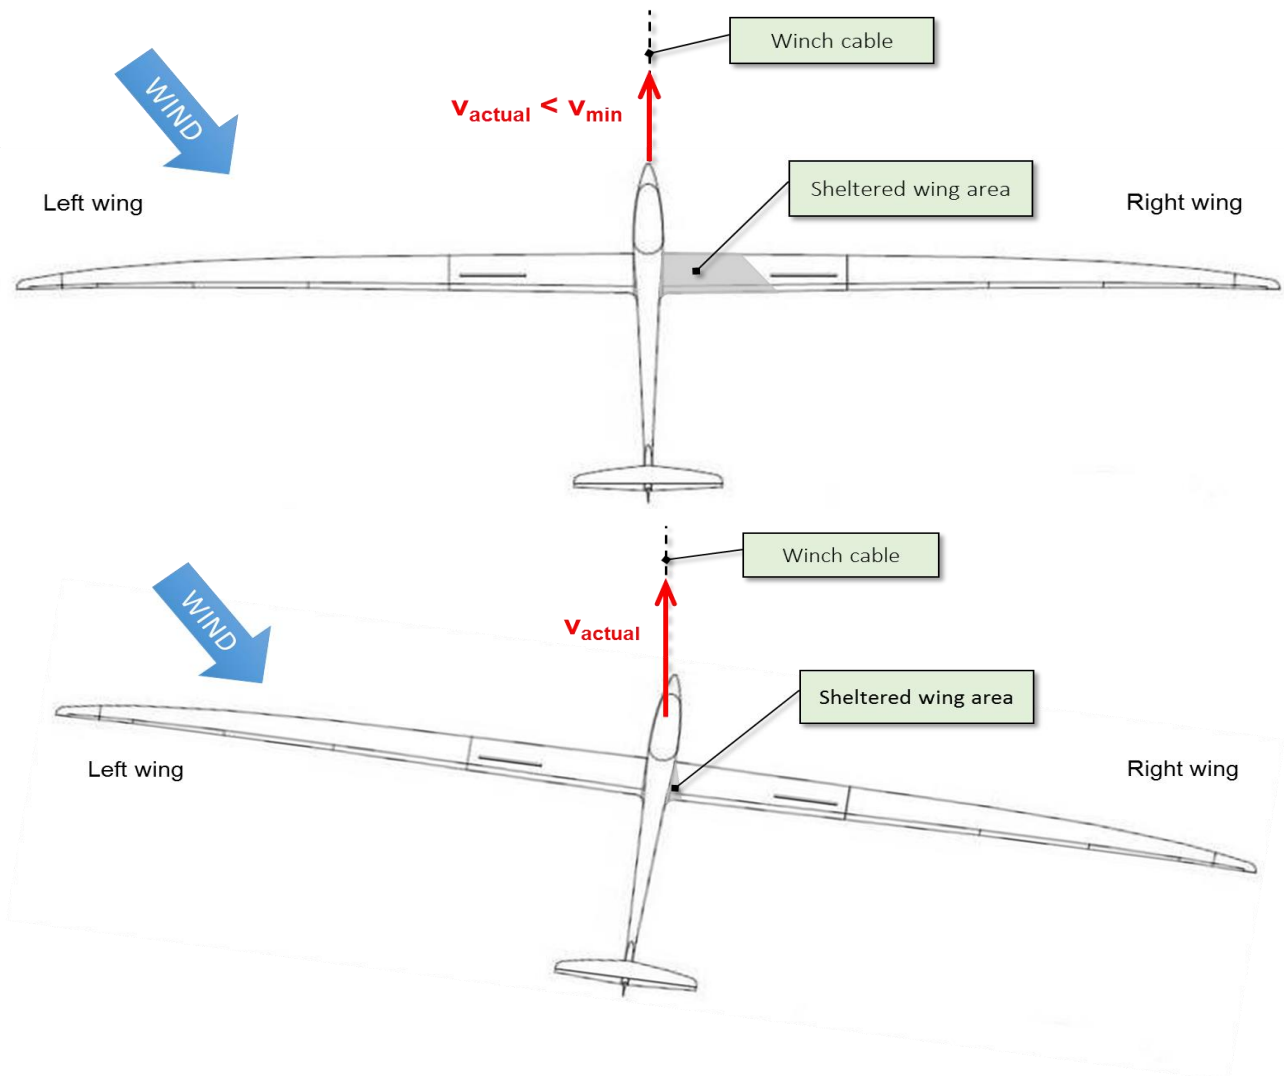
According to weather data, there was a slight crosswind at the time of the take-off. Given this wind direction, less lift force will be generated at the right wing due to the sheltering effect of the airframe, which results in asymmetric lift force distribution between the two wings (**Figure 2**). As a consequence, a torque arose which moved the left wing upward and the right wing downward. This effect was even increased by the fact that the aircraft turned right of the original take-off direction due to touching the terrain with the wing tip, i.e. the right wing “lagged behind”, while the left wing accelerated. The different speeds of the two wings resulted in different amounts of lift force, which then produced an additional lean torque to the right.

Figure 2 (upper: before lift-off, lower: the moment after the right wing touched the ground)
