TRANSPORTATION SAFETY
BUREAU OF HUNGARY

FINAL REPORT

**2014-093-4P
Serious Incident**

**Airbus A320-232
G-EUUE**

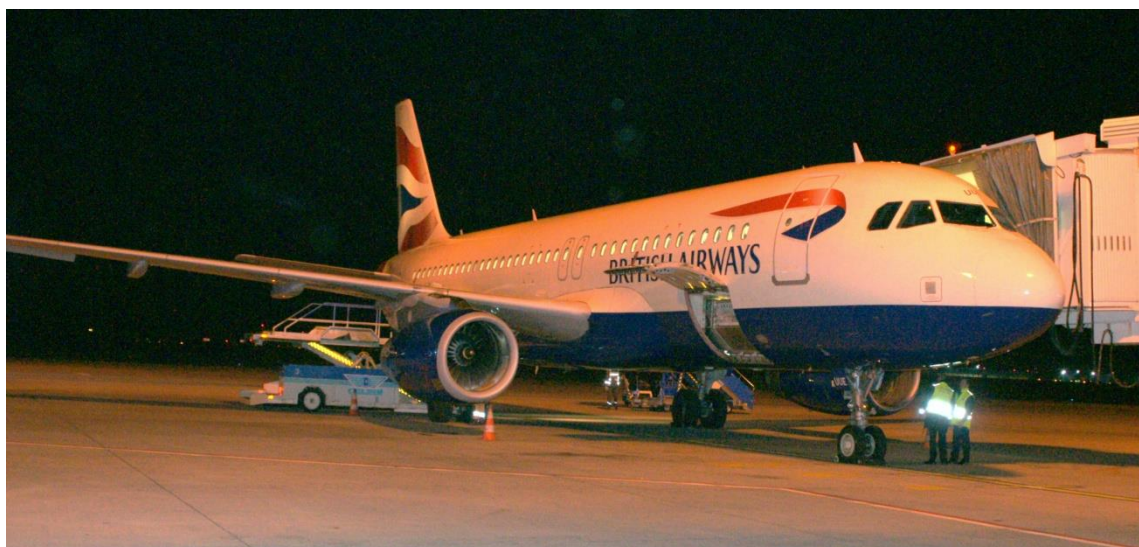
Figure 1: The airplane with Registration mark G-EUUE in Budapest after landing

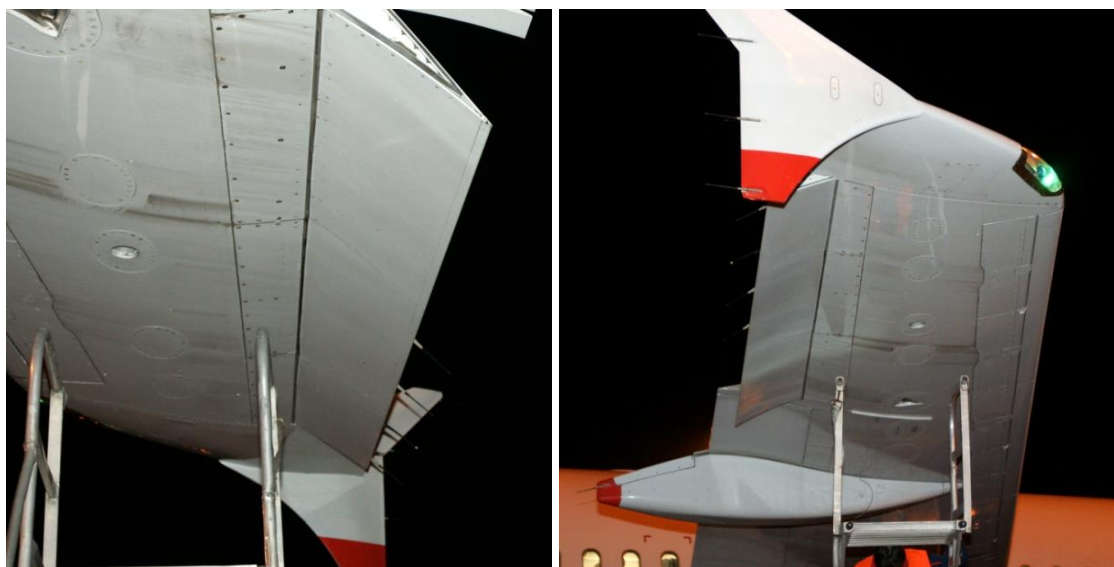
Figures 2 and 3: Position of the right aileron with pressurized hydraulic systems after landing

After landing, with the decrease of speed, the deflection of the right aileron decreased, and then it deflected downward, reaching a value as high as 13°.

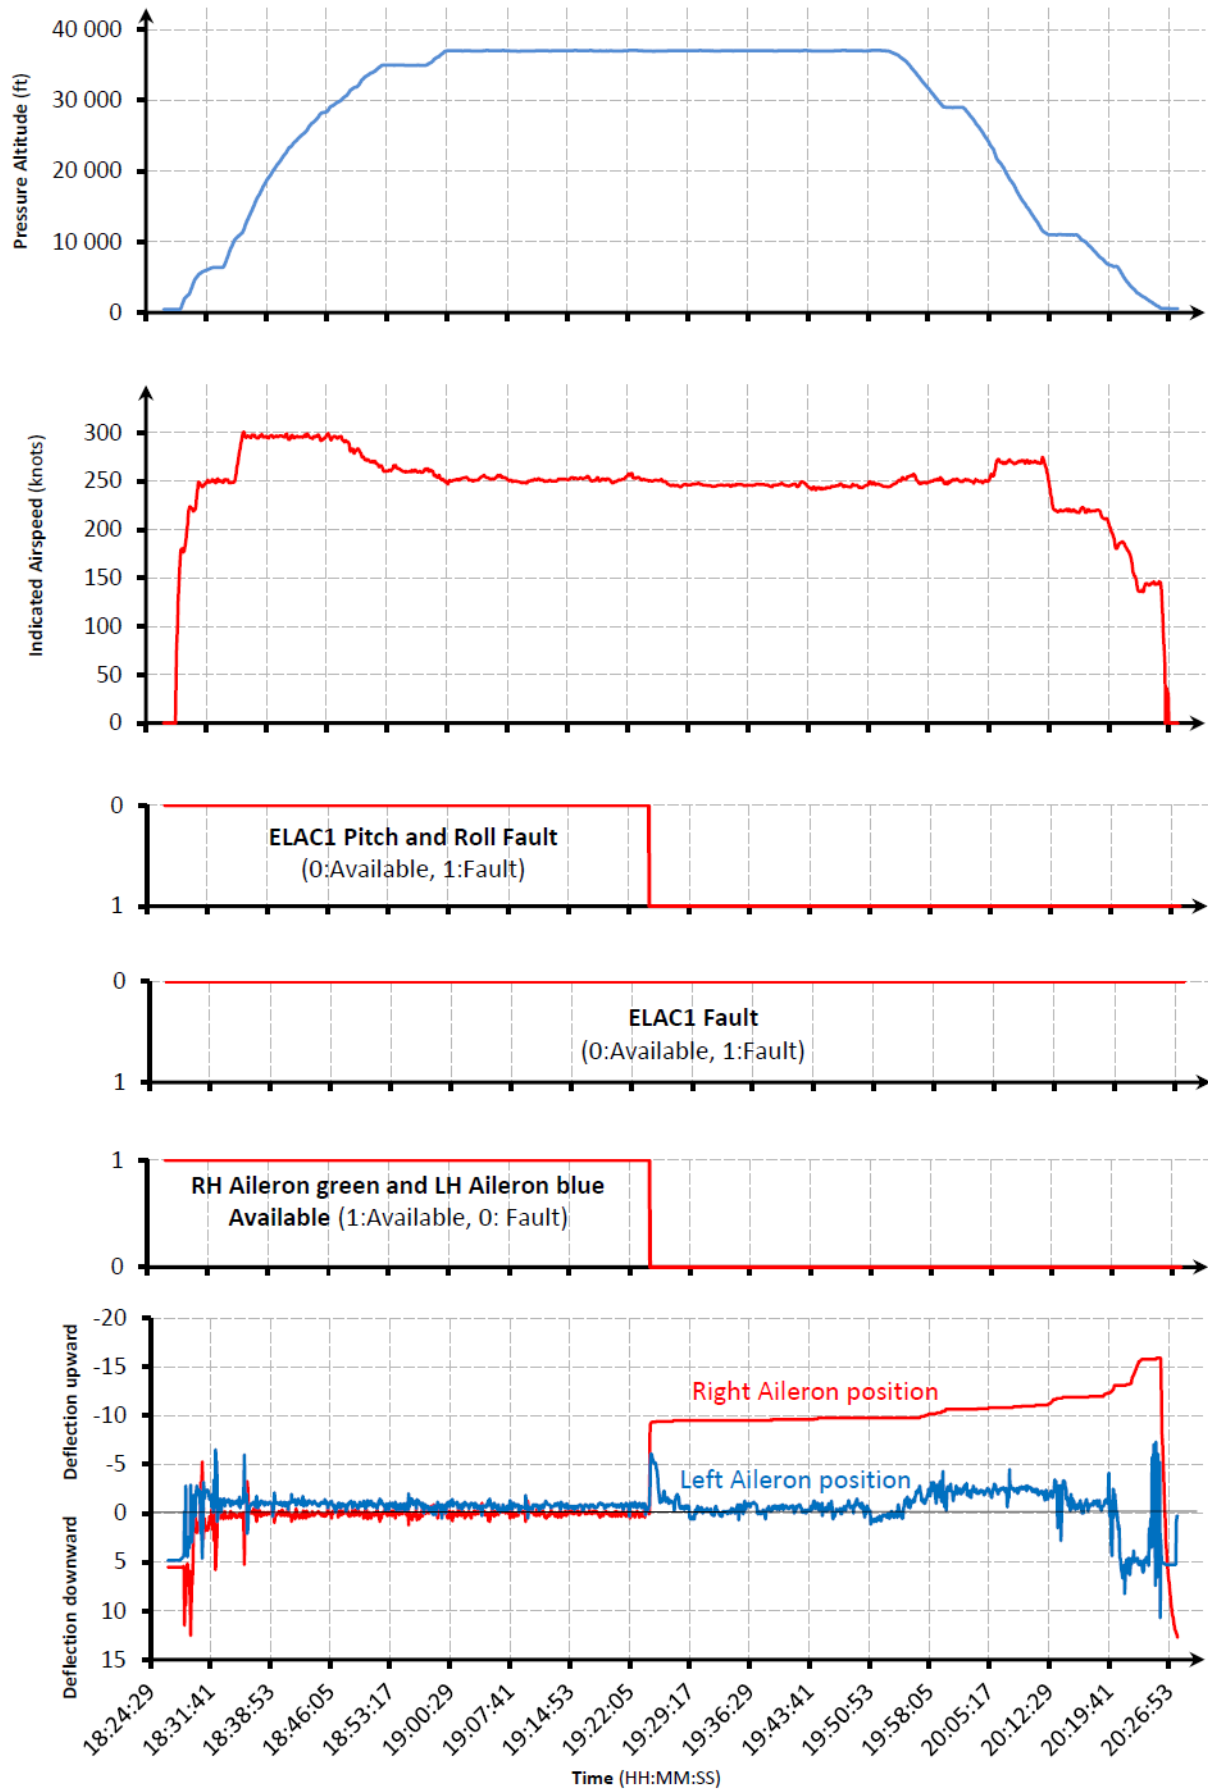
The ELAC1 roll and pitch channels of the FDR failed at 19:24:32, and the green hydraulic system of the right aileron and the blue hydraulic system of the left aileron became inoperative also at that time.

The Post Flight Report (PFR) showed the following fault message: “ELAC1 OR INPUT OF CAPT ROLL CTL SSTU 4CE1”.

Figure 5: Changes in the parameters during the complete flight based on the FDR readout

The IC takes the FDR data as evidence, and on the basis of such data, "ELAC1 pitch fault" and "ELAC1 roll fault" occurred during the malfunction (see Figure 5 page 12). The IC does not exclude the malfunction of the Captain Side-Stick during the event under investigation; this is indicated in paragraph 9, page 16 of the Final Report. The e-mail of 22 March 2016 sent by the AIRBUS Factory contained the information that "Shop Findings of the ELAC and Side-Stick are No Fault Found", so the IC has no evidence to establish whether it was the fault of the ELAC1 or the fault of the Captain Side-Stick that actually caused the fault of the right aileron. The fault code from the Post Flight Report reads "ELAC1 OR INPUT OF CAPT ROLL CTL SSTU 4CE1", on the basis of which it cannot be unambiguously proved that any or both of the malfunction acted as the actual fault.

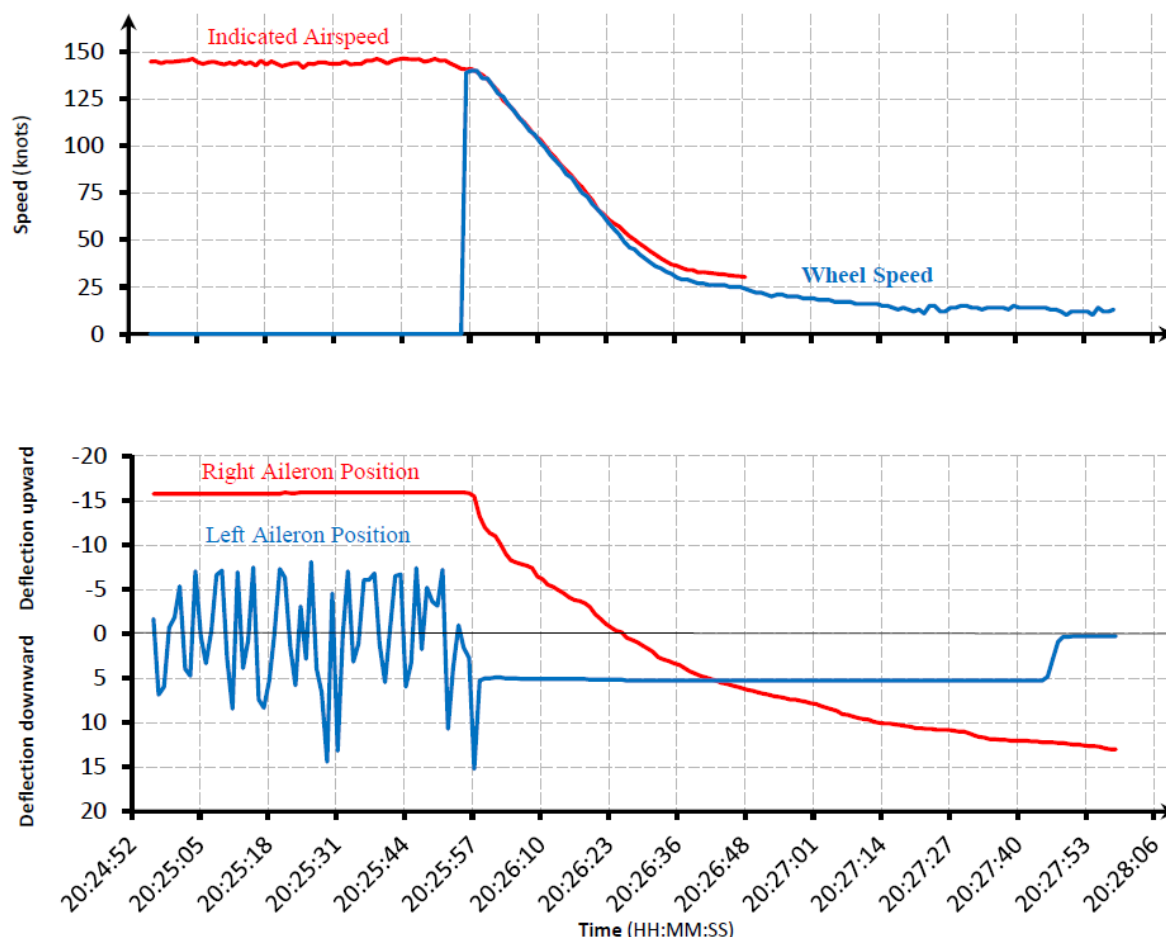
The time of landing may be determined on the basis of FDR data, namely the speed of the main landing gear wheels. For the sake of clarity, Figure 6 only shows the speed of the wheel No. 4 of the main landing gear, but the speed of the wheels No. 1, 2, and 3 are nearly equal with it. According to data, landing took place at 20:25:57.

Figure 6: Changes in the parameters in the last 3 minutes of the flight based on the FDR readout

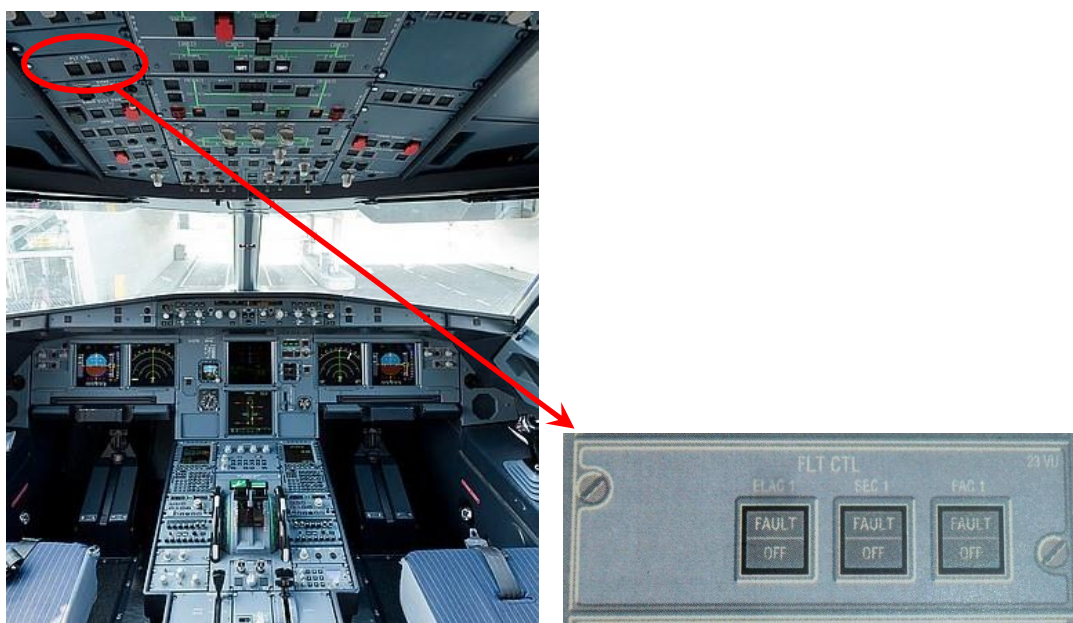
At 19:24:32, when the airplane was cruising at an altitude of 36 950 ft and speed of 250 knots, the crew perceived the indication “Right Aileron Fault & ELAC1 fault”, but the “Fault” light on the “ELAC1 PB Switch” was not illuminate. Figure 7 shows the position of the pushbutton switch.

Figure 7: Position of the ELAC1 pushbutton switch on the Overhead Panel (illustration)
