MINISTRY OF  
NATIONAL DEVELOPMENT  
TRANSPORTATION SAFETY  
BUREAU OF HUNGARY

# **FINAL REPORT**

**2014-243-4P**  
**Serious incident**

**Cessna 150F**  
**OK-DAN**

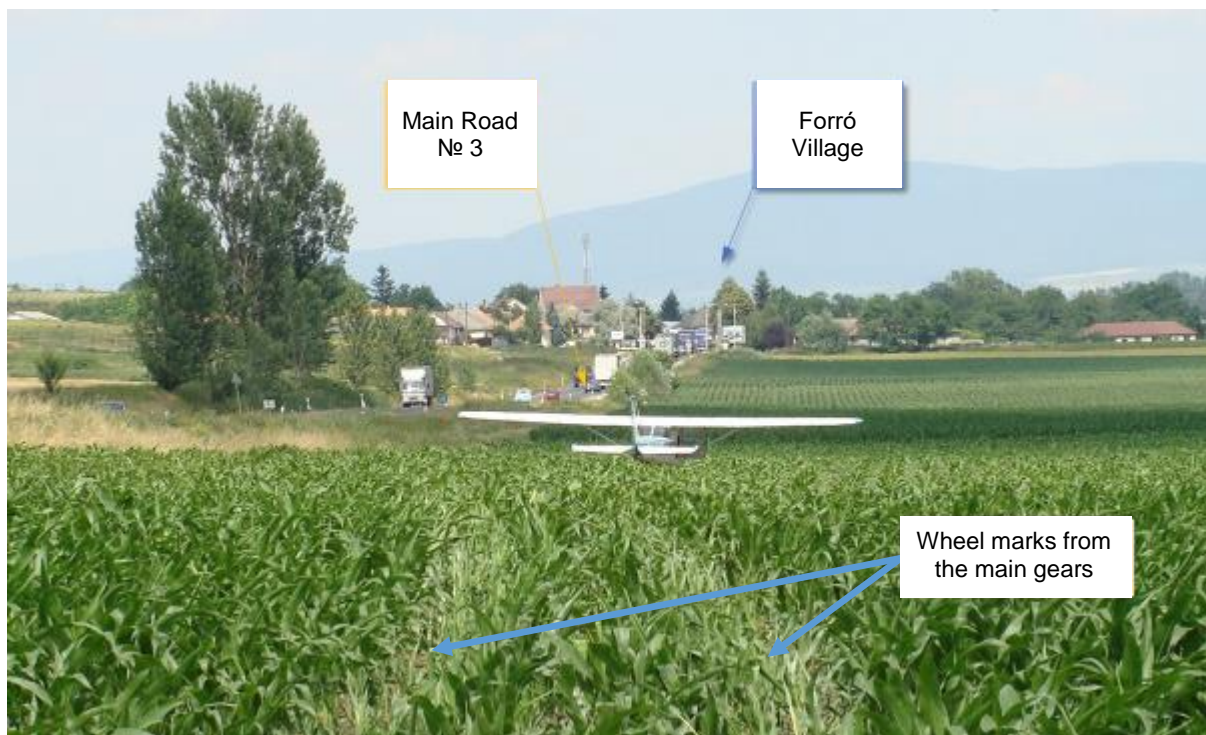
**Picture 1:** Position of the aircraft with registration mark OK-DAN after it stopped

When choosing the terrain for landing, the crew had the areas shown in Picture 1 to choose from. As seen in the photo, the traffic on Road 3 was fairly busy in both directions, and there were bushes and trees right at the sides of the road, so appropriate, unobstructed space was not available for landing. At the north-west side of the road (to the left in Picture 1) there was a dry wheat land waiting for harvest, and the crew, as well as the IC, found that it was too risky due to potential fire hazard following landing. The area looking suitable for landing was the green field located south-east of the main road (to the right in Picture 1).

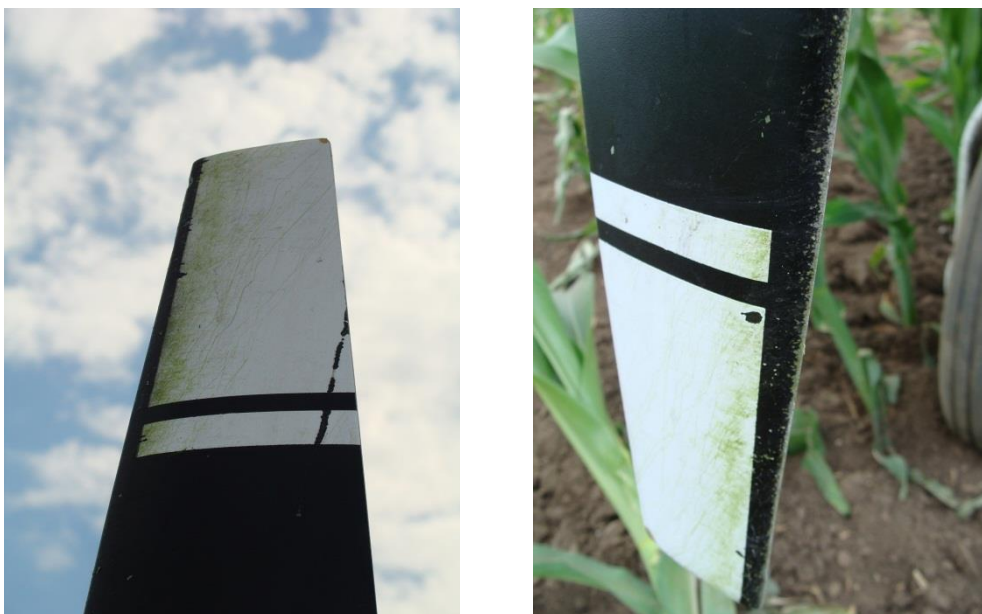
The IC inspected the propeller blades, the outer sections of which are shown in Pictures 3 & 4. Both propeller blades show the marks from the green plants clearly, which suggests that the propeller was rotating, and the engine was working, during landing. The mild degree of damage caused by the propeller to the vegetation clearly support that the rotating propeller was working at low engine performance during landing as well as afterwards, during the roll until stop.

**Pictures 3 & 4:** Marks from the vegetation on the outer sections of the propeller blades after the aircraft landed and stopped
