FINAL REPORT

2006-0033-5 RAILWAY ACCIDENT

**Between Csajág and Balatonkenese stations
at level crossing no. AS380**

15 July 2006

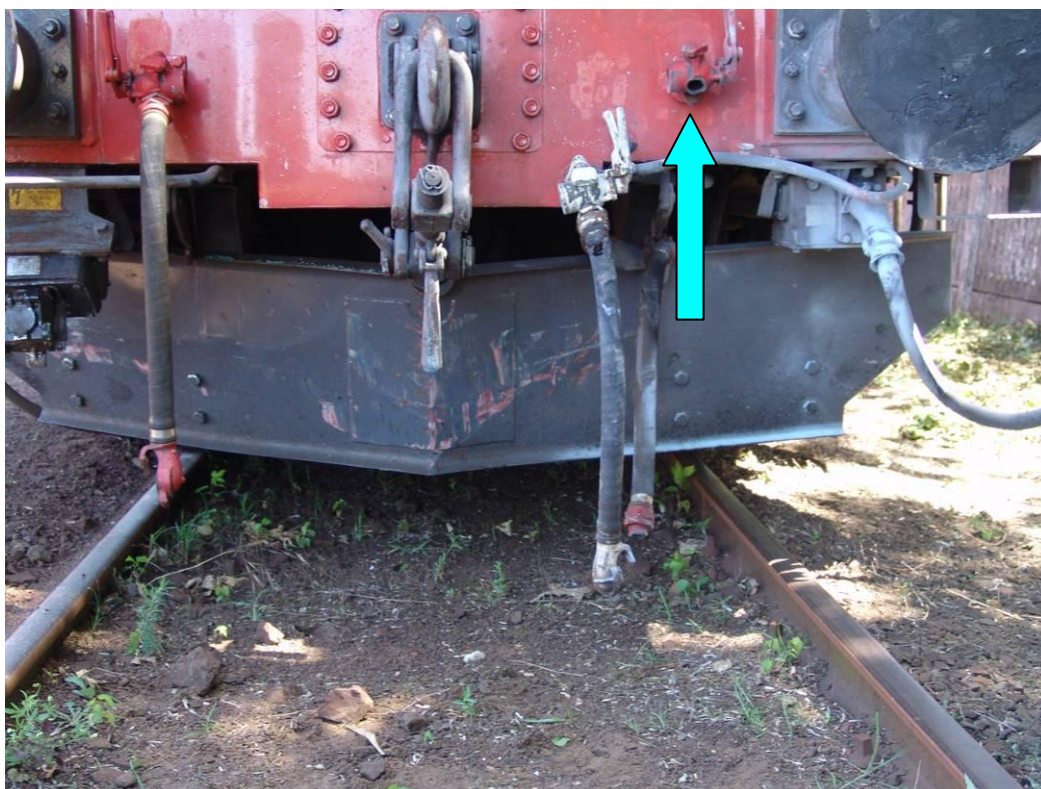
- **Diesel locomotive (registration number M41-2311) of passenger train no. 1972 of MÁV Zrt.** became unserviceable (See Figure 4), its Ackermann pneumatic switch broke off, its main brake cylinder sustained damage and its deflector bent.
- According to MÁV Zrt. BIG Regional VBO (Szombathely city), the repair of the locomotive cost 160.000 HUF. The repairs were carried out by KJK.

Figure 4: The unserviceable locomotive

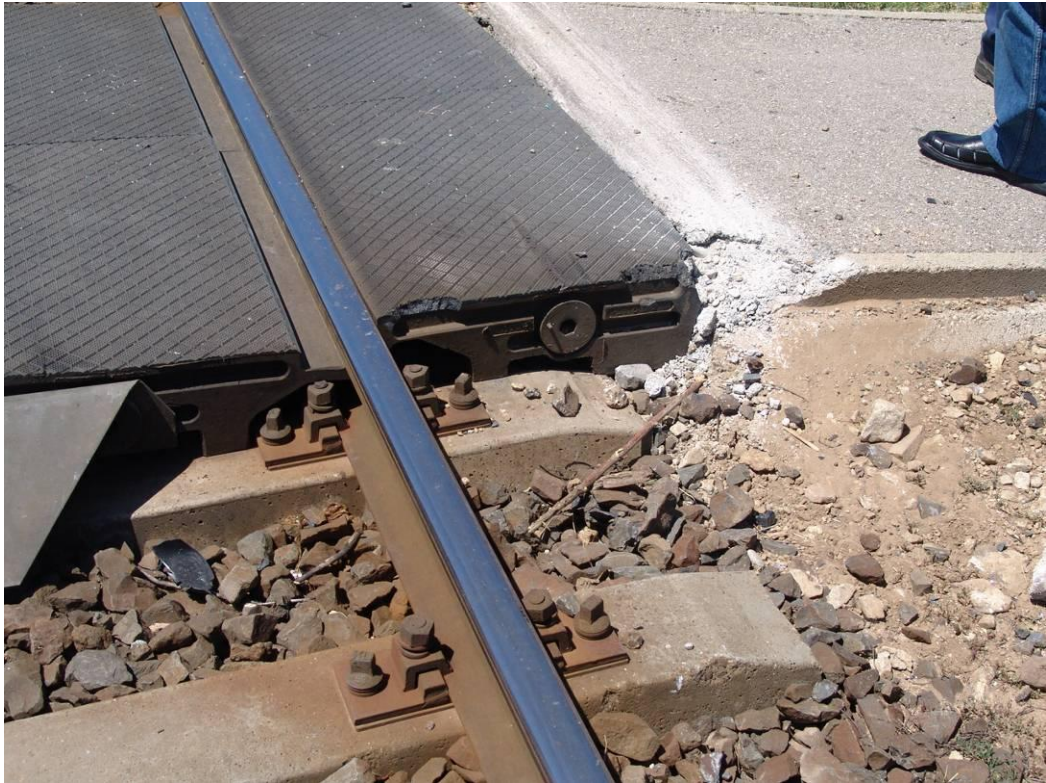
- According to VBO Szombathely, the railway track was not damaged. However, the shifted STRAIL plate of the pedestrian crossing had to be set back. (See Figure 5).
- The service of the signal box specialists cost 14 086 HUF.
- Although the engine oil and the fuel spilt from the car to the railway embankment, it did not cause significant damage, therefore it was not necessary to indemnify damages.

Figure 5: The slightly shifted STRAIL plate at the pedestrian crossing

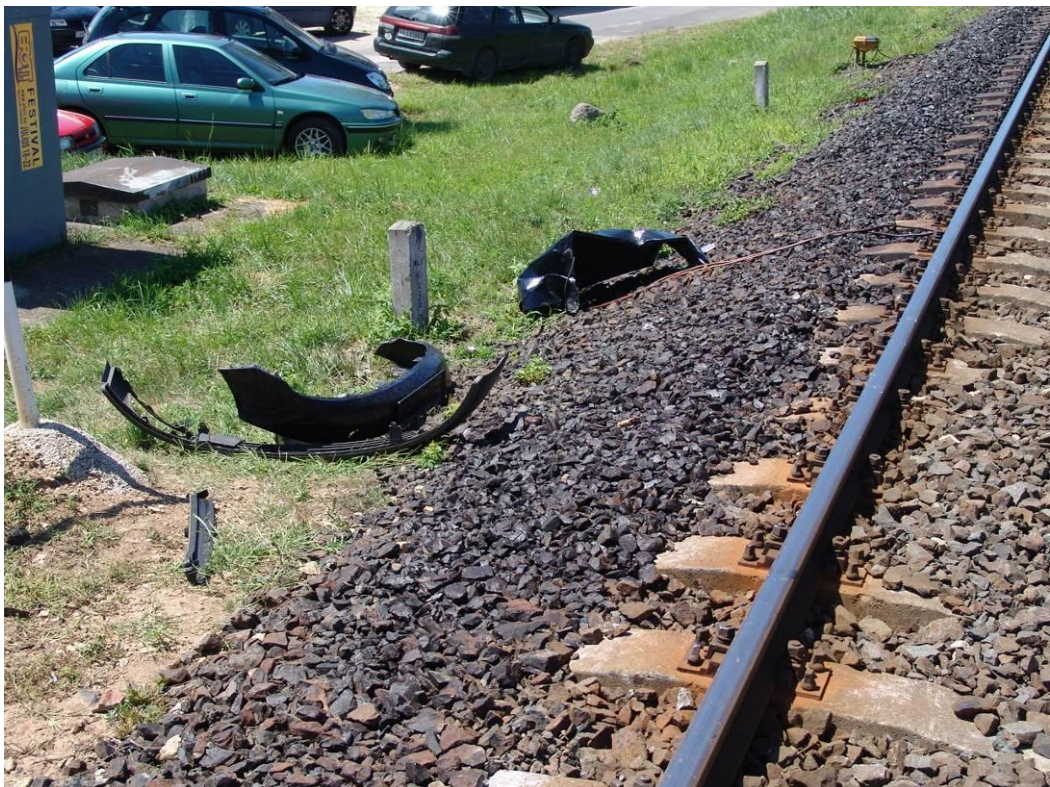
Figure 6: The engine-oil and fuel spilt from the car to the ballast.

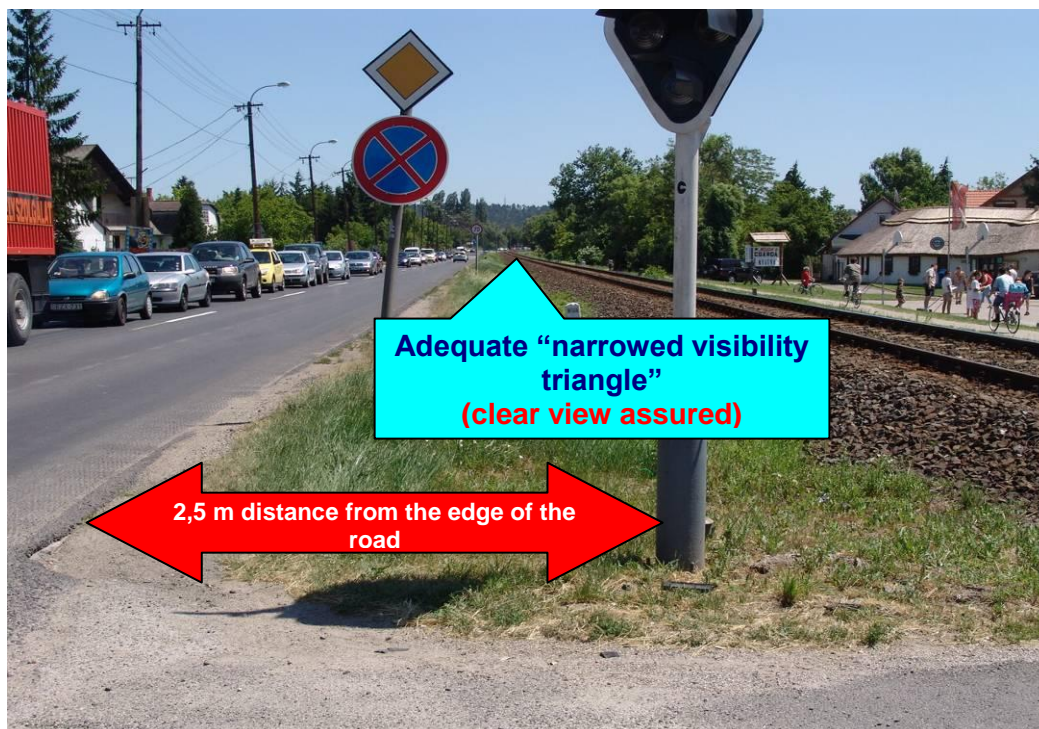
Figure 8: Narrowed visibility triangle

The visibility (so called “narrowed visibility triangle” - $L_v=400$ m) was assured – in compliance with 26.4 of KM Decree of 20/1984 (XII. 21.) – on the right side of the rail track in the direction of Csajág. The rail track is visible for over 400 metres length in the direction of Csajág from a 1 metre distance measured from the centre of the road which runs across the LC (See Figure 8).

“a” and “c” warning lights are 2.5 metres from main road no. 71 (See Figure 8).

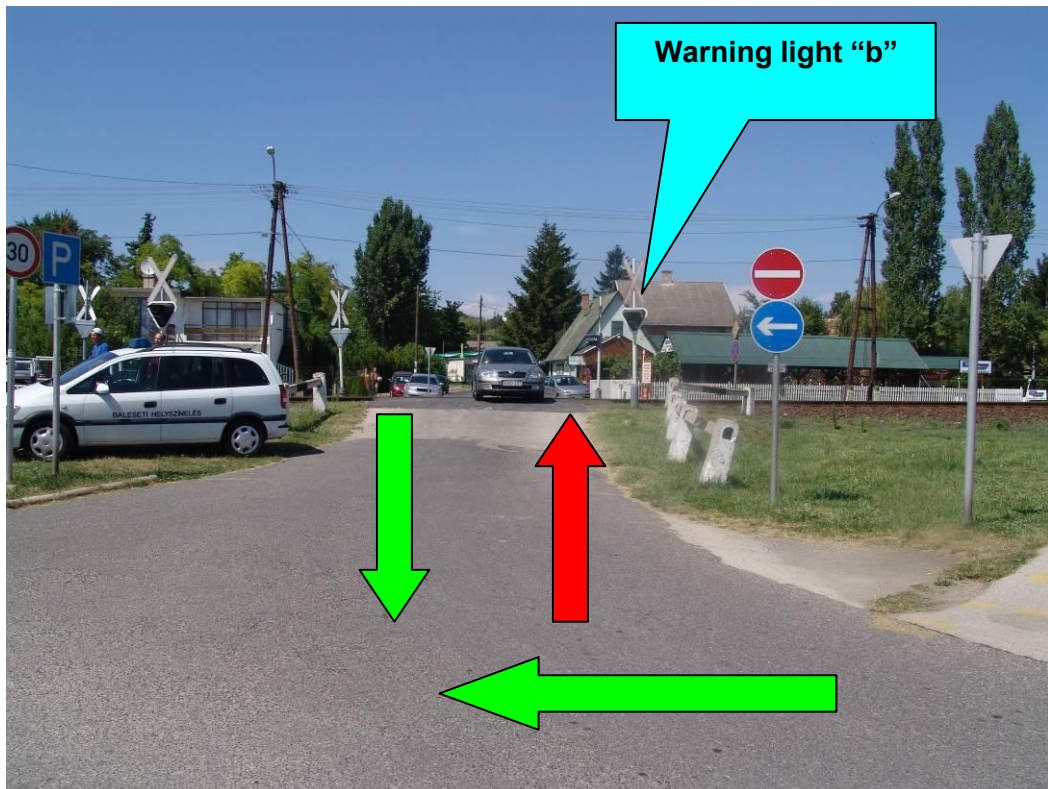
Figure 11: LC no. AS380 from the direction of Lake Balaton

Warning light "b" is perpendicular to the rail track and is set in the direction of Lake Balaton from where there is a "No Entry" traffic sign prohibiting the left turn

towards the LC (See Figure 11). However, there is no sign from the direction of main road no. 71, which would indicate that there is one-way traffic through the LC in the direction of Lake Balaton.

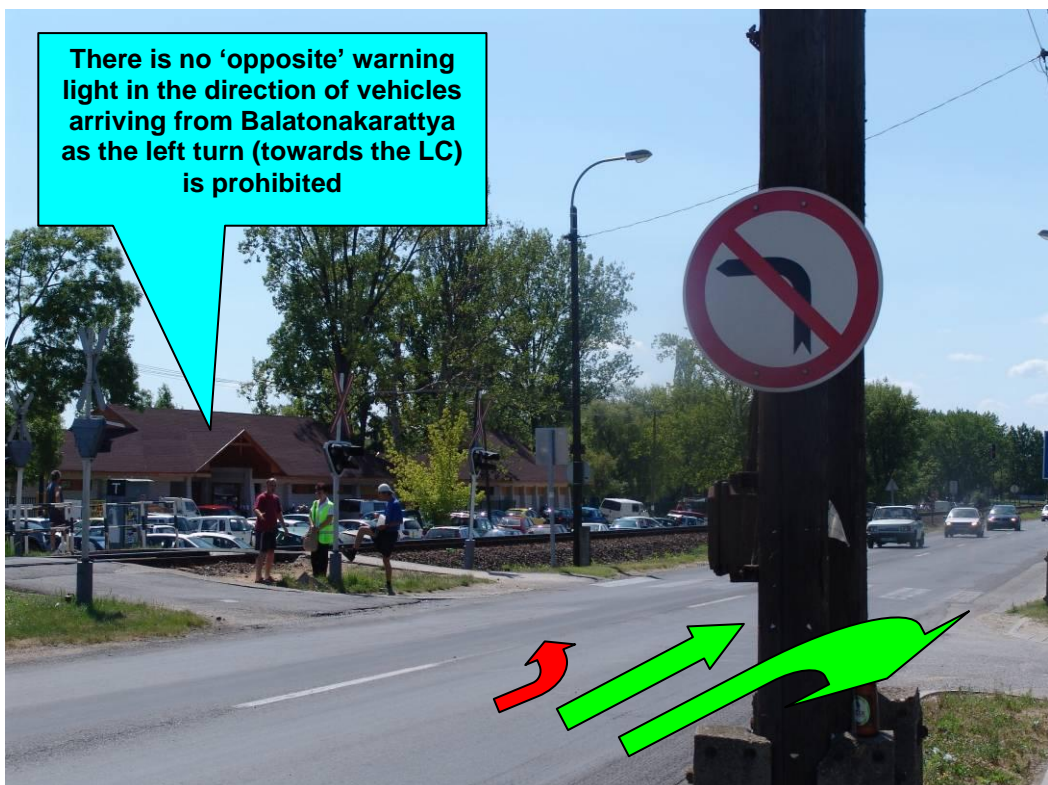
Figure 12: LC no. AS380 on Balatoni út from the direction of Balatonakarattya

There is no warning light on Balatoni út in the direction of vehicles arriving from Balatonakarattya as a “No Left Turn” traffic sign prohibits the entry to the LC (See Figure 12).

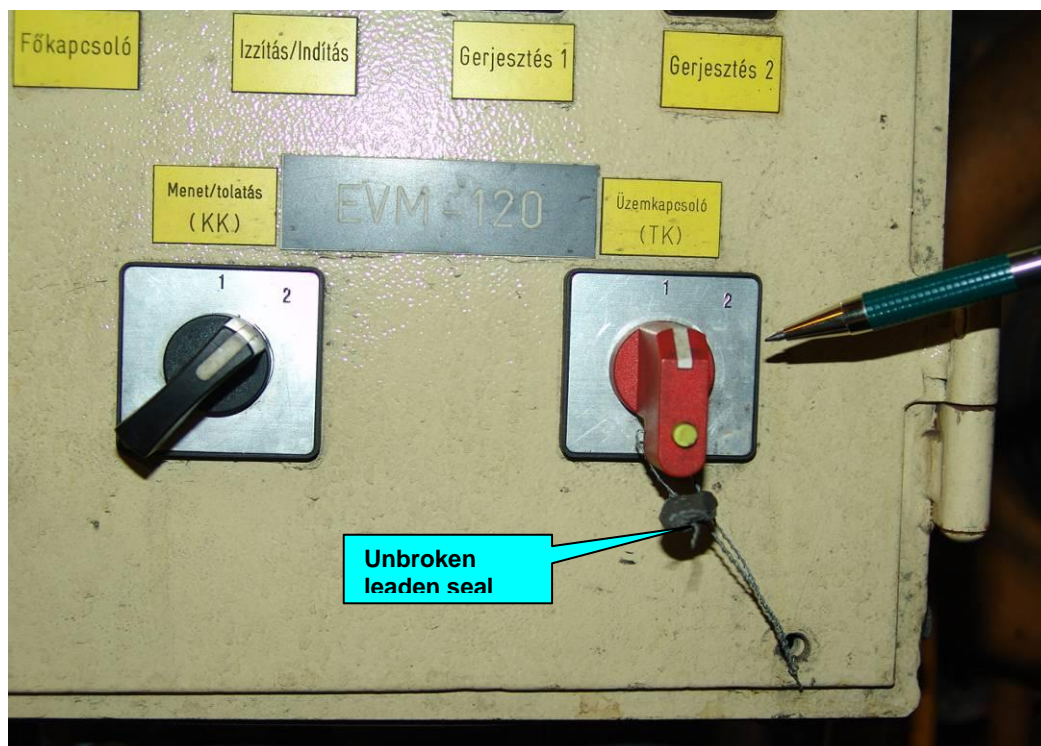
Figure 14: EVM 120 handle fitted with an unbroken leaden seal

The EVM 120 handle was sealed adequately (See Figure 14).

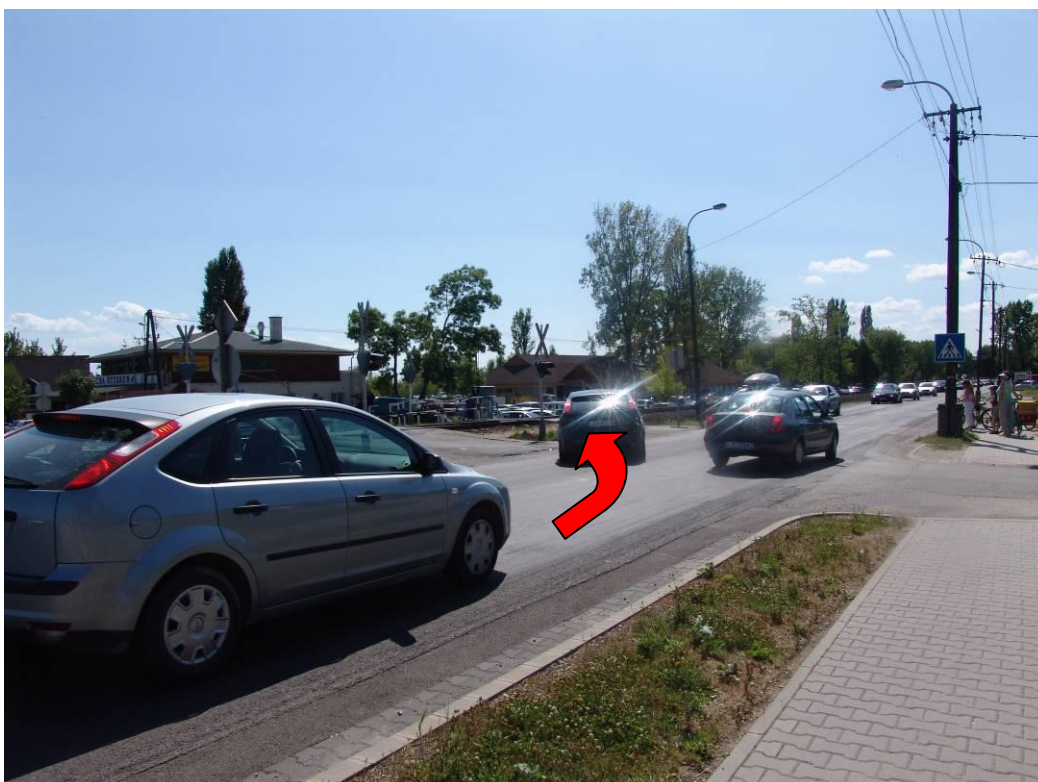
On 24th June 2007, the IC recorded on VHS and on photographs (See Figure 16) that several cars coming from the direction of Balatonakarattya turned left and drove through LC no. AS380 regardless of the "No left turn" traffic sign (on 12 occasions in 30 minutes). On one occasion, a car turned left and drove past warning light "a" when the driver realised that a train was coming from the direction of Balatonakarattya. He then stopped and quickly reversed back to main road no. 71 where he nearly crashed into a car coming from the direction of Balatonkenese. (The driver had noticed the red "Stop" signal of the warning lights only in the last minute before the train ran through the LC as there is no opposite warning light in the direction of Balatonakarattya). On five occasions, cars drove onto main road no. 71 from the direction of Lake Balaton through the LC ignoring the "No entry" traffic sign.

Figure 16: A car turning left regardless of the "No left turn" traffic sign

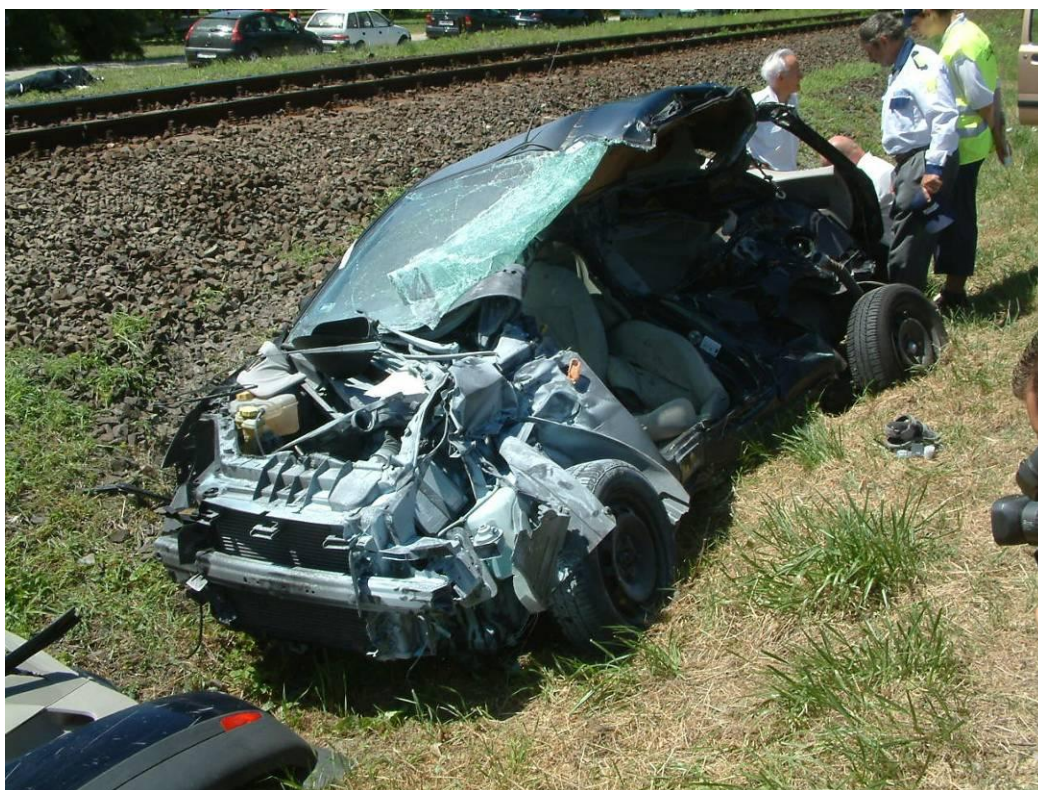
The Ford Fiesta car was written off (See Figure 17).

Passenger train no. 1972 running from Budapest-Déli station (Budapest Southern Railway Station) to Balatonfüred collided with a Ford Fiesta type car at 10 hours 09 minutes on 15th July 2006 between Csajág and Balatonkenese stations at level crossing no. AS380 secured by warning lights (operating normally) giving stop signal towards the road. The car was turning left from main road no. 71 (Balatoni út) from the direction of Balatonakarattya onto the LC, ignoring the “No left turn” traffic sign. As a consequence of the collision, one of the two persons sitting in the car died at the site of the accident, the other suffered serious perilous injuries (See Figure 17).

Figure 17: Collision involving train no. 1972 and a car occurred on 15th July 2006

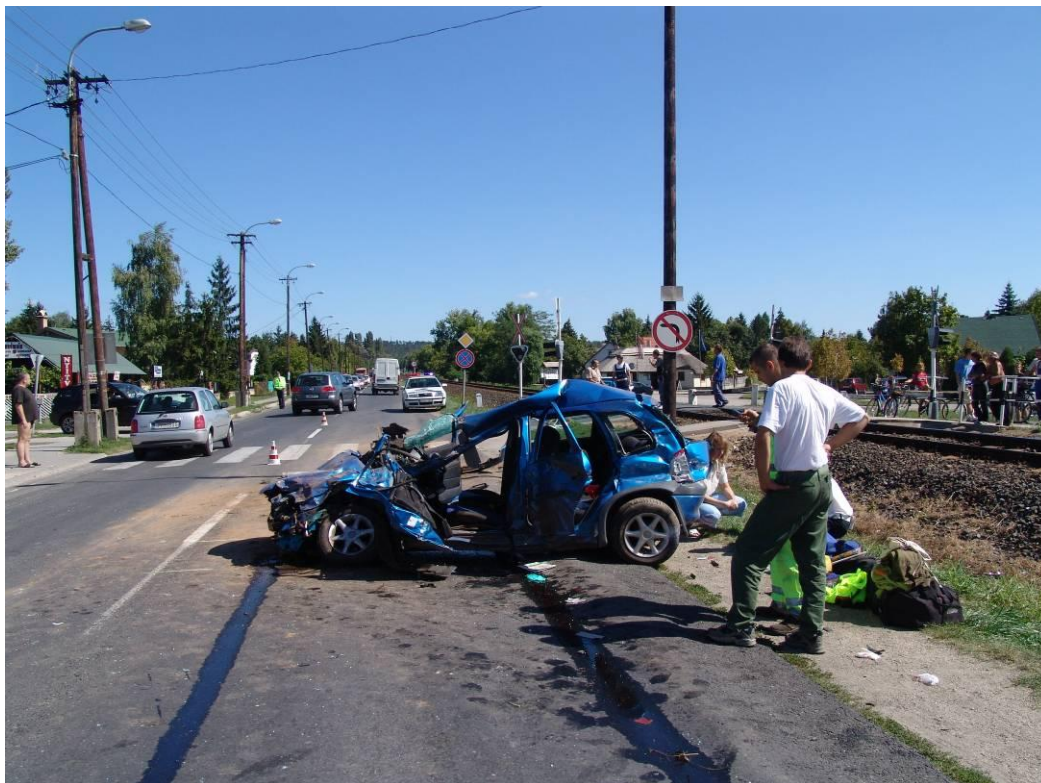
Non-scheduled passenger train no. 13972 collided with an Opel Corsa type car at 11 hours 18 minutes on 9th September 2006 between Csajág and Balatonkenese stations at level crossing no. AS380 secured by warning lights (operating normally). The car was turning left from main road no. 71 (Balatoni út) from the direction of Balatonakarattya onto the LC, ignoring the “No left turn” traffic sign. As a consequence of the collision, one of the four persons sitting in the car suffered serious injuries while the other three persons suffered minor injuries (See Figure 18).

Figure 18: Collision involving train no. 13972 and a car occurred on 9th September 2006

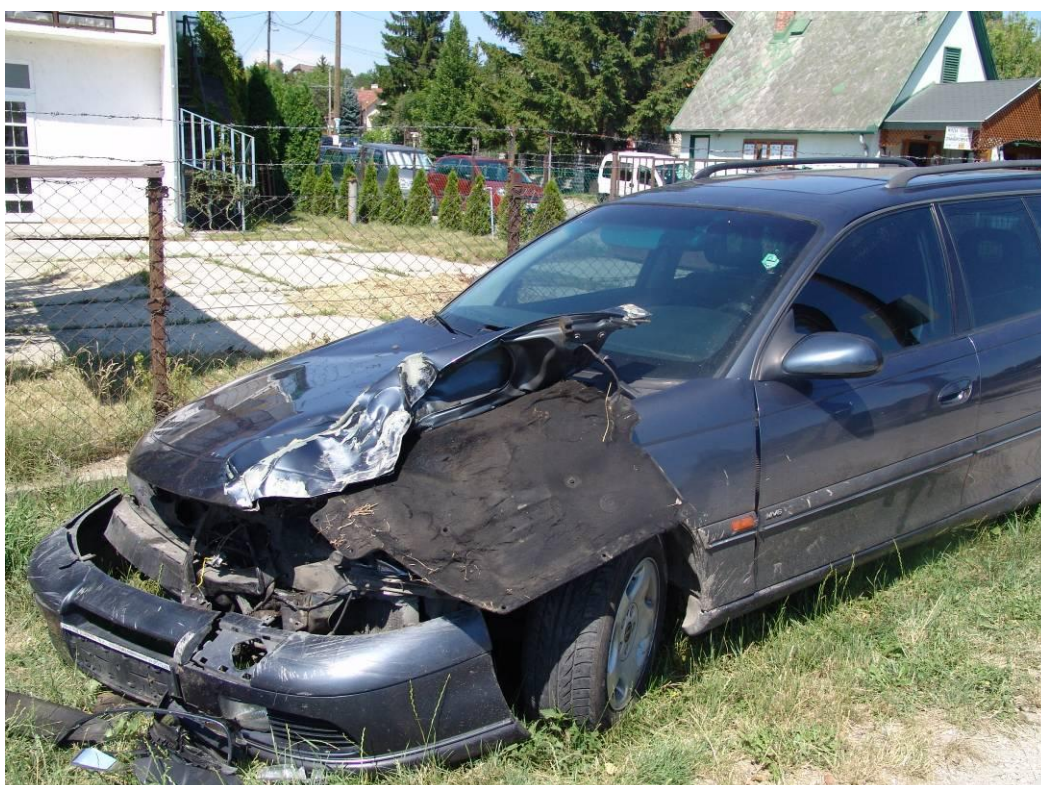
Figure 19: Collision involving train no. 16909-2 and a car occurred on 24th June 2007

Train no. 16909-2 running from Székesfehérvár to Tapolca collided with an Opel Omega type car at 11 hours 43 minutes on 24th June 2007 between Csajág and Balatonkenese stations at level crossing no. AS380 secured by warning lights (operating normally). The car was turning left from main road no. 71 (Balatoni út) from the direction of Balatonakarattya onto the LC, ignoring the “No left turn” traffic sign. No one was injured in the accident (See Figure 19).

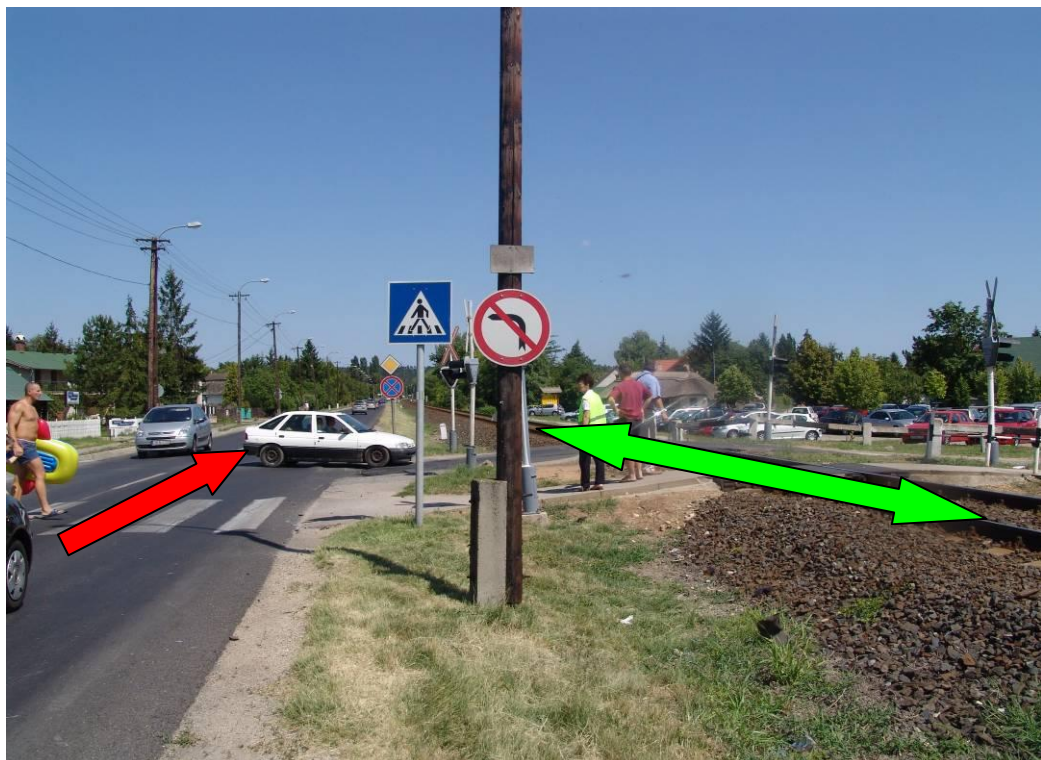
As “a” and “c” warning lights of LC no. AS380 are only 2.5 metres from the edge of the main road, there is not enough space for vehicles to stop in front of the warning lights (when the lights are red) and thus, stopping vehicles may hinder the traffic on main road no. 71 (See Figure 24).

Figure 24: Vehicles standing in front of the Stop signal of the warning lights hider the traffic on main road no. 71

BA2006-0033-5-01: The IC recommends the National Transport Authority that it should - together with the bodies concerned - re-examine the position of LC no. AS380. The NTA should also consider whether it is justified to maintain LC no. AS380 - taking into consideration that LC no. SR2 at Balatonkenese station approximately 500 metres away is secured with warning lights and half barrier, and LC no. AS373 approximately 700 metres away in the direction of Lake Balaton are much safer and there are turning lanes to both latter LCs - or whether the application of other technical instruments should be ordained.

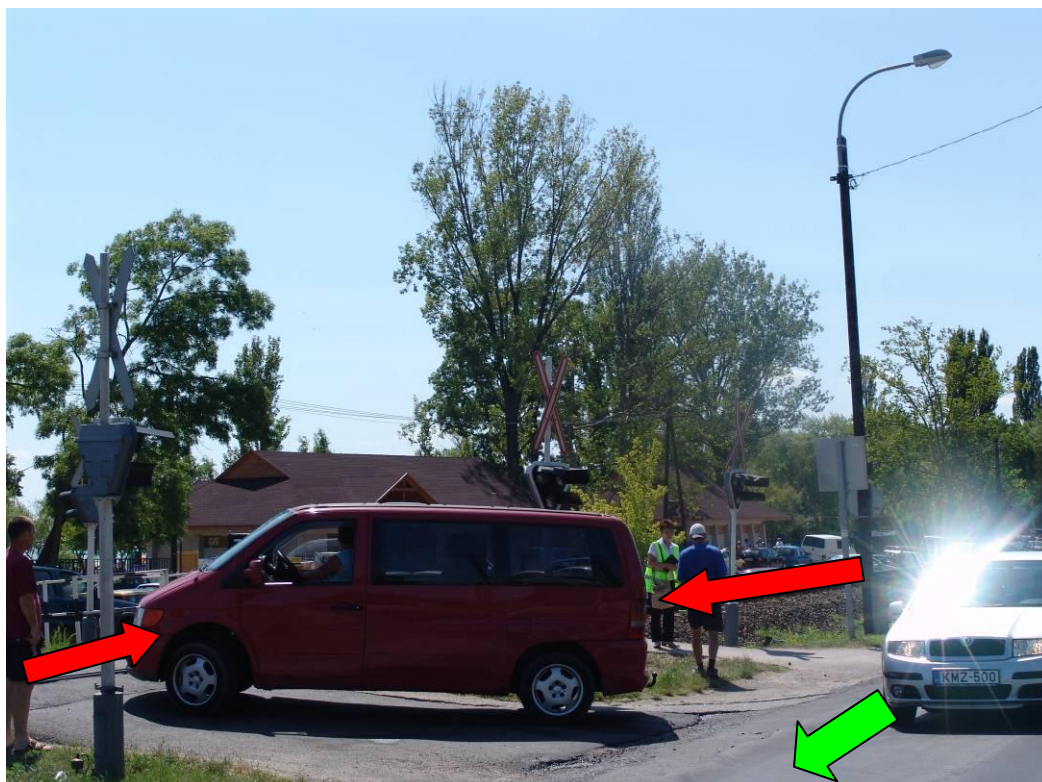
Figure 25: Running trains may reach and collide with vehicles passing the warning lights or those stopping in the clearance

Although the vehicles passing or stopping at “a” and “c” warning lights of LC no. AS380 no longer hinder other vehicles from driving on main road no. 71 from the direction of Balatonkenese, they are in the clearance area posing obstacles to trains arriving from Balatonakarattyá or Balatonkenese (See Figure 25).
