**FINAL REPORT**

**2006- 0048-5**

**RAILWAY ACCIDENT**

**Komárom station**

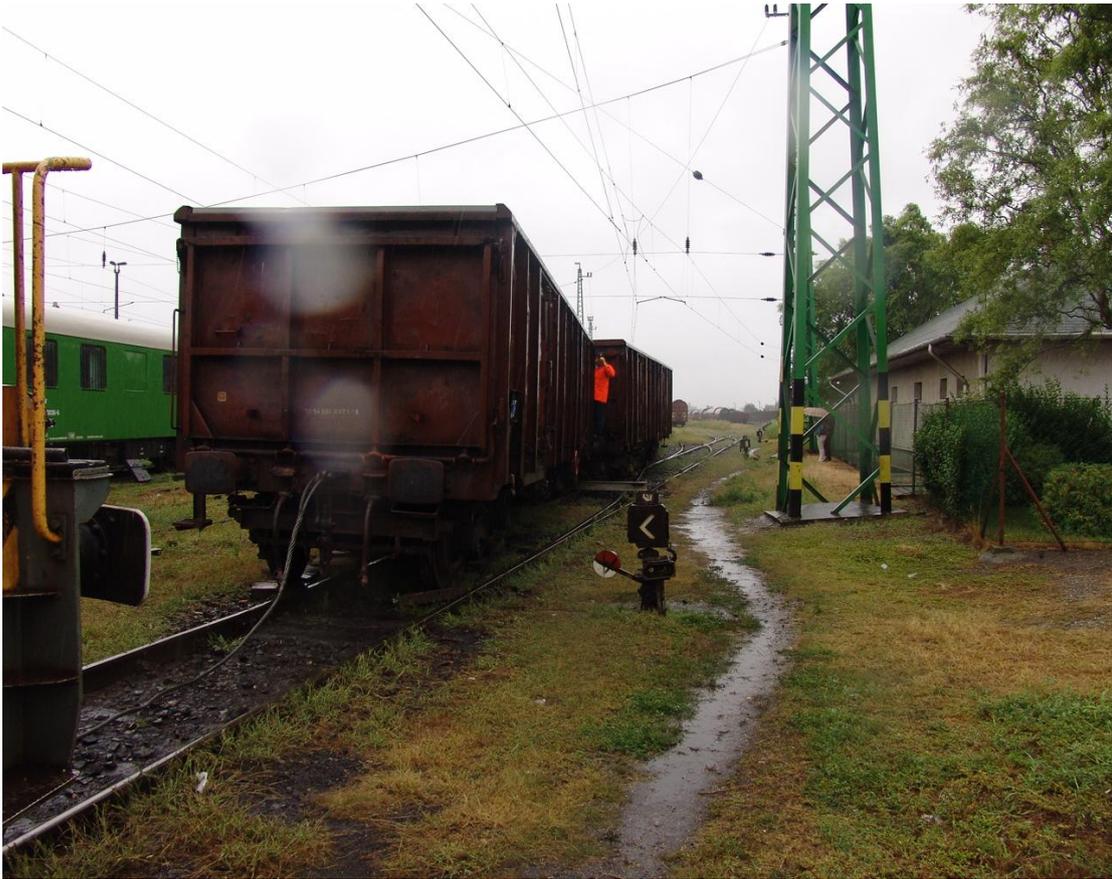
Train no. 45552 of BRKS a. s. railway undertaking was signalled out from platform no. XVI at Komárom marshalling yard in the direction of Komarno. At 05 hours 55 minutes, the first freight car derailed with 4 shafts and the second freight car with 2 shafts at the common crossing of switch no. 428.

Figure 5: Location of the accident (switches 427, 428)

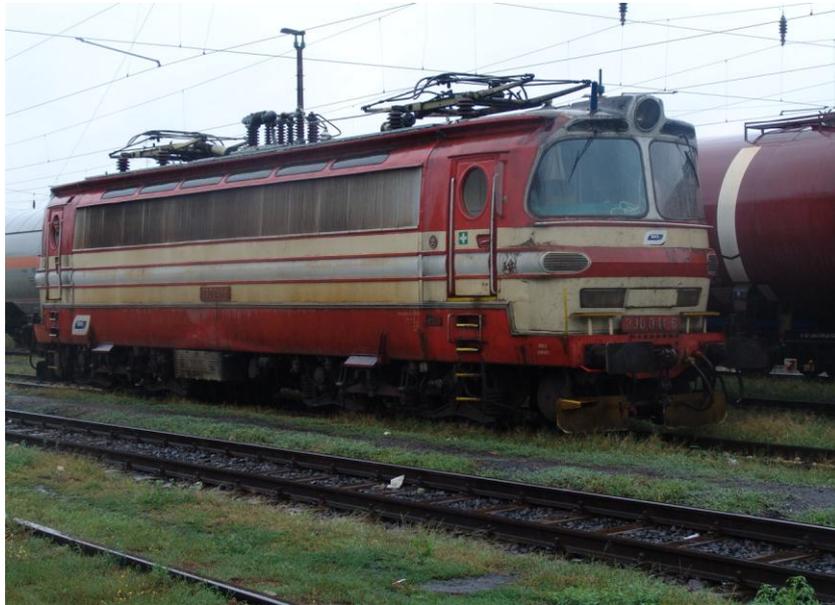
- The electric locomotive (registration number: **BRKS a. s. 230 041-6**) was not damaged.

Figure 6: electric locomotive of train no. 45552

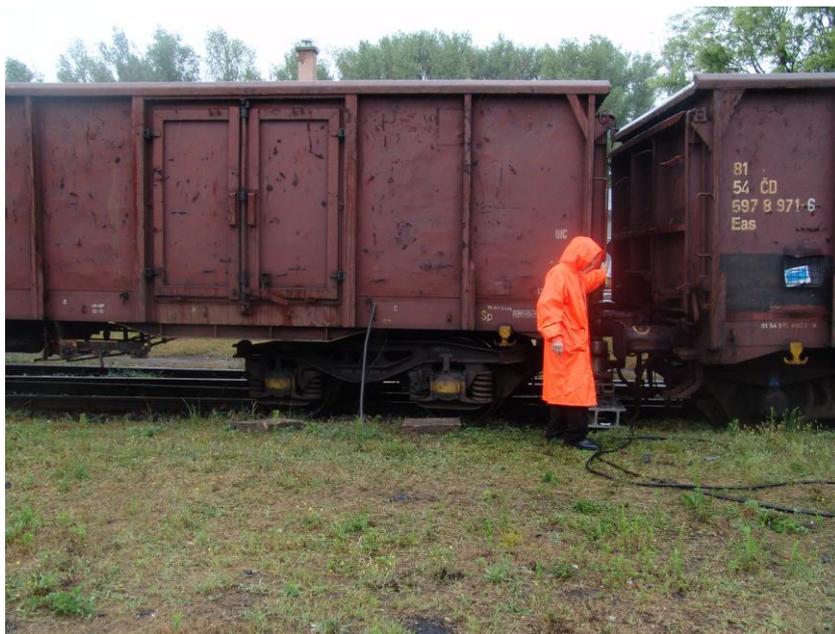
- **Sequenced cars**  
31 54 596 19864 Easu car derailed with 2 shafts and  
81 54 597 89716 Eas car derailed with 4 shafts and both were slightly damaged.

Figure 7: Derailed freight cars

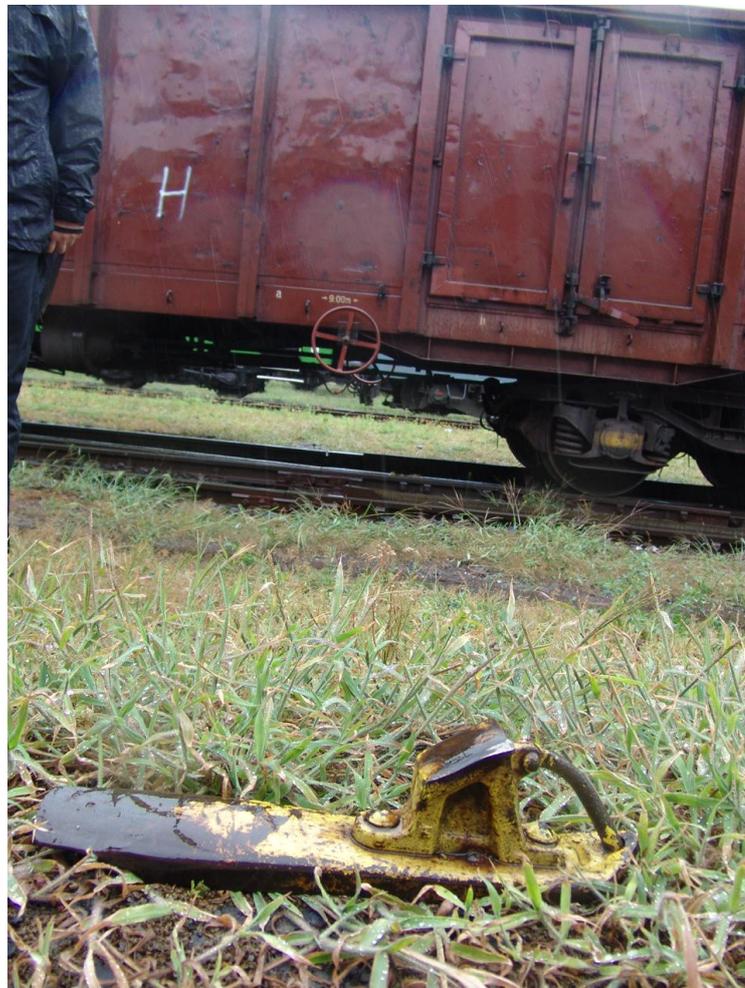
The investigation established that the accident was caused by a scotch block left under the first pair of wheels of the first freight car.

Figure 8: The scotch block left under the first freight car causing the accident.

The signalled out train 45552 departed from platform XVI and accelerated approximately to 15 km/h. The left front wheel of the first car pushed the scotch block in front of itself until the common crossing of switch no. 428 where the scotch block got stuck. As a result, the first freight car derailed with two shafts and the second freight car with four shafts. The scotch block flew off the rail due to the arising forces.

The immediate cause of the accident was that during the coupling and the inspection of the train it was not noticed that the scotch block had been left under the left front wheel of the first freight car.

**BA2006-048-5\_1:** TSB recommends the introduction of an instrument or sign which makes the scotch block clearly visible from a distance.
