TRANSPORTATION SAFETY
BUREAU

FINAL REPORT

SERIOUS RAILWAY ACCIDENT

**Between Almásfüzitő and Komárom stations
6 February 2007**

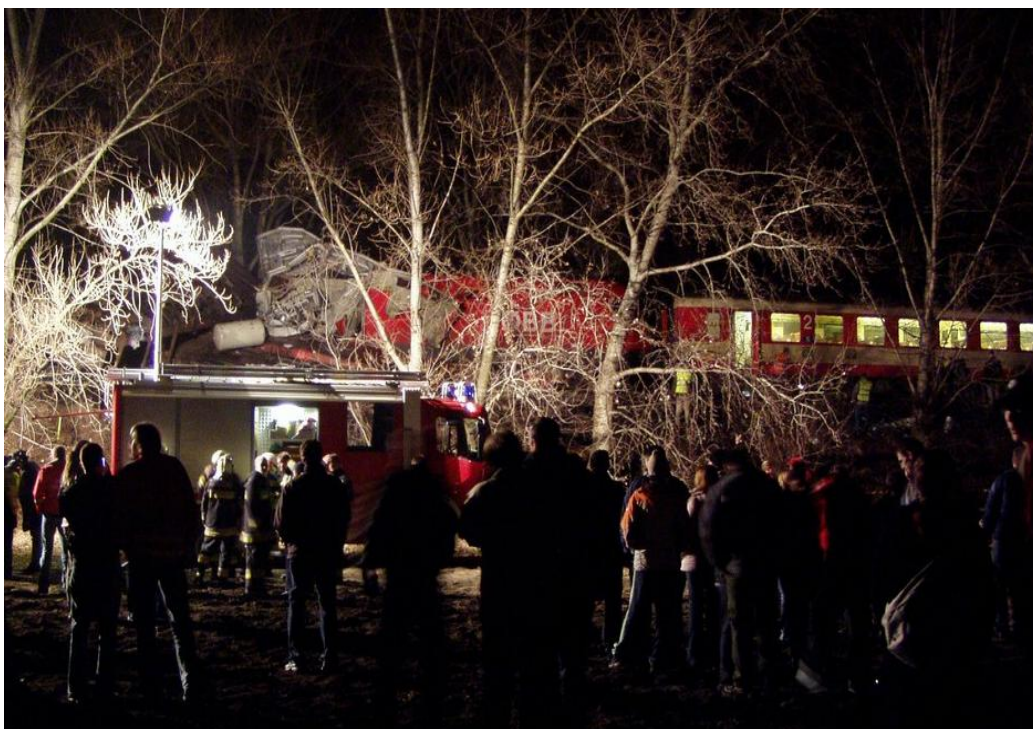
Figure 3: Site of the accident

The engine driver of the passenger train died at the site of the accident, two passengers suffered serious injuries, another four passengers, the chief ticket inspector of the passenger train and the engine driver of the freight train suffered minor injuries. The electric locomotive (registration number 1116-017) of the passenger train owned by ÖBB sustained serious damage. 5 cars of the DB-owned freight train derailed, 4 of which sustained serious damage. The right track of the railway line sustained serious damage in approximately 120-meter-length, while the left track sustained less serious damage in approximately 30-meter-length. The catenaries over both tracks broke and two catenary supports fell.

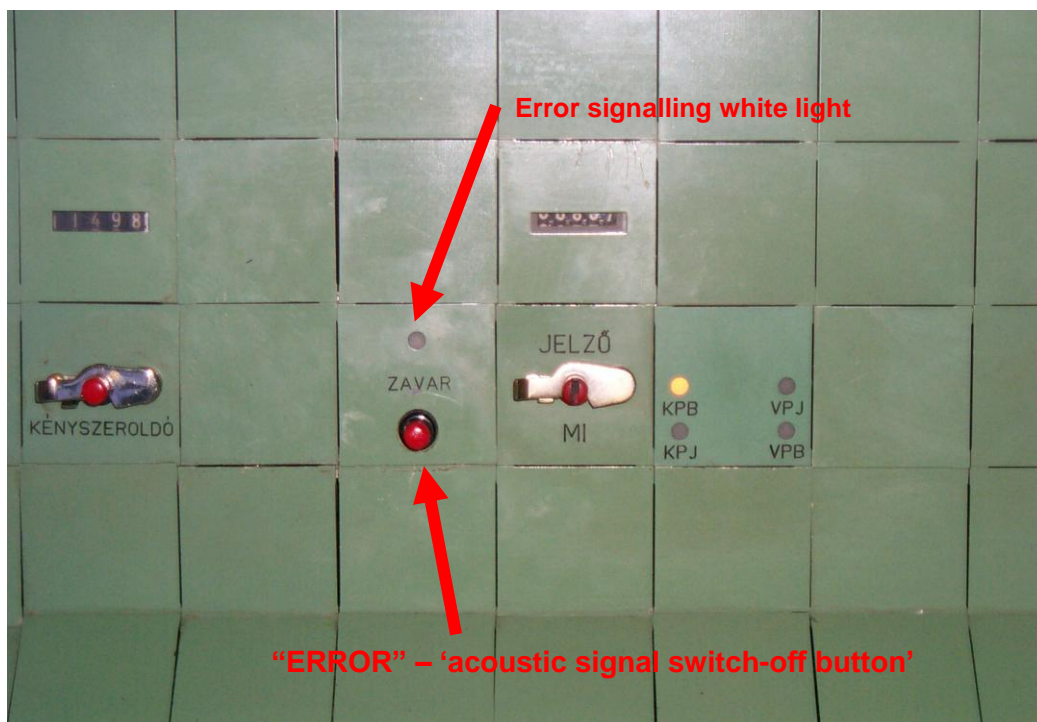
Figure 4: Control panel of Domino 55 type signal box

As the Domino 55 type signal box does not have a built-in system for registering operations, the operation and the errors cannot be checked subsequently. There was no entry in the error log regarding operational problems or errors. Presumably, the signal box personnel on duty in the morning of the day of the accident had handled the error similarly, and - disregarding the importance of the error signalling - did not inform the other signal box colleagues. Once the error signalling came on due to any error (e.g. burnt out light-bulb, etc.) and the signal box personnel switched off the ERROR button - however the white light continued to be on - a further error (in case of switching off the chargers) could not have been indicated either by acoustic signal or by another light signal – according to the construction of the error circuit. Therefore the signal box personnel could not have perceived a further error. The IC did not find entry in the error log regarding such further error.

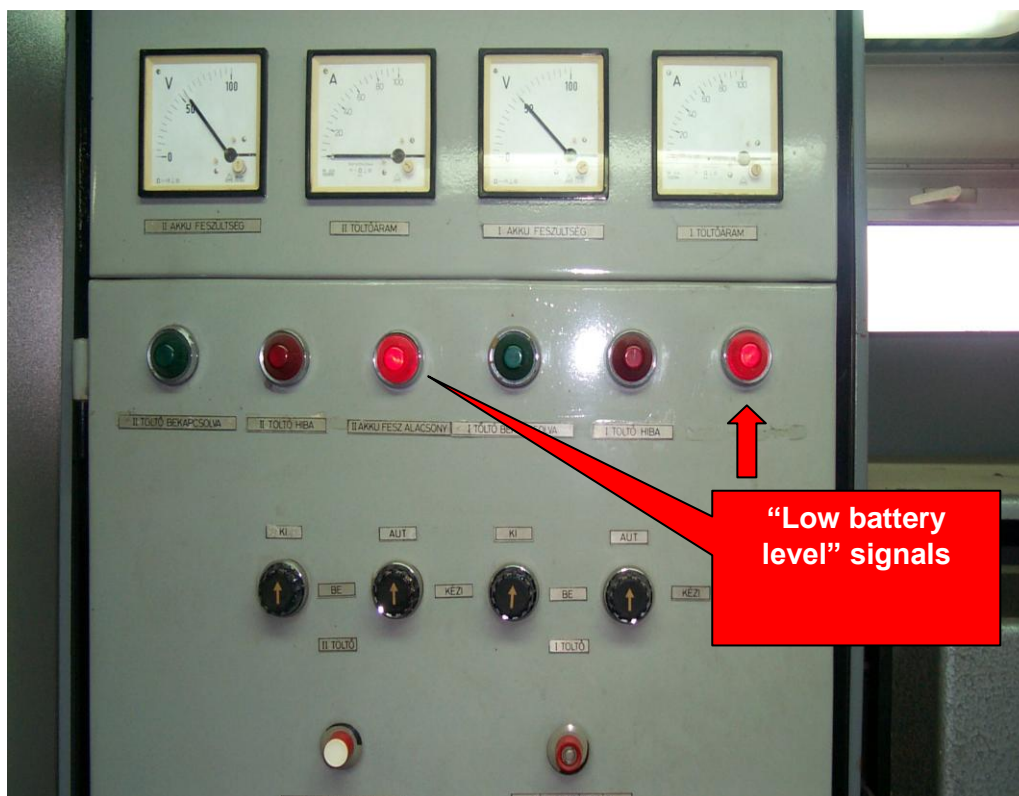
Figure 5: E-11 type battery charger

In the course of the subsequent tests (see 1.12), after switching off “E-11” type battery chargers (as a consequence of the adequate voltage drop of the storage batteries) a so called “general error signal” appeared on the control panel of Domino 55 type signal box. This general error is indicated by an acoustic signal and a white light. This light is next to the ‘acoustic signal switch-off button’ inscribed with the word “ZAVAR” (“ERROR” in English) – see Figure 4 below. The movements inspector on duty - who was also responsible for the control panel of the signal box - pressed the “ERROR” button automatically, without finding out the reason inducing the acoustic signal. However, the white light signal remained on. He was unable to answer to the question of the IC as to what might have caused the error. When the IC switched the battery chargers back on, the error signal automatically ceased, that is, the white light went out.

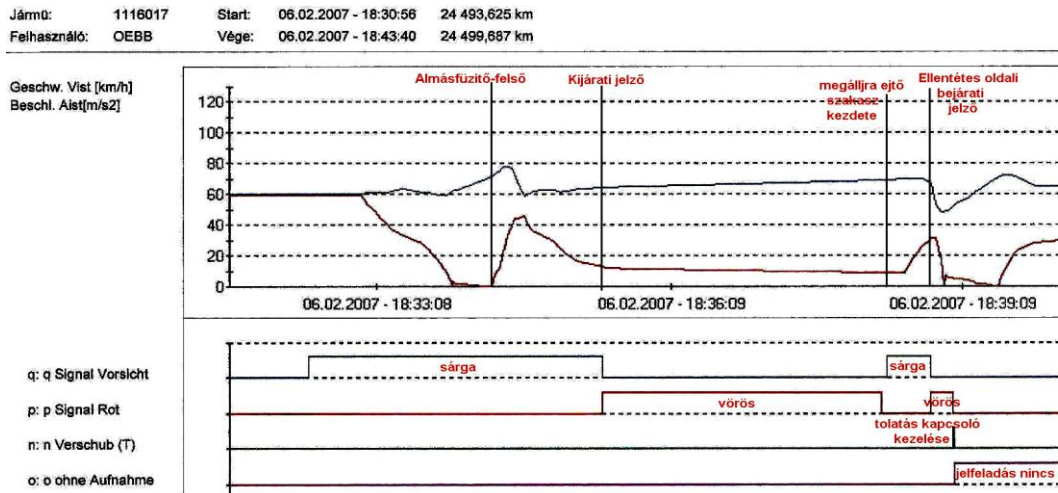
Figure 6: Recordings of the strip chart recorder of the locomotive (registration number 1116-017)

Based on the data read-out from the data recorder of the locomotive, it can be expressly established that 4 minutes after stopping, the train was put into 'shunting mode' (by applying the 'shunting mode handle' which is located in the driver's cab behind the engine driver on the left) for one minute, and then it was set back to 'train' mode. Consequently, the train control installation of the locomotive "forgot" the 15 km/h speed limit and further on it operated as if the train was running on a rail track section built without continuous signalling, and it did not serve its speed limiting function.

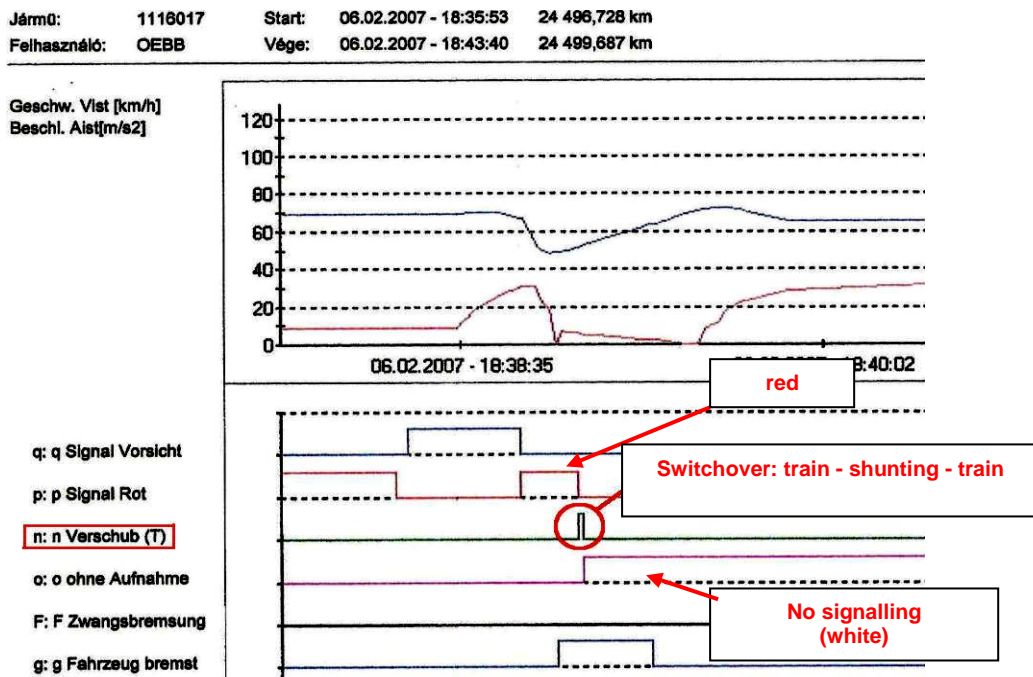
Figure 7: The train/shunting/train' switchover signal indicated on the recordings of the strip chart recorder

This switchover can be done in the front driver's cab - where the engine driver was - by a definite movement, which excludes the possibility that the switchover happened owing to circumstances beyond the engine driver's control.

The direct cause of the occurrence of the accident was the switching the “EVM 120 vigilance warning device and train control installation” of the locomotive of train no. 9438 over to shunting mode and back to operation. As a result of this act, the train control installation stopped functioning as a speed limiting device and therefore the train exceeded the speed limit six-sevenfold.

BA2007-0047-5-03: The IC recommends railway undertakings operating traction vehicles to work out a solution to be able to control switchovers from train mode to shunting mode on the train control installations of locomotives and other traction-vehicles by checking the recordings of strip chart recorders – automatically where possible. This way, engine drivers would be obliged to operate the installation as prescribed.

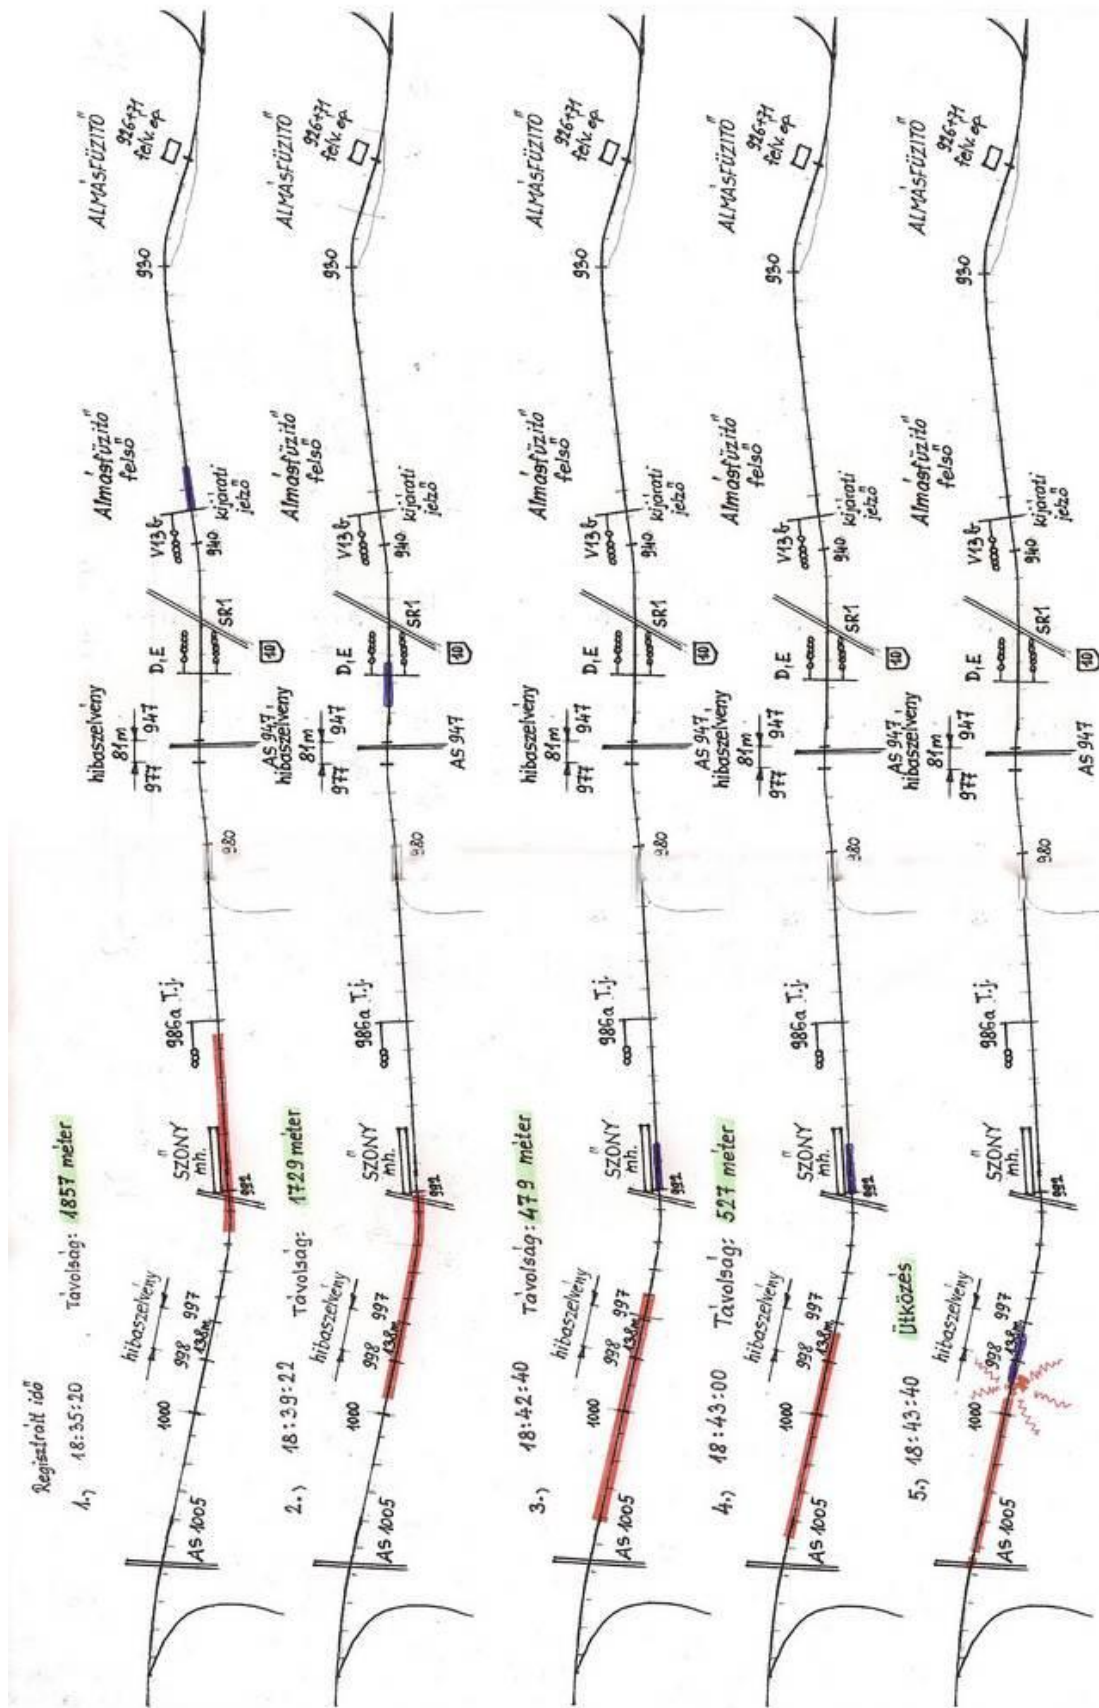
Figure 10: The position of train no. 45224 (red) and train no. 9438 (blue) prior to the accident

Having evaluated the recordings of the data recorder of the locomotive (registration number 1116-017), the IC established that the engine driver stopped the traction approximately 34 meters before the collision. Based on the above described active, definite movements of the engine driver, it can be stated that the engine driver could not have become inert prior to the accident.

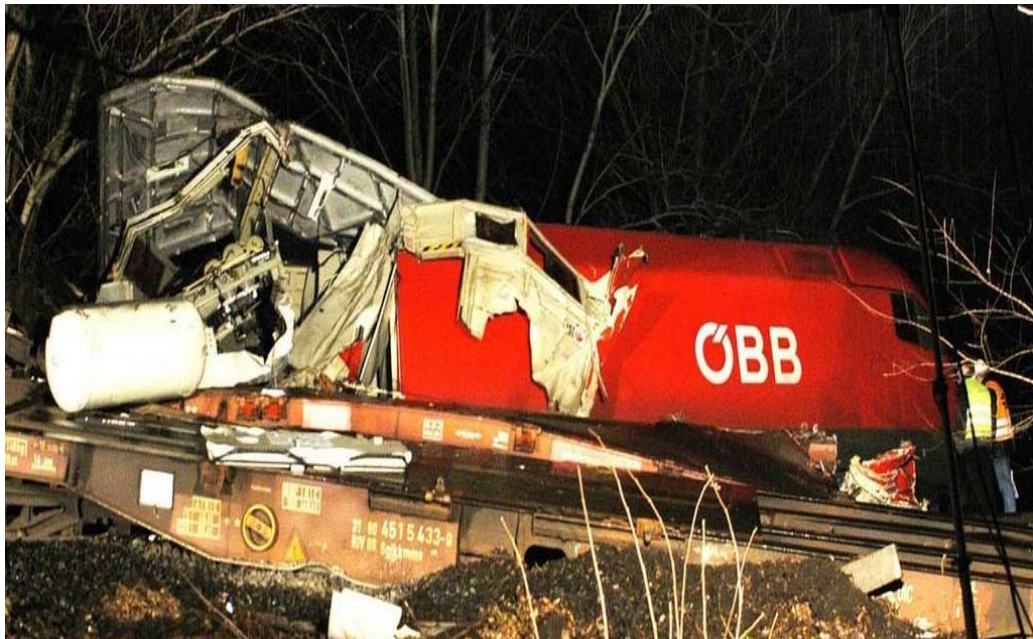
Figure 11: Consequences of the accident

- The electric locomotive of **ÖBB** (registration number 1116-017) sustained extensive damage,
- **Damages to the freight train:**
Reg. no. 31 80 495 4752-0 flat car derailed, and
Reg. no. 31 80 356 0015-0,
Reg. no. 31 80 451 5433-9,
Reg. no. 31 80 453 6061-3,
Reg. no. 21 80 442 6644-1 flat cars derailed and sustained extensive damage as they heaped up on one another and on the locomotive.

- The right track of the railway line sustained serious damage in approximately 120-meter-length, while the left track sustained less serious damage in approximately 30-meter-length.
- The catenaries over both tracks broke and two catenary supports fell.
- The environment did not suffer damage. The trains did not transport dangerous goods.
