TRANSPORTATION SAFETY
BUREAU

FINAL REPORT

2007-0462-5

RAILWAY INCIDENT

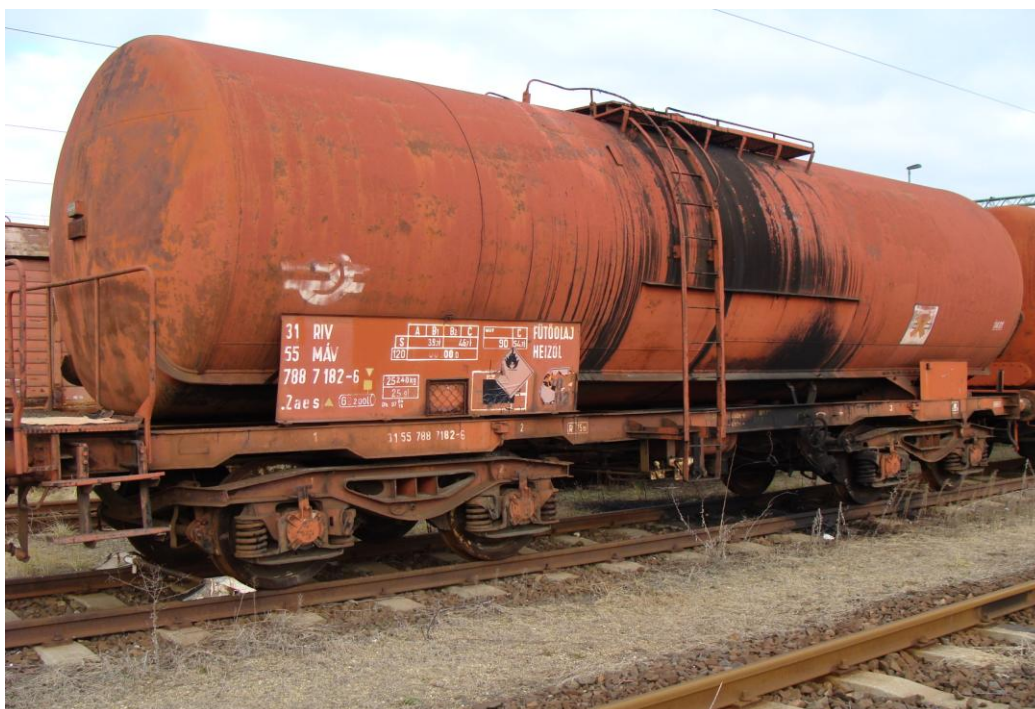
Figure 4: The wagon involved in the incident

Presumably between 14 hours 30 minutes and 15 hours 30 minutes on 15th December 2007, two children climbed up on top of the Zaes tank wagon (registration no. 31 55 788 7182 - 6) stored on track XII of the private-sidings at Kaba station. One of the children suffered an electric shock.

According to information received from Regional Centre of MÁV Zrt. Infrastructure Management, the wagon involved in the incident had been stored permanently on track XII of Kaba station for five years.

BA2007-462-5-01: In order to reduce the number of accidents in which the involved persons suffer electric shock as a result of climbing up on permanently stored wagons, the IC recommends MÁV Zrt. that these wagons should be stored on tracks without overhead contact lines or the contact lines should be off voltage. The wagons should also be kept at physically fenced off areas.

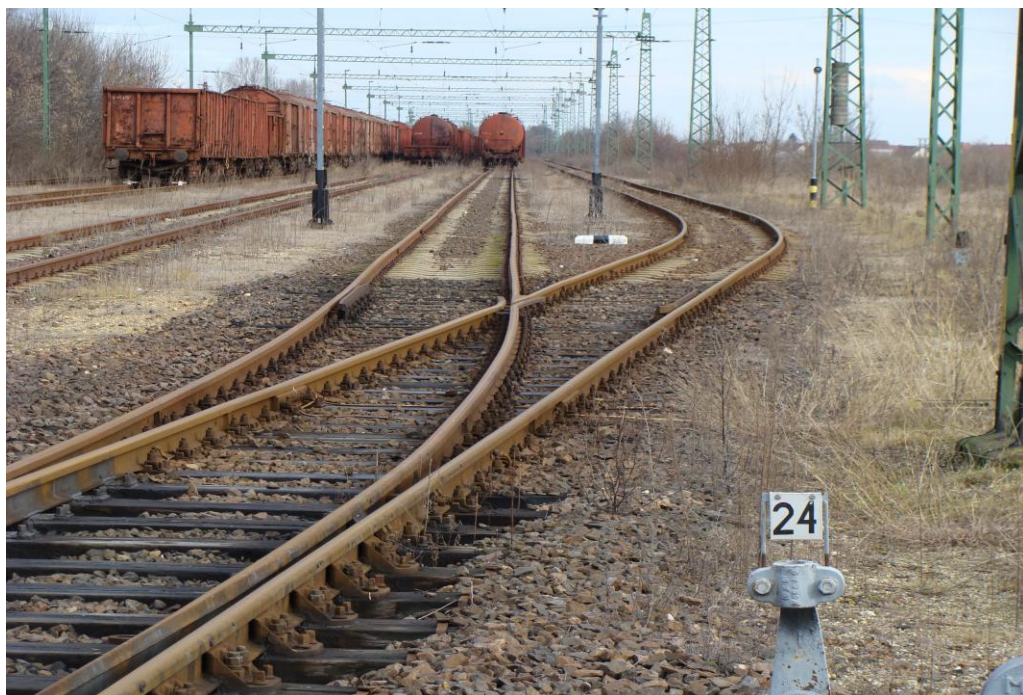
Figure 3: The site of the incident

Track XII. Of Kaba station is used to store freight wagons permanently. This track is not physically closed from unauthorised personnel.

Wagons stored permanently at the station are not closed off from unauthorised personnel.

According to the above, it can be stated that on tracks where wagons are stored permanently, there is no need to keep the overhead contact lines under voltage as it is an additional source of danger. The danger is increased by the fact that the stored wagons are not closed off, and therefore unauthorised personnel - children among them - can climb up on them unhindered.

The viewpoint of the IC with regards to powering down the overhead contact line over tracks used for storing wagons is that they shall be powered down where feasible, and local regulations shall be made accordingly. At stations where tracks are used to store wagons

permanently (e.g. Kaba station), the electric network shall be modified to allow separation of contact lines over individual tracks.
