KÖZLEKEDÉSBIZTONSÁGI
SZERVEZET

FINAL REPORT

RAILWAY INCIDENT

Devecser-Túskevár

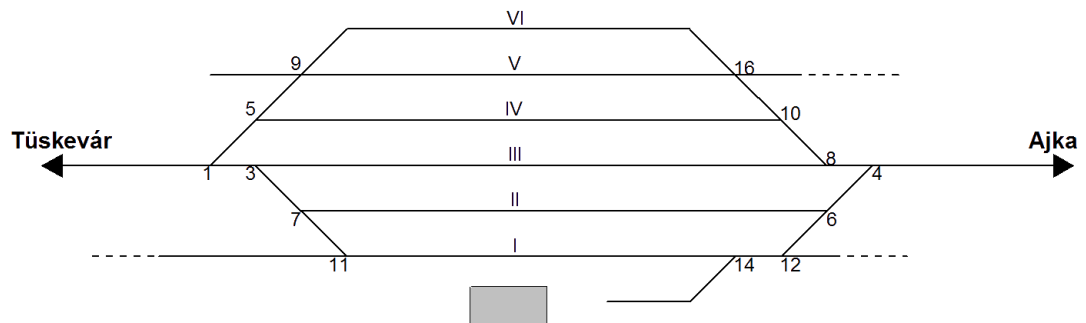
Figure 4: Track network of Devecser station

There are six tracks at the station, four of which are arrival tracks (II-V). The main transit track is track no. III. The open track is protected by dead-end tracks and industrial tracks from tracks. I, V and VI.

The area of the station slopes (1.8 ‰) towards the end point (Túskevár).

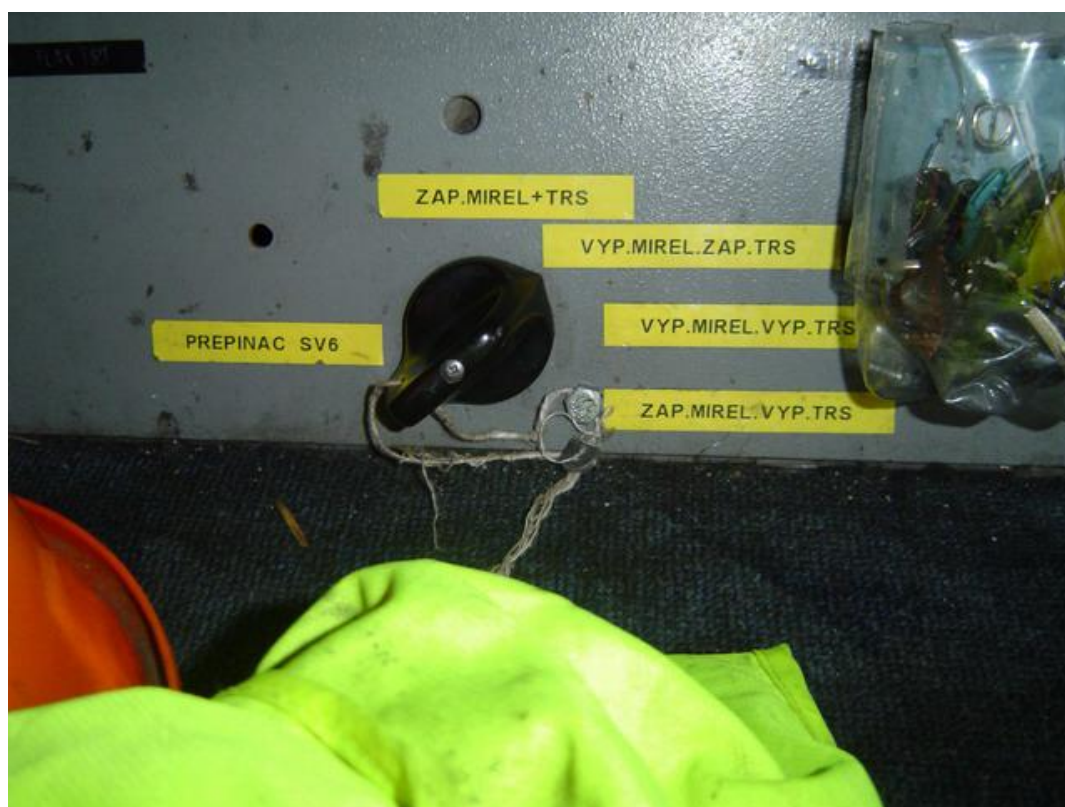
Figure 5: The switch of the train control device on the locomotive (Photo: VBO)

This switch is only labelled in a foreign language (see Figure 5). According to the knowledge of the engine-driver, the switch should be used as shown in the photo when travelling on the railways in Hungary. However, he did not know what the other (Czech) labels/signs meant.

According to the translation obtained by the IC, the meanings of labels are as follows (the switch was in the position indicated with yellow colour):

PREPINAC SV6	SV6 switch (the name of the switch)
ZAP. MIREL + TRS	Mirel and TRS on (line radio system)
VYP. MIREL, ZAP. TRS	Mirel off, TRS on
VYP. MIREL, VYP. TRS	Mirel off, TRS off
ZAP. MIREL, VYP. TRS	Mirel on, TRS off

The IC has found in the course of the investigation that the locomotive crew did not know the functions of the switches on the locomotive adequately, therefore - despite previous trainings - they were not sure how to operate them.

Therefore the IC recommends the NTA to obligate railway undertakings to provide traction vehicle staff with standard, concise 'type'-documents which include the essential safety information and handling/operation rules in a language known to the staff. Engine-drivers should have the opportunity to get to know these documents. A

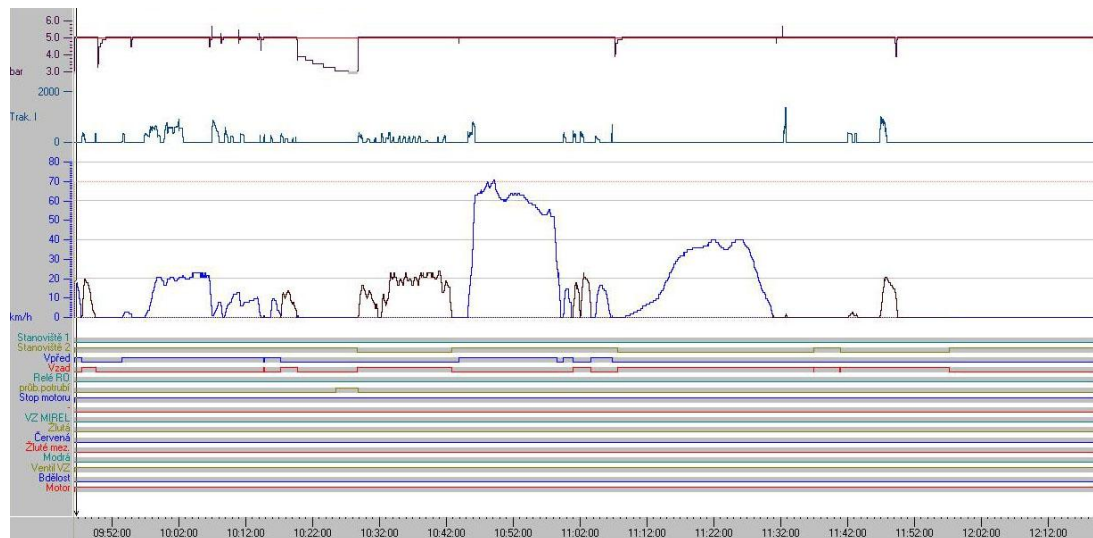
Figure 6: the data recorder of locomotive no. 740 604-4

MIREL type speedometer and data recorder was operating on both locomotives. For the time-proportional movement diagram of the assisting locomotive, see Figure 6 below. The distance-proportional diagram was not available for the IC.

The blue and the black lines indicate the direction of the movement.

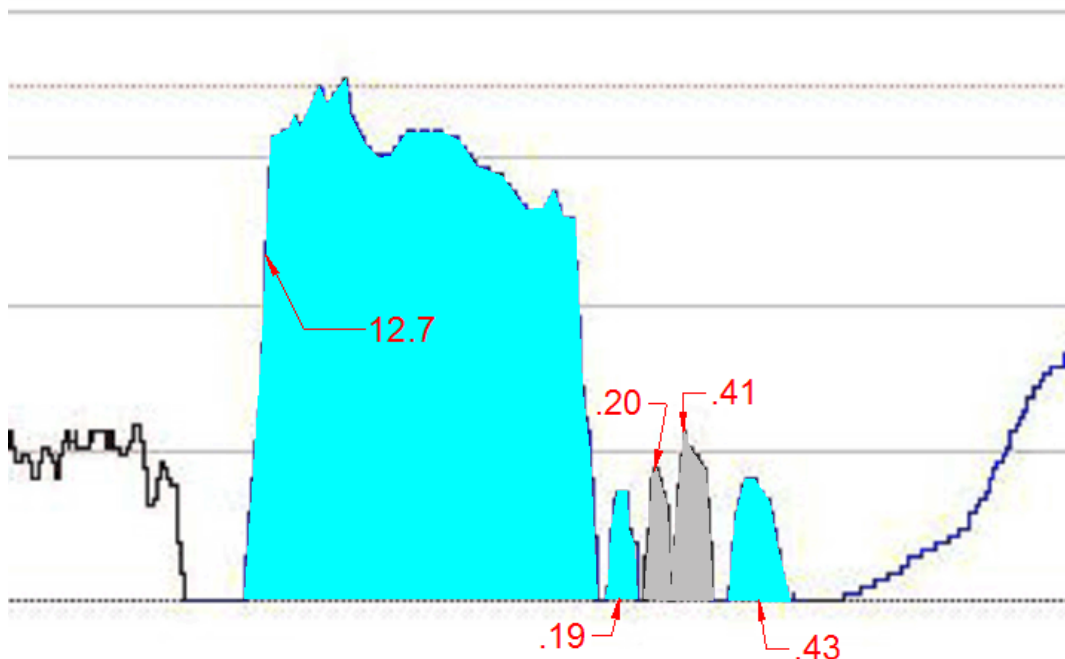
Figure 7: distance estimates on the recording

As the IC only possessed the time-proportional recordings, the distances are estimated (based on the area measurements - see Figure 7). The known distance between Ajka and Devecser is 12.7 kms.

According to the recording, the locomotive went back from Ajka-Bauxitrakodó to Devecser station and then its movements were the following:

1. kb. 190 m movement towards Túskevár,
2. kb. 200 m movement towards Ajka,
3. kb. 410 m movement towards Ajka,
4. kb. 430 m movement towards Túskevár.

First the locomotive ran until the rear of the 170-metre-long train and then was coupled to the train (movements 3 and 4 - the distance between the traffic office and the outermost points). According to the recordings, the locomotive was coupled to the train 2 minutes before the 'free run'.

Based on the clock of the data recorder, the train broke loose at 11:09 hrs and it stopped at 11:31. It ran free for 22 minutes, during which its maximum speed was 40 km/h. The distance ran was 9.1 kms, that is, the train rolled with an average speed of 25 km/h.

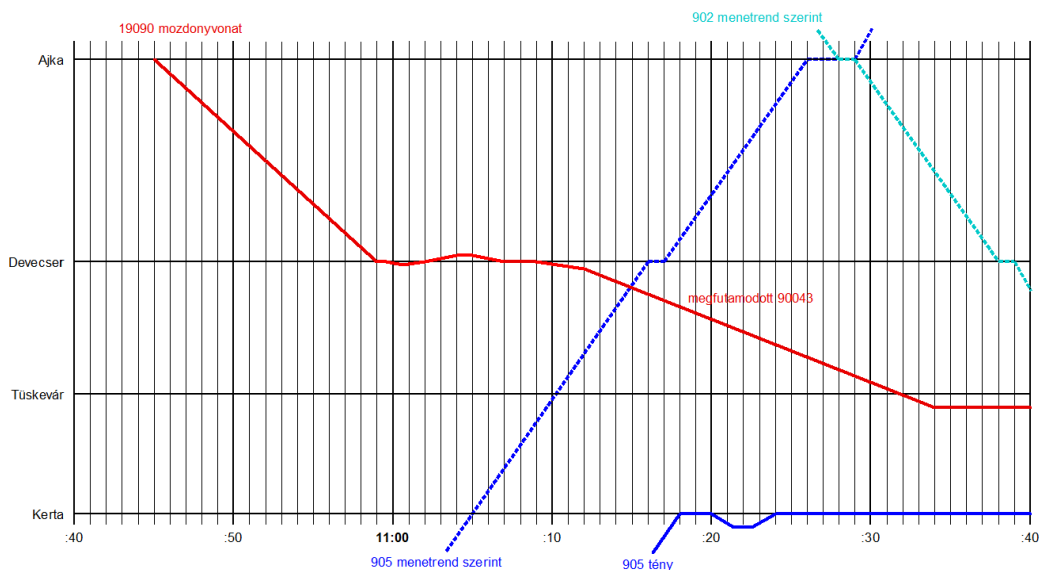
Figure 8: traffic circumstances when the freight train broke loose

As the movements inspector of Túskevár station did not answer the phone when Devecser called (supposing that it was inquiring about the delayed passenger

train), he was only later informed about the danger and he gave the permission for the fast train to run on the same track as the freight train was running free in opposing direction. This action created even more risk.
