FINAL REPORT

2010-069-5

Railway accident

**Budapest- Nyugati station
9 February 2010**

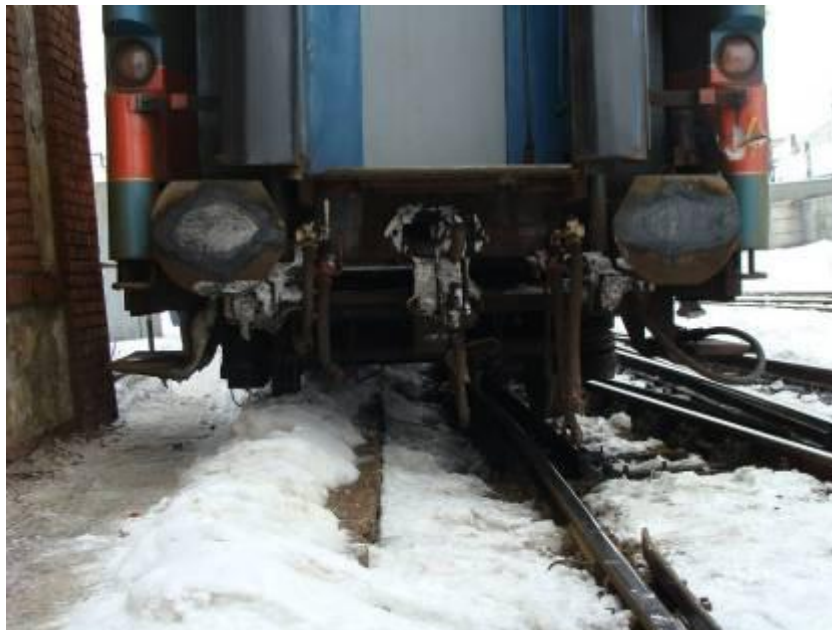
On 9 February at 08:27 hrs, the fifth carriage of passenger train no. 2759 - on the Szolnok-Cegléd-Budapest route derailed with four axles between points no. 13 and 19 when approaching track XIV of Budapest-Nyugati station. As a consequence of the occurrence, the train pulled apart and the coupling of the fourth carriage broke off. The derailed carriage damaged the rail track on an approximately 15-metre-length and stopped half metre from the points operation building (see Figure 3). The blades of points no. 19 (double slip) sustained minor damage.

Figure 3: the derailed carriage beside the wall of the points operation building

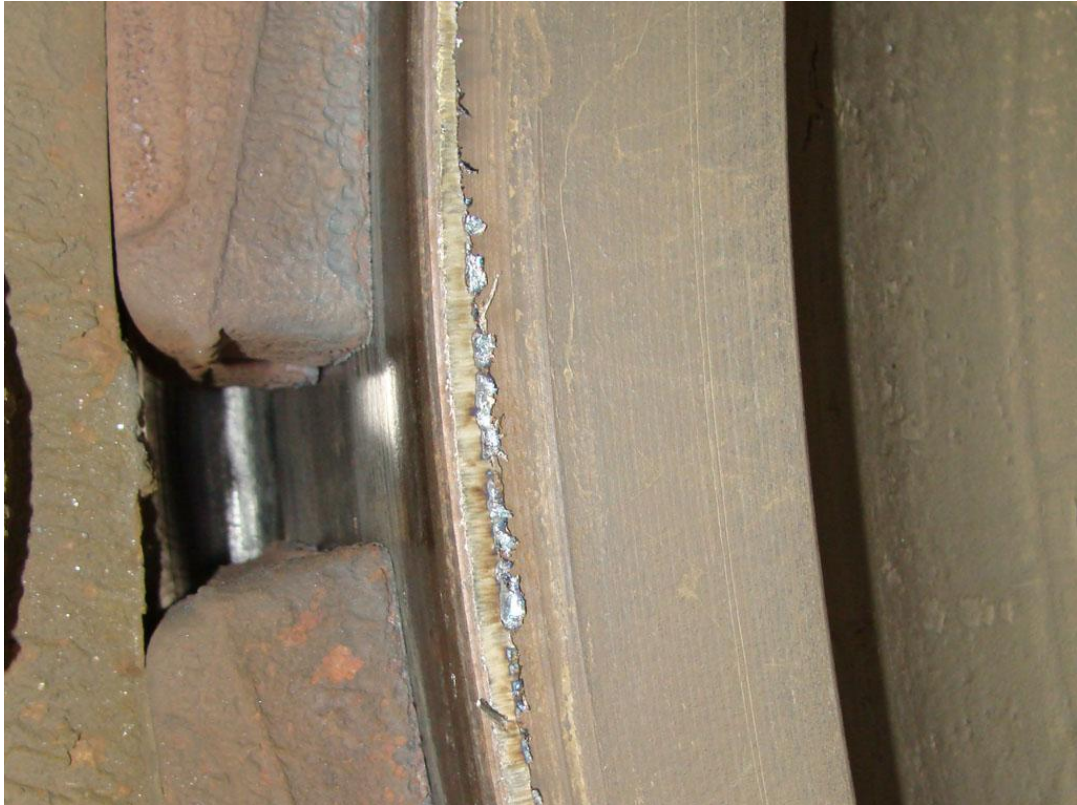
Scrapes were visible on the derailed wheel of the derailed carriage. Similar marks were also found:

- on one of the wheels of the locomotive (see Figure 4), one of the wheels of the first carriage and that of the control car;
- on the locomotive and one carriage of train no. IC 709 running on the same track previously (two trains before the derailed train).

Figure 4: marks (scrapes) on the wheel of the locomotive

The typical marks on the wheels of the derailed carriage (see 1.7.1 and Figure 4) indicate that the wheel running on the inner side of the arch first fell in between the rails, and while in motion, the outer surface of the wheel grated against the rail. From this position (towards the end of the gauge widening) the wheel running on the outer rail jumped over the rail and left the track.

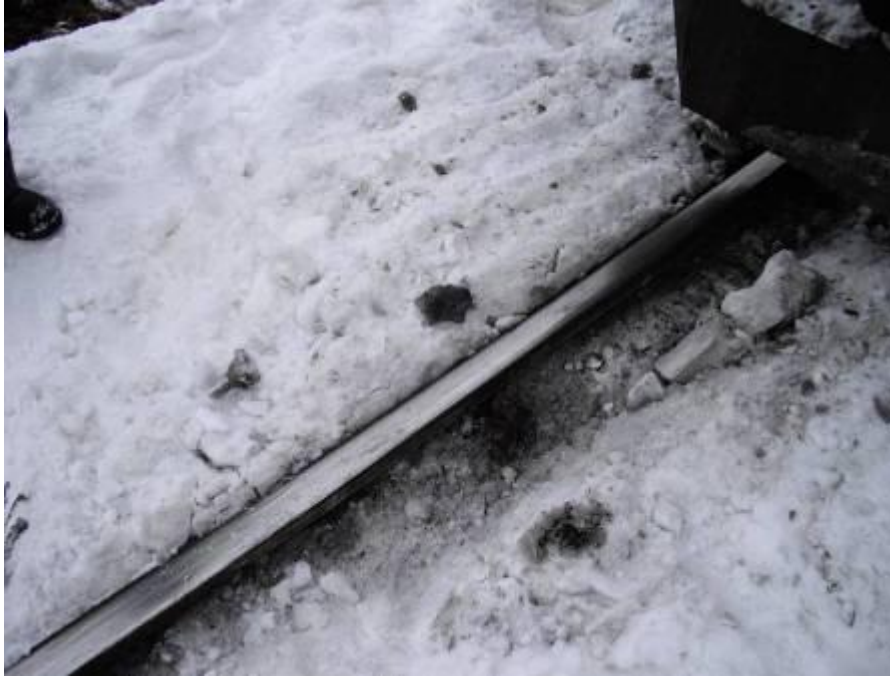
The first derailment mark was found on the left rail (from the running direction of the train) between the 2nd and 3rd sleeper (see table 1.8.3 at the area of sleeper 24.)

Figure 5: first derailment mark on the rail

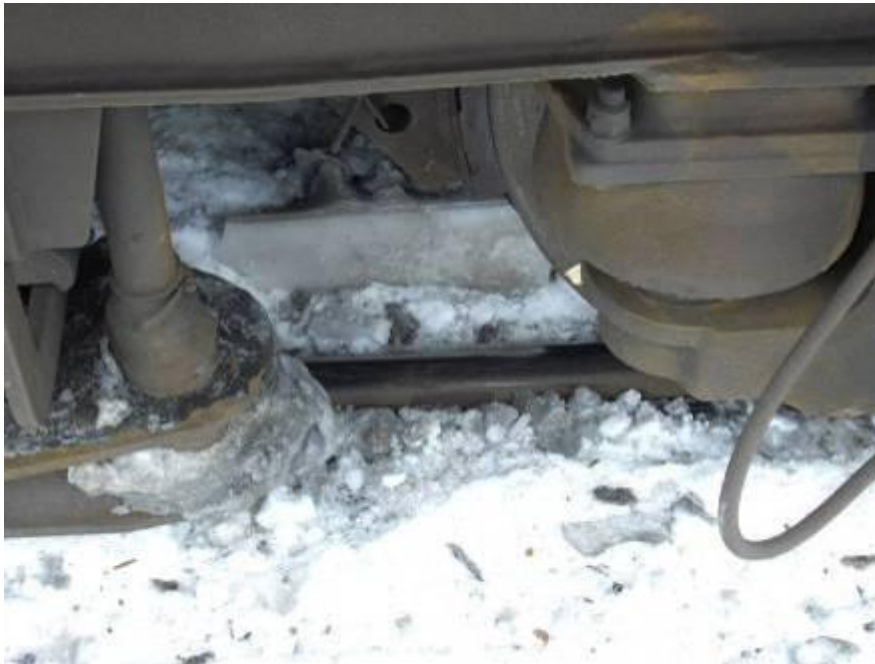
The second derailment mark was found on the right rail, under the rear bogie of the control car, in the area of sleeper 31 (see Figure 6)

Figure 6: second derailment mark on the rail

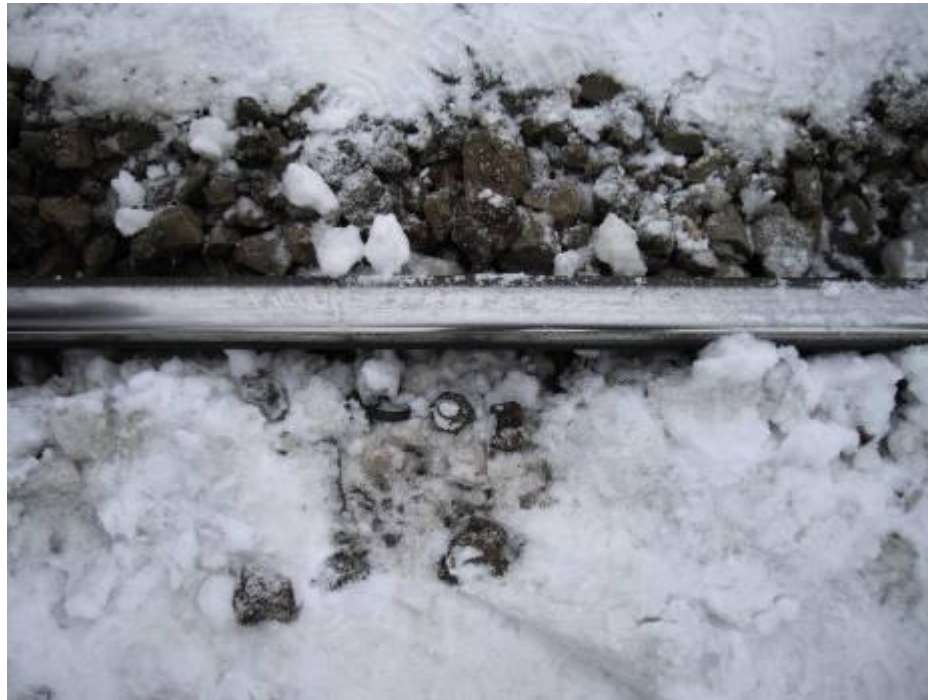
Marks of ploughing and corrosion were visible on the right rail where the wheel flange touches the rail-head in the area of sleepers 14-21 (see Figure 7).

Figure 7: marks of ploughing and corrosion

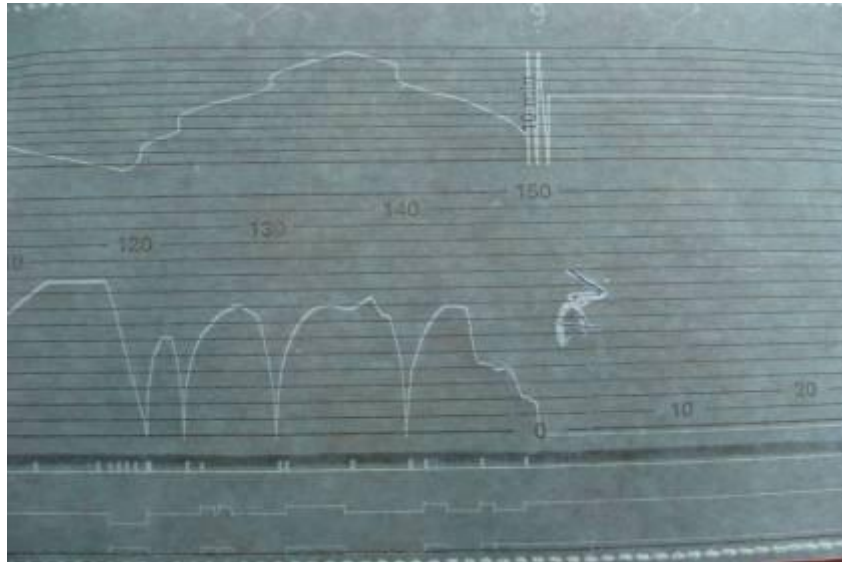
Figure 8: the strip chart recorder of locomotive no. V43 2291

The IC evaluated the strip chart recorder of the locomotive (see Figure 8) and established that train no. 2759 did not exceed the 20 km/h speed limit.
