KÖZLEKEDÉSBIZTONSÁGI
SZERVEZET
TRANSPORTATION SAFETY
BUREAU

**2010-308-5
Railway accident**

**Pécs station
19 July 2010**

Collision of locomotive with its carriages (train no. 8015)

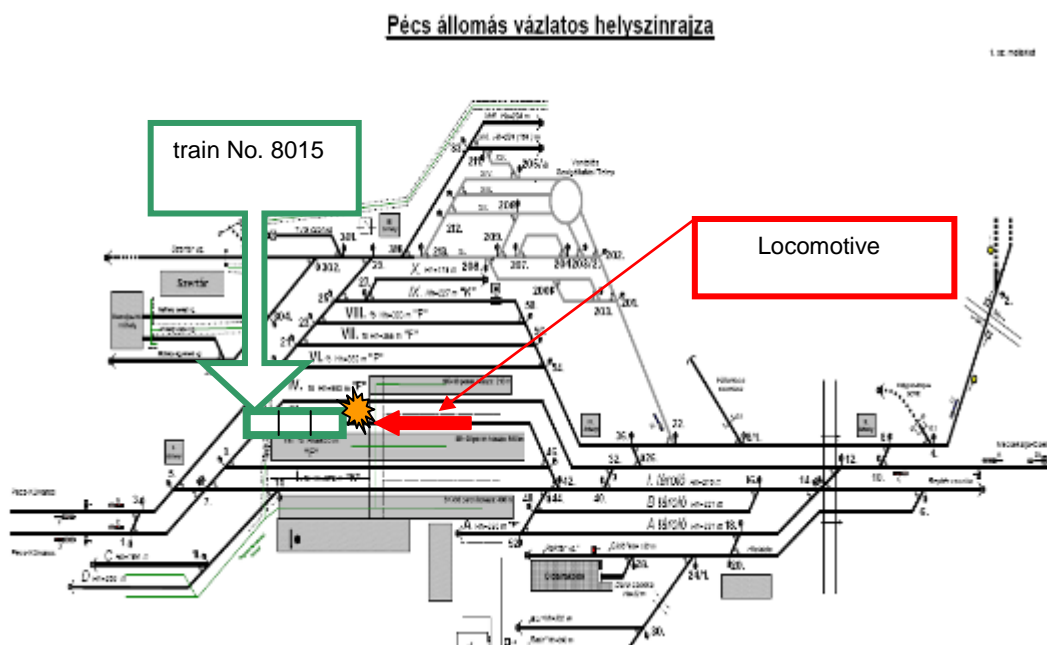
Figure 3: The scheme of the accident site (location of collision is marked)

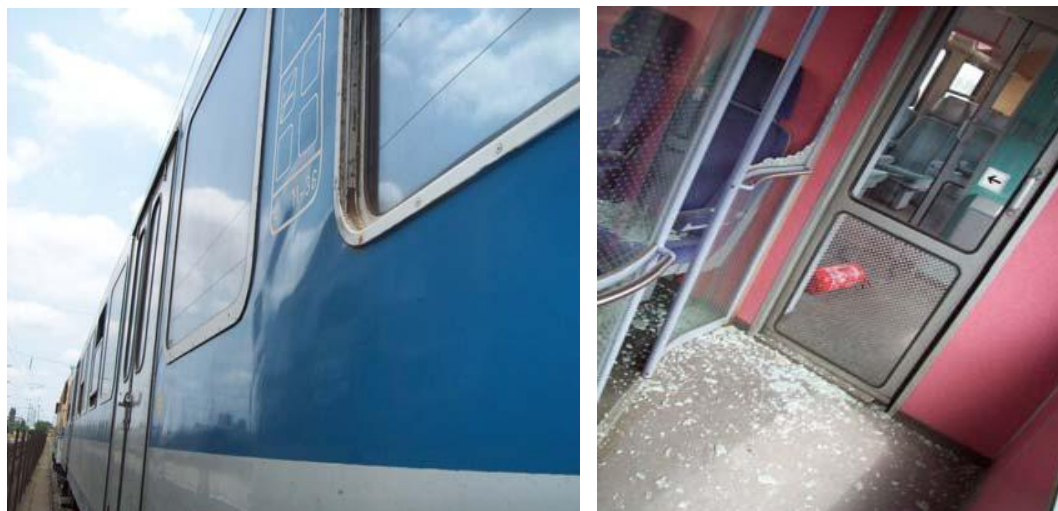
As a result of the collision, the collision plates located on side 2 of the locomotive got damaged. Carriages No. 50 55 21-55 561-3, 50 55 21-55 628-0 and 50 55 21-55 957-3 also sustained external and internal damage (see Fig. 4).

The involved V43-3224 locomotive's collision plates got deformed on side 2. Train No. 8015 sustained various damages (see Fig. 4). Carriage No. 5055 21-55 957-3 was pulled into a repair shop, lifted and examined, during which no additional damage was found.

Figure 4: external and internal damage of the carriages

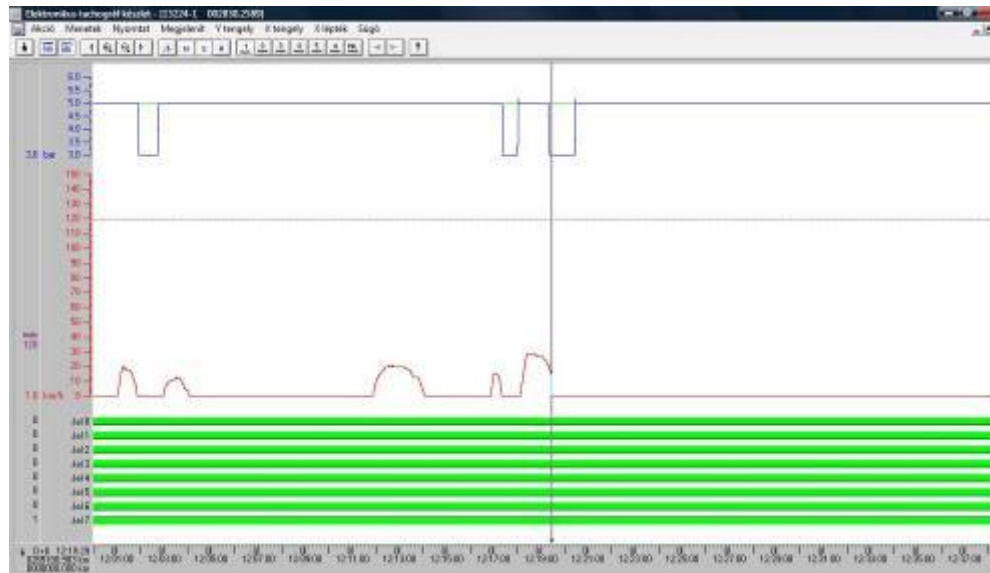
Figure 6: strip chart recorder of V43-3313 locomotive

- The collision occurred at 12:19'28" at a speed of 15 kph. When the driver started the braking the speed was 26 kph, at this moment the locomotive was 115 metres from the train. He applied fast brake when the locomotive was 28 metres from the train. The selection of braking distances refers to a cautious driver.

- The braking effects for the two sides of the locomotive were not identical. The driver used the same cab (No.2 cab) at the very first and the last movement. Initial speed and average deceleration values for the above movements are: 18 kph and 0,294 m/s² for 1st, 26 kph and 0,1389 m/s² (to 15 kph) for the 5th.

- The engine-driver also applied fast brake prior to the collision. The deceleration, however, was only 47% of the deceleration rate calculated for the first normal braking.
