MINISTRY FOR  
INNOVATION AND TECHNOLOGY  
TRANSPORTATION SAFETY BUREAU

## **FINAL REPORT**

**2018-0679-5**

**Railway incident / Runaway of a vehicle**

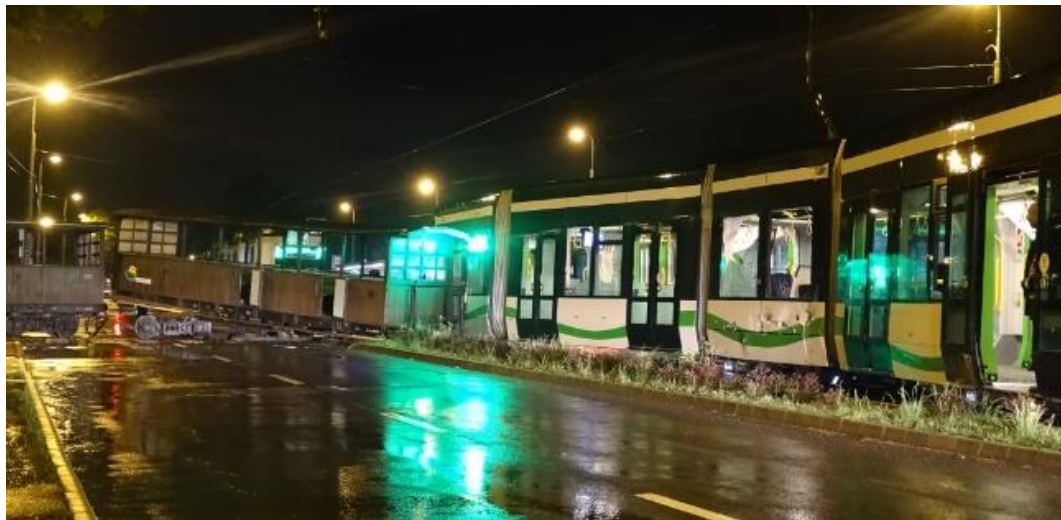
**Figure 3: View of the wrecks at the scene of the collision**

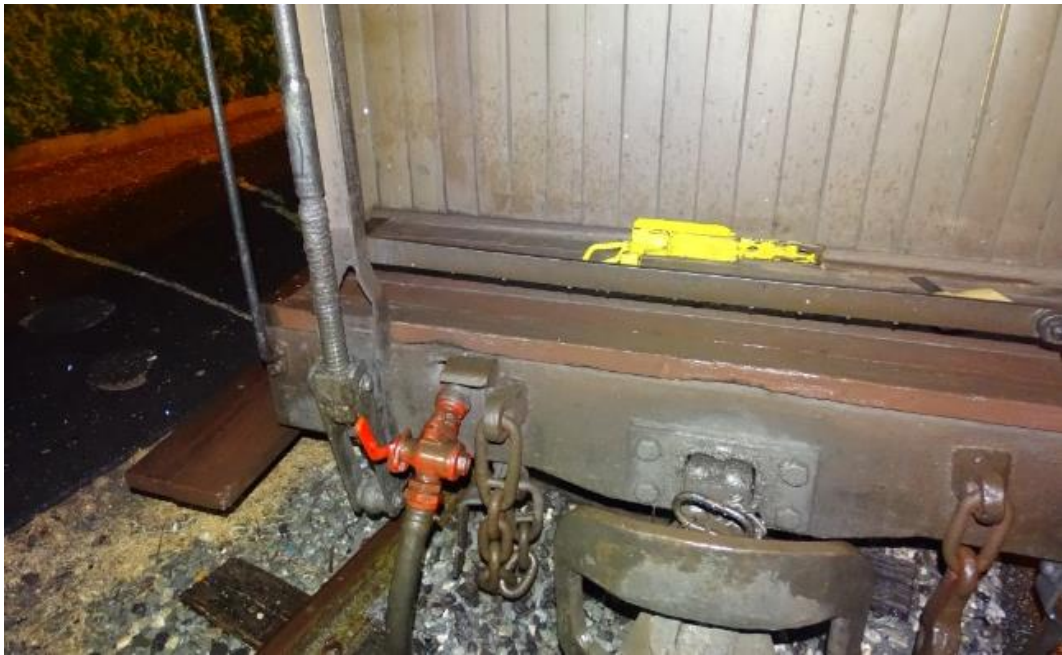
The runaway run started at Majláth station and finished after the buffer stop, at the station in Dorottya street where the railway wagons crossed the road and collided with the tram running there and caused it to derail (Figure 3). During the investigation of the scene after the occurrence, it was found that the brake nuts on the brake spindles of the parking brakes of both passenger wagons were in the lower position, and a rail skid was also found on the brake platform of the wagon with reg. 305 (Figure 4).

**Figure 4: The brake spindle and a rail skid on the passenger wagon with reg. № 305**

That is, the device is available: the IC even found the rail skids distributed for the runaway wagons (Figure 4). Therefore the absence of the device is not a cause of the omission of securing of the wagons against runaway, and the crew did not refer to it either.

(However, it should be noted that the rules specify double rail skid (or dunnage) (1.10.1), but only a single rail skid was available on each wagon. But, as a single rail skid would also have been sufficient to keep the wagons still, this fact cannot be related to the occurrence.)

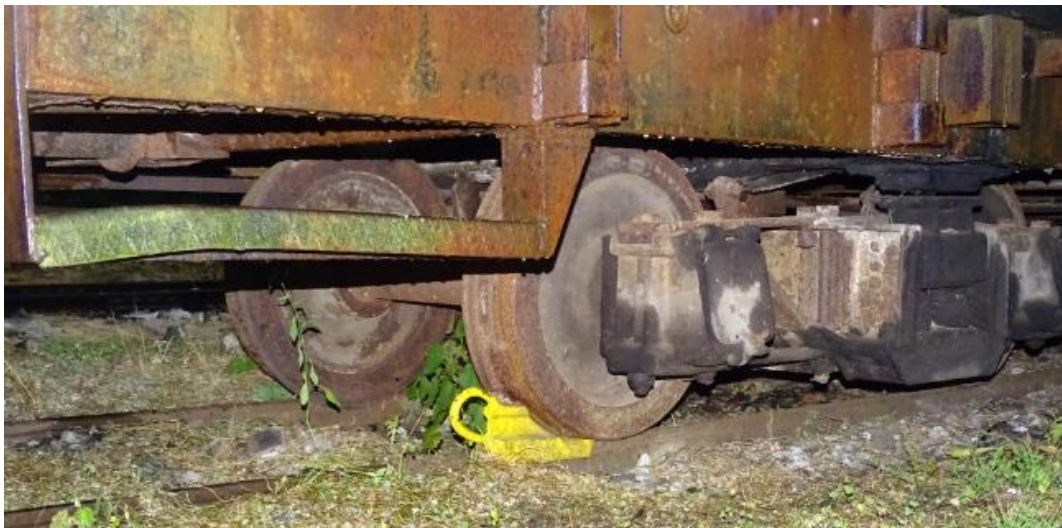
Upstream of some half-ruined freight wagons stopped long ago and secured with rail skids (Figure 5), there were 3 passenger wagons in two groups without being secured either with rail skids or dunnage (Figure 6) on Track III at Majláth Station. On Track I, upstream of some freight wagons pushed against the buffer stop (in the direction of an upward slope), stood a group of wagons, again without being secured either with rail skids or dunnage

**Figure 5: Half-ruined freight wagons stopped long ago and secured with rail skids on Track III at Majláth Station**

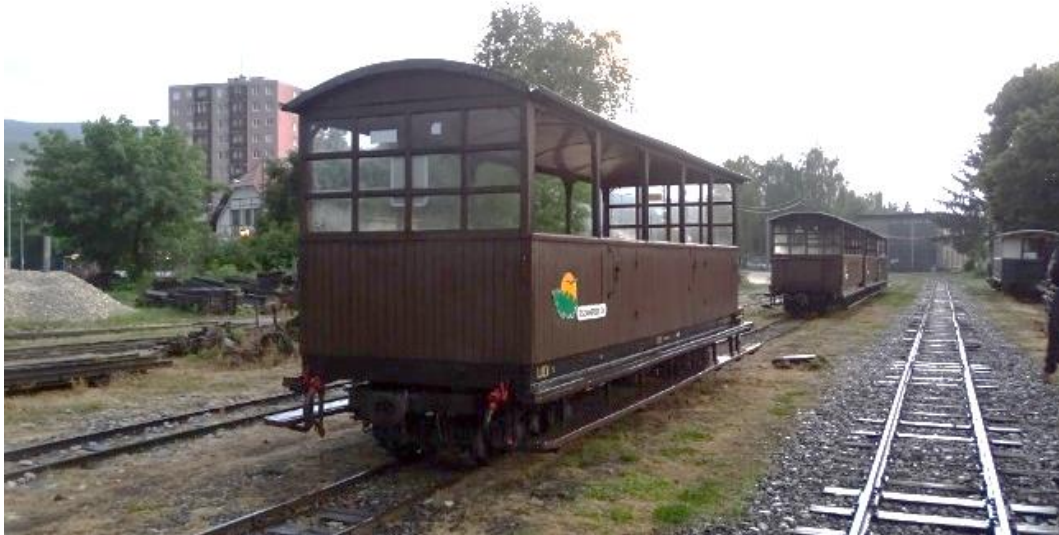
**Figure 6: Wagons stopped without any rail skids applied on Track III at Majláth Station**

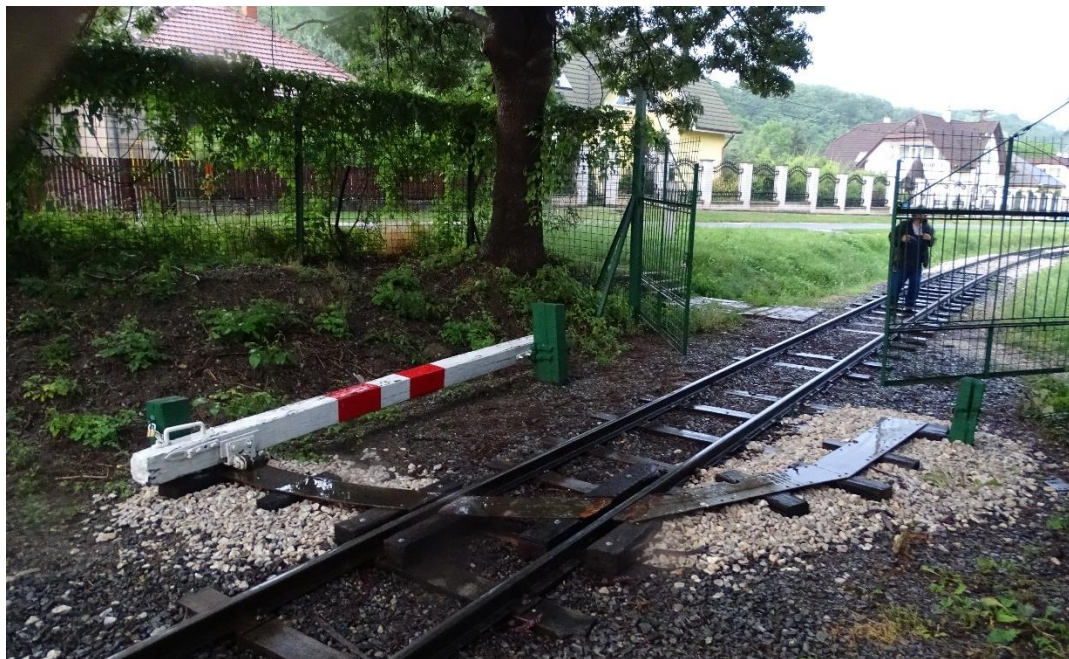
At the up-side end of Majláth Station, just inside the fence of the depot, is the red-white track barrier number VS1<sup>1</sup>, in the section number 18+65.

**Figure 10: The red-white track barrier and the gate forced open by the runaway wagons, in the morning after the occurrence (the position of the gate leaves in the photo do not reflect the direction of roll of the wagons)**

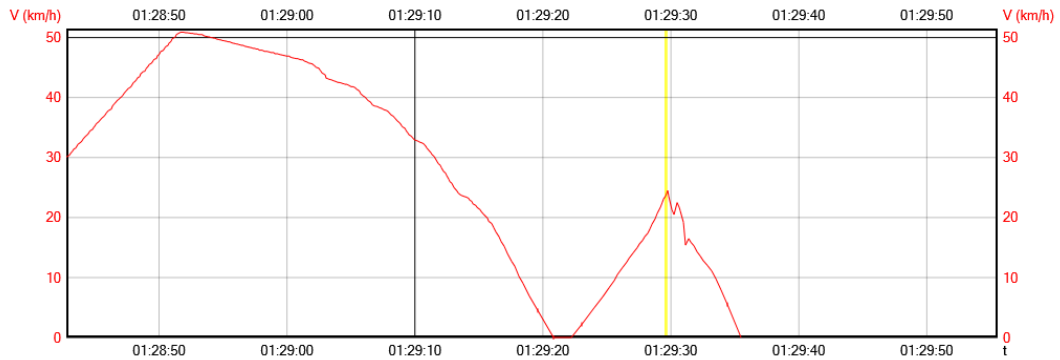
Figure 11: Speed data of the tram

The speed data readouts from the data recorder of the tram are shown in Figure 11.

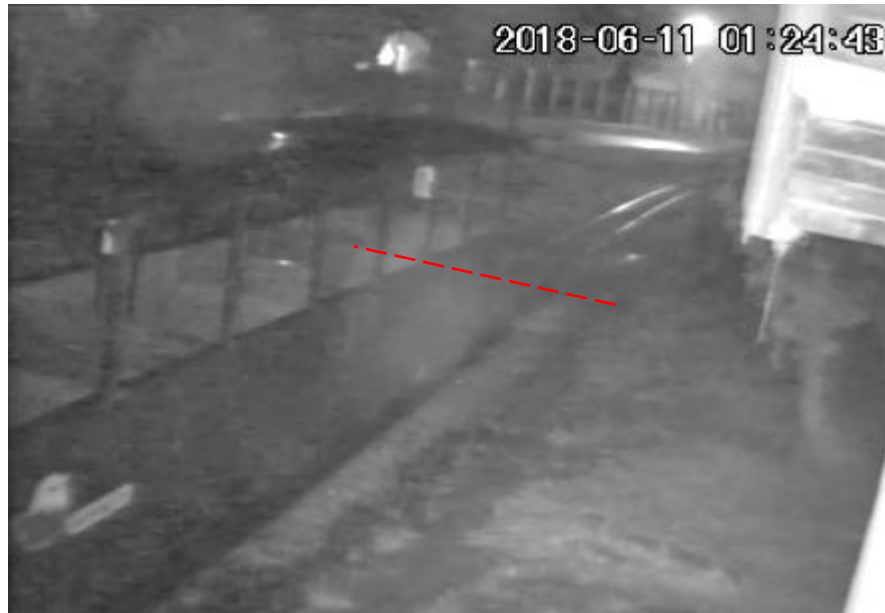
- On 10 June 2018 (the day before the date of the runaway), at 6:30 pm, the gate was closed, and the red-white track barrier was left open.
- On 11 June 2018, at 01:24:40 to 43 (96 frames), the first wagon passes along (Figure 14),
- the latter record shows a weak breeze.

**Figure 14: the runaway wagons in front of the gate, and the desirable position of the red-white track barrier (the open red-white track barrier is covered by the wagon)**

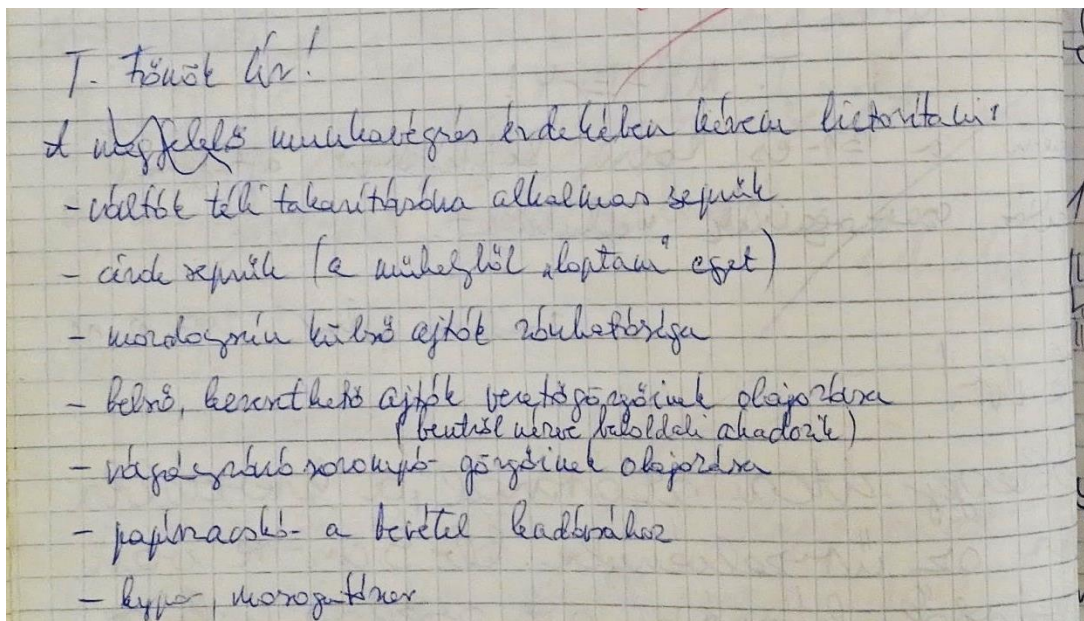
The rough book for recording defects at the Railway Operations contains the comments and repair requests from employees from all specific areas. It includes, for instance, an entry in which an employee requests lubrication of the rollers of the red-white track barrier (Figure 15).

**Figure 15: An entry in the rough book for recording defects**

The cause mentioned by the crew for not closing the red-white track barrier was that it was difficult to operate it (as suggested by an entry in the rough-book for recording defects), while the management mentioned that this problem had been eliminated by the reconstruction of the device (1.12).

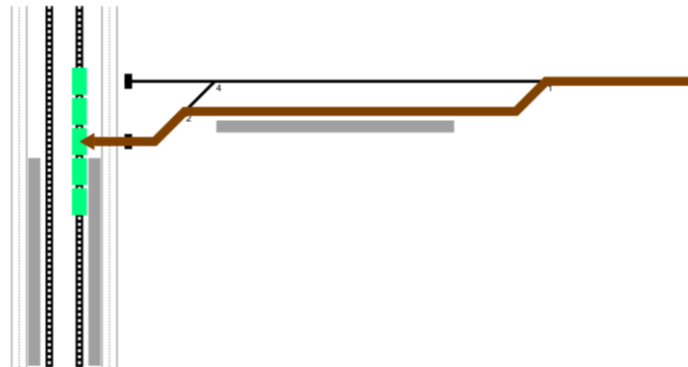
The wagons rolled through Dorottya str. Station on Track I, as guided by the switches, and then broke through the buffer stop at the end of the truck at a speed exceeding 40 km/h (based on a simulation (1.17) the IC finds even a speed exceeding 50 km/h possible) (Figure 17).

**Figure 17: Miskolc, Dorottya str. Station, Miskolc with the track route of the runaway wagons and the tram**
