MINISTRY FOR
INNOVATION AND TECHNOLOGY
TRANSPORTATION SAFETY BUREAU

FINAL REPORT

2020-0789-5
(HU-6321)

Railway Accident / Fire in Rolling Stock
Biatorbágy, 14 August 2020

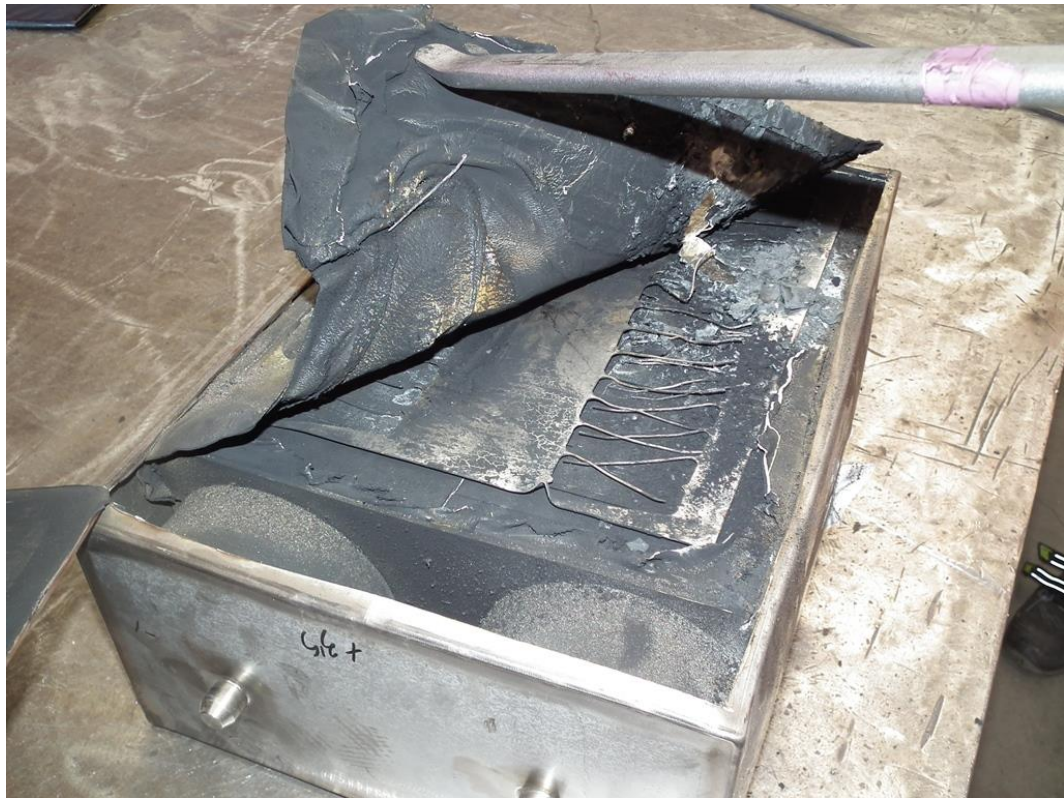
The construction of these capacitors is such that if – due to the deterioration of the dielectric strength – a minor puncture occurs between its armatures, the capacitor will be capable of self-healing, which maintains serviceability of the capacitor despite the defect, but its capacity will decrease. However, if such self-healing process takes place too often, it will lead to harmful overheating.

The capacitor test showed a lot of traces of this self-healing process (Annex 1. Annex 3), which, according to the person who tested it, but in a much higher number than normal in a capacitor of this type.

The dielectric of the capacitor is a polypropylene film that decomposes into combustible gases in the case of overheating (Annex 1). After the capacitor was opened it was clearly visible that overheating had occurred, i.e. combustible gases had also been present.

Figure 2: The inside of the capacitor

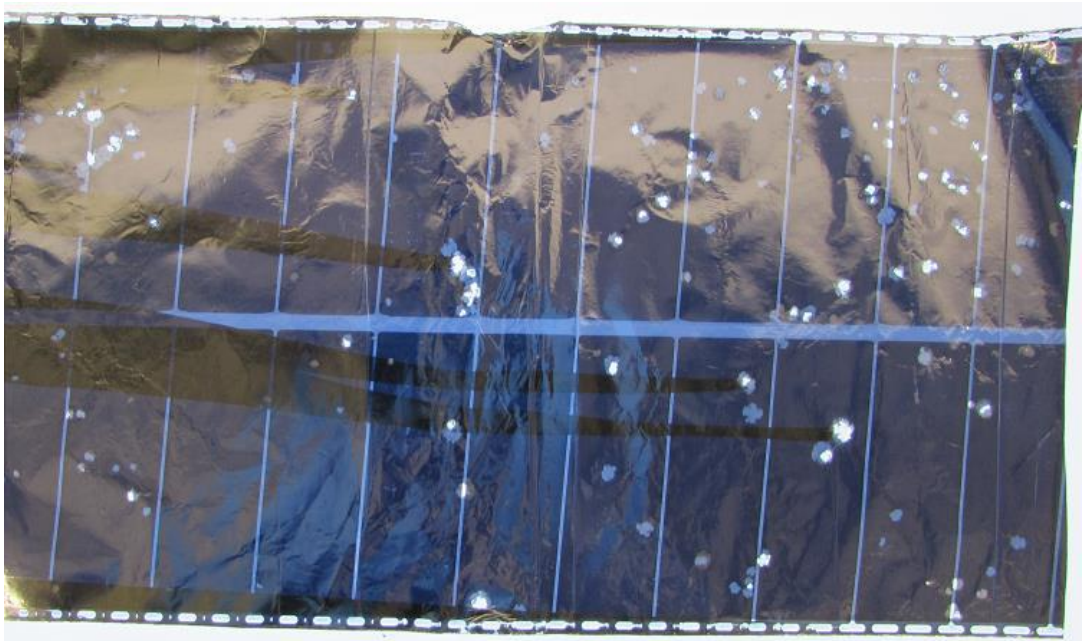
The film from the C2 windings shows a lot of self-healing marks in both the flat and the round areas. Such self-healing marks were present in both rows, but there were much more of them in one row than in the other; almost all safety elements of the segmentation were fused at the side which showed the worse damage.

Figure 4: Capacitor film with marks of self-healing

Experience shows that perforation occurs only to very low extent in metallised film capacitors under normal operating conditions even in 15 to 20 years and therefore no satisfactory answer has been given to the issue of the increased occurrence of perforation in this case. It is observed that the perforations occur to a greater extent at the end of the lifetime, but the capacitors tested are not even close to the end of their lifetimes according to the datasheet. Their failure could have been caused by some other problem(s). It is assumed that the reason(s) may be as follows:

In view of the fact that the same degree of perforation and a similar decrease in capacity was observed in capacitors produced by the producer during the same period but with a film layer other than the film layer used for the capacitors concerned, the fault probably lies in the manufacturing technology used at that time.
