MINISTRY OF
NATIONAL DEVELOPMENT
TRANSPORTATION SAFETY BUREAU OF HUNGARY

Subject: Issue of Safety Recommendation BA2017-371-4-1A

MND TSB is performing an investigation regarding the accident of a type Bellanca 8GCBC aircraft, registration mark HA-KYL at Dunaújváros Airfield (LHDV) on 04 August 2017.

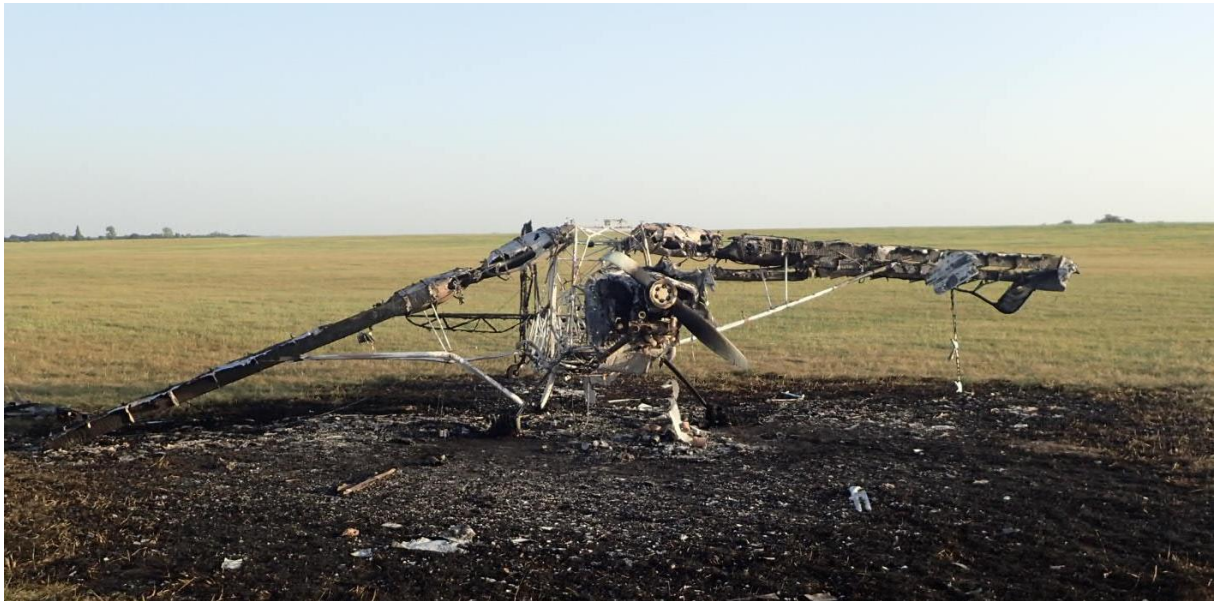
After engine shutdown, the aircraft stood still for about 10 minutes. During engine restart, fire started in the engine compartment and spread over to the fuel system of the aircraft as well. The aircraft was destroyed as a consequence of the fire.

Appendix 1: HA-KYL airplane wreckage after the fire

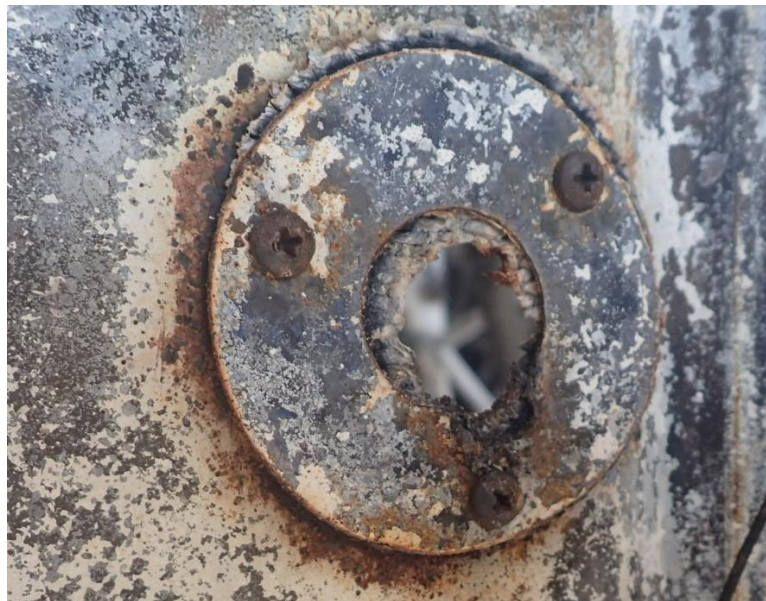
BA2017-371-4-1A In the course of its investigation, the Investigating Committee of Transportation Safety Bureau found that the fire probably started at the passage of the high-power cable through the firewall. Proofs of this are the signs of electric discharge at the passage, and melting of the electric cable in the line of the firewall.

Appendix 2: Sign of electric discharge at the passage

Ministry of National Development Transportation Safety Bureau of Hungary recommends Federal Aviation Administration to consider the possibility to issue an Airworthiness Directive in accordance with Service Letter 418 Rev. A made by American Champion Aircraft Corporation.

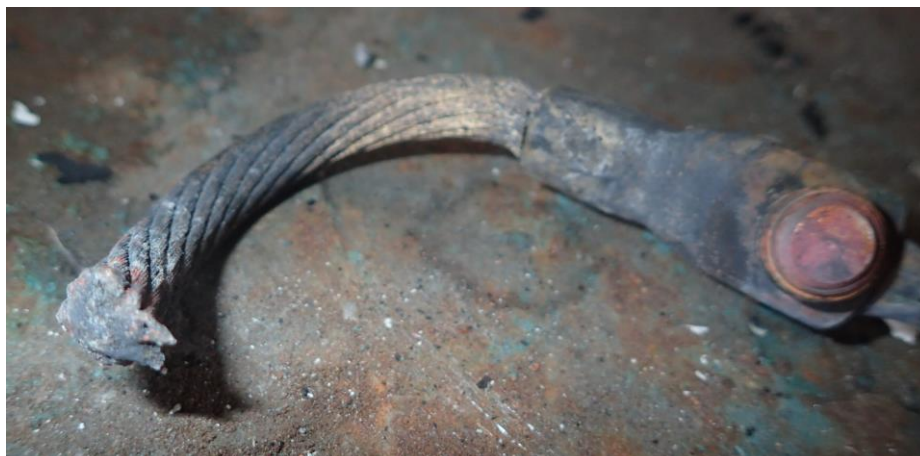
According to information received from the manufacturer during the investigation, there have been 8 aviation incidents before in which an airplane fire was caused by short circuit between aged cables and the firewall.

Appendix 3: Melted surface of the electrical cable

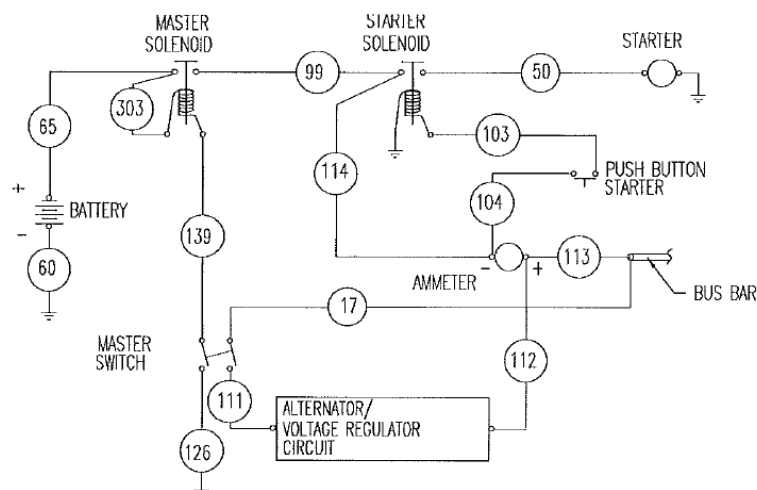
Concept: The primary electrical system on most rear mounted battery models looks similar to the schematic in figure 1. The diagram has been simplified to show only the affected areas. Upon inspection, it can be seen that there is no circuit protection for the voltage regulator circuit before the voltage regulator. This wire is in a bundle with other critical wires and is a source of concern. Also, the circuit from the battery to the bus bar is not protected. This was due to the 'sharing' of a line to the starter. To accommodate circuit protection for these two circuits, the electrical system must be modified to look similar to figure 2.

Figure 1 Schematic of Primary Electrical System (Aft Mounted Battery) Before Modification

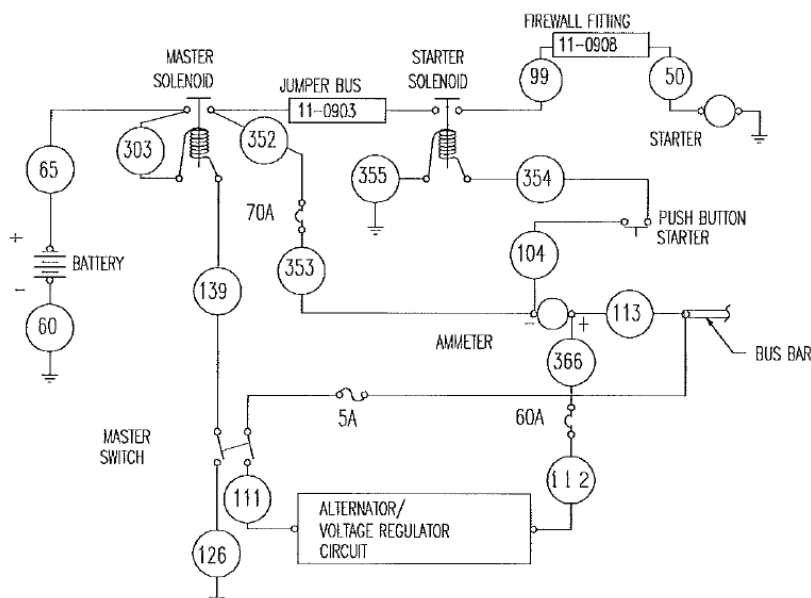
Figure 2 Schematic of Primary Electrical System (Aft Mounted Battery) After Modification

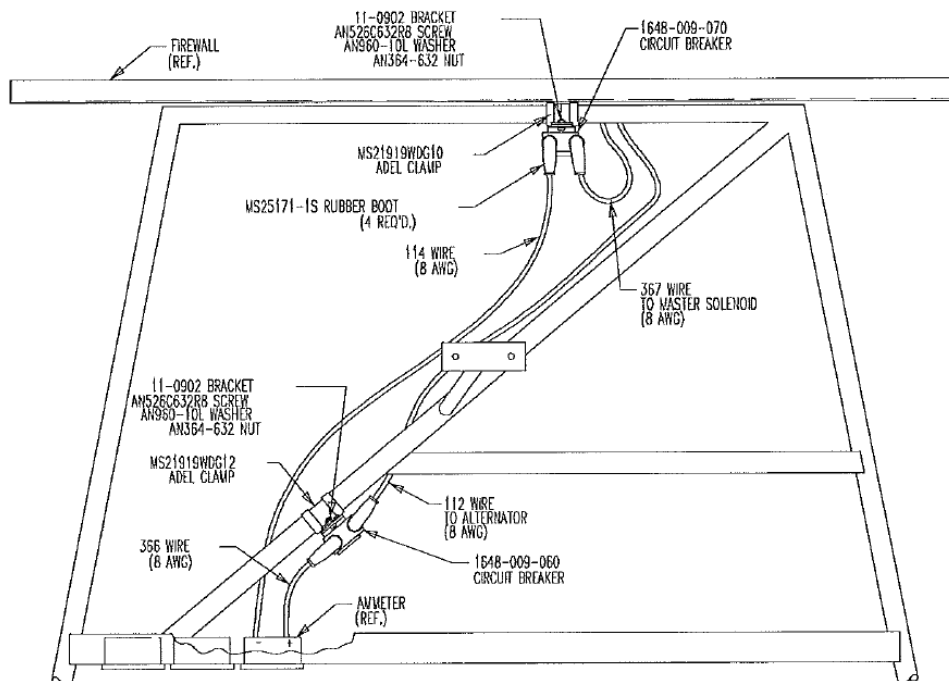
Figure 3 Typical installation for a Firewall Mounted Battery

A properly installed firewall mounted battery requires the installation of circuit protection from the battery and the alternator. Mount the 70-amp battery circuit breaker inside the firewall using an Adel clamp and 11-0902 bracket. On the output side of the master solenoid, disconnect wire #114 and, mount wire #367 to the input (line) side of 70-amp circuit breaker. The wire #114 should then be attached to the output (load) side of the circuit breaker. Figure 3 depicts a typical installation.

Attach the 60-amp alternator circuit breaker to the diagonal fuselage tube with an Adel clamp and 11-0902 bracket. Disconnect the #112 wire from the ammeter and replace it with wire #366 attached to the input (line) side of the 60-amp circuit breaker. Attach alternator wire #112 to the output (load) side of the 60-amp circuit breaker. Figure 3 depicts a typical installation.

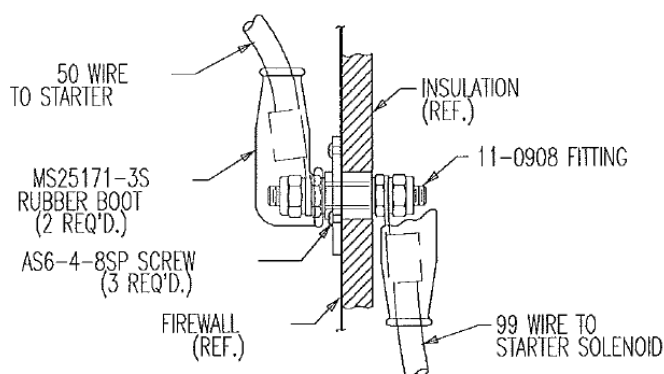
Figure 4 Assembly of Firewall Fitting

Remove the firewall fitting for wire #99 and push inside the airplane. Install fitting 11-0908 in the firewall in place of the former fitting. Mount wire #50 to the engine side of the fitting and wire #99 to the insulation side of the fitting. Use a rubber boot over each connection. The Assembly is depicted in figure 4. The starter solenoid should then be mounted to the battery board in close proximity to the master solenoid as depicted in Figure 5. This may require that the master solenoid be shifted as well. The wire #99 should be removed from the master solenoid and mounted to the starter solenoid. The 11-0903 jumper bus should then connect the two solenoids. The starter solenoid needs to be grounded if it is mounted on a wood battery board. Use wire #355 to connect to an appropriate ground. Route wire #354 up to the starter button in place of the former wire #103. Figure 5 depicts a typical installation.

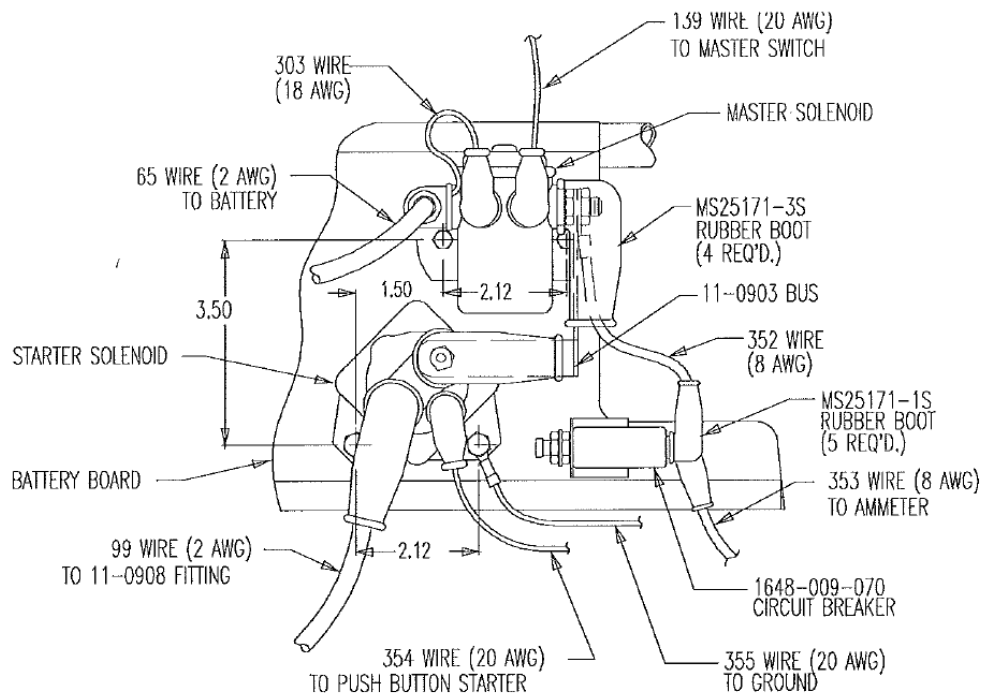
Figure 5 Typical Battery Board Installation

Power to the bus bar from the battery must be restored by replacing wire #114. On the output side of the master solenoid, mount the short wire #352 to a 70-amp circuit breaker. Mount the breaker to the battery board using an appropriate bracket. This is also depicted in figure 5. Route the longer wire #353 to the ammeter in place of wire #114. The #353 and #354 wires should be bundled with wire # 99 to keep them away from fuel lines and control systems.

Disconnect wire #112 from the ammeter and replace it with wire #366 attached to the input (line) side of the 60-amp circuit breaker. Attach alternator wire #112 to the output (load) side of the 60-amp circuit breaker. Figures 5 and 6 depict a typical installation.

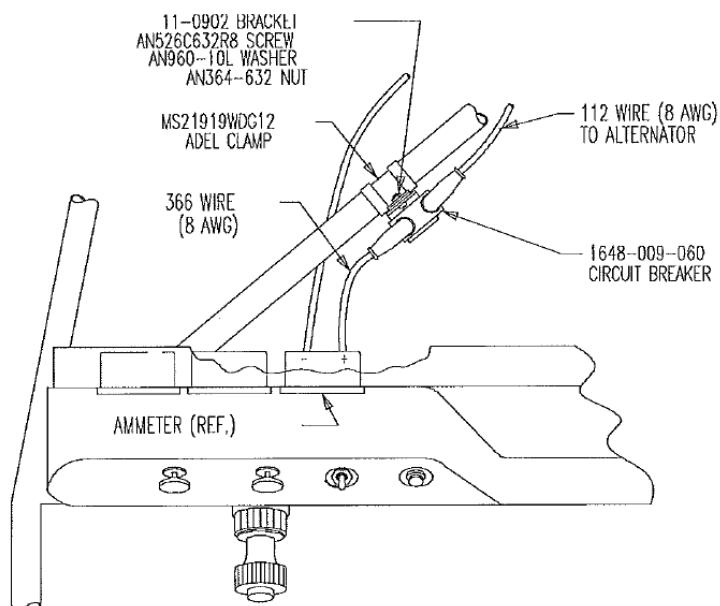
Figure 6 Under Dash Installation for Aft Mounted Battery
