KÖZLEKEDÉSBIZTONSÁGI  
SZERVEZET

TRANSPORTATION SAFETY  
BUREAU

# **ANNUAL REPORT 2008**

## **Transportation Safety Bureau**

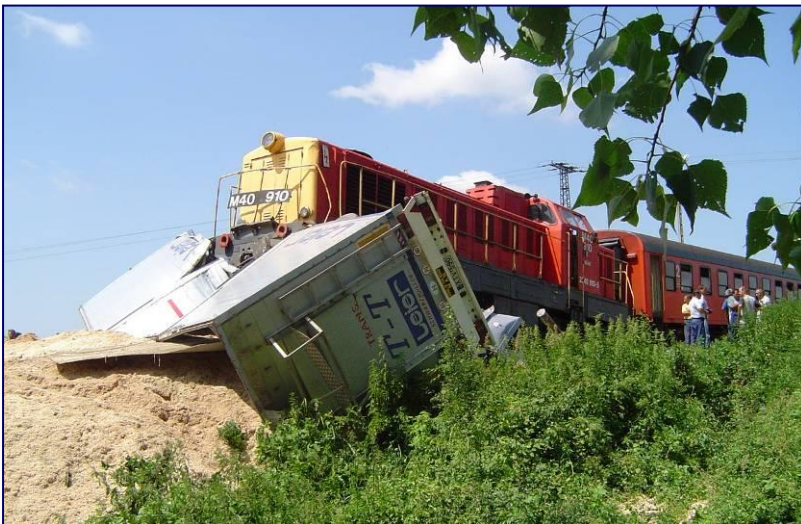
### 2006-020

A heavy lorry drove onto LC no. SR1 at Vásárosnamény station regardless of the red lights and collided with a passenger train. No one was injured. There were material damage and traffic was hindered.

The IC established the indirect cause in the course of the site survey as follows: the road and the railway track run parallel for an 80-metre-length and then the road intersects the railway with a small bend towards the level crossing. Prior to the accident, the car and the train had been running in the same direction, thus the driver of the car had not seen the running train, however while approaching and turning onto the LC, he should have seen the warning lights of the LC.

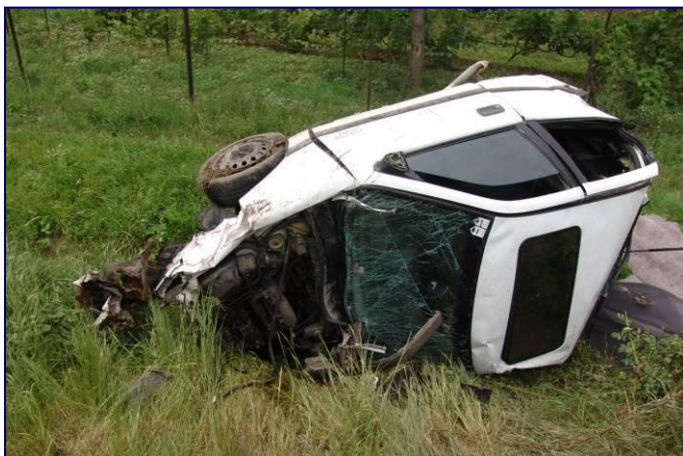
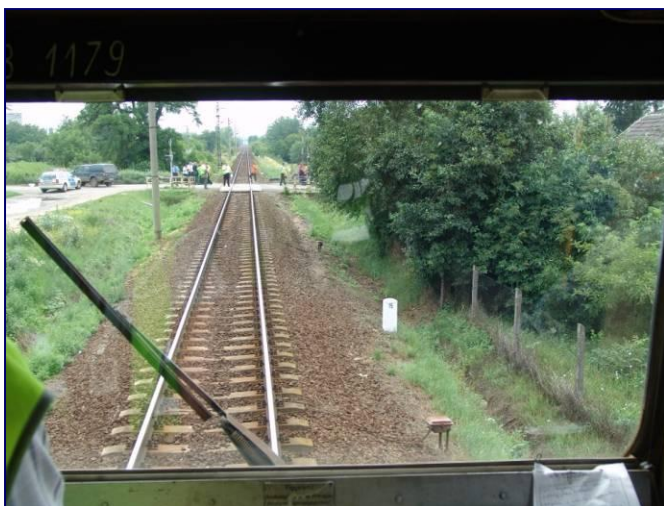
**2006-023**

An Opel Vectra type car collided into the side of an electric locomotive of a passenger train running from Budapest-Déli pu. to Balatonfüred. The collision occurred between Érd-elágazás and Tárnok stations at level crossing no. AS15 protected with warning lights and half-barrier. The warning lights were dark towards the road - as a consequence of an error. Four people were travelling in the car, three of whom suffered minor and one person serious injuries as a result of the collision.

- On the right side of the track towards Érd-elágazás, the overhanging vegetation hindered visibility, thus the so called “narrowed visibility triangle” ( $L_v=600$  m) was not assured.
- The train was approaching LC AS15 with 88 km/h speed regardless the previously received order though the locomotive radio.
- When LC no. AS15 became dark (inoperative), no immediate measures were taken to inform the train at the station nearest to the LC about it.
- The car did not comply with the traffic regulations when driving onto the LC.

The IC established in the course of the investigation that the regulations regarding the assurance of the so called ‘visibility triangle’ are adequate. Nevertheless, the overhanging vegetation hindered visibility at the time of the accident, therefore the accident would not have been avoidable even if the driver of the car had complied with traffic regulations. Based on the site survey, only approximately 30 metres of the rail track is visible from the LC, and

the train runs this distance within 1 second, therefore there would be no chance for safe crossing.

**BA 23.1:** The IC recommends Máv Zrt. to take internal measures by which the following regulation can be enforced: “good visibility shall be ensured in a suitable ‘visibility triangle’ according to the characteristics of the LCs and their way of protection” (Regulation no. D.5, point 3.9.8 on the “Traffic safety inspection of level crossings and pedestrian crossings”).

**BA 23.2:** The IC recommends Máv Zrt. that Appendix 7 (1.169) of F.2. Traffic Regulations should be complemented with the following: “if warning lights on the open track are unserviceable and if error correction has been performed, it shall be entered in the Station Log in detail”.

**BA 23.3:** The IC recommends Máv Zrt. that 15. 233 of F.2. Traffic Regulations should be complemented with the following: “on railway lines on which there is block section traffic, movements inspectors shall apply signals to trains which have not been informed by a ‘written instruction’ on the failure of open track warning lights, which ensure that the trains are able to stop in front of the given level crossings”. This way it would be possible to reduce the speed of the train more directly and quickly, which would prevent accidents.

**BA 23.4:** The IC recommends that a technical solution should be worked out so that on rail tracks equipped with automatic block signals, when these block signals are switched to ‘Stop-position’, the locomotives would receive 75 Hz alternating-current coded signals from the track circuit (i.e. signal – long pause – signal). This would enforce the automatic and immediate stopping of trains by means of a technical solution. Furthermore, time-lags and chances of faults due to human factors could be reduced further. After stopping, the train would only be able to depart again when the situation has been clarified.

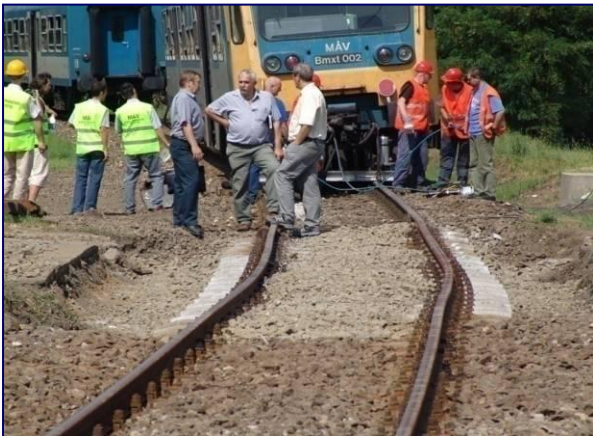
## **2006-027**

The control car of a passenger train which was at the rear of the train derailed with all four axles at a level crossing under construction between Rákospalota-Újpest and Fót stations (track section 12+32). The train was running with a speed of 20 km per hour. There was no injury. As a result of the accident, a 6-metre-long section of the track was damaged.

Construction and rebuilding works were in progress at the level crossing the day before the accident occurred. The level crossing is in track section No. 12+35, with asphalt road surface and easer-rails. As the work had not been finished the previous day, the crossing was temporarily opened for the traffic with a 20 km per hour speed limit.

During the construction work, the rails and the bedding were also removed and replaced in its entirety at the LC and on an approximately 22.5 metre length. According to the local chief inspector who lead the replacement work, the temperature of the rails at the opening of the track panel was +25°C and +20°C when fixing the clips at dawn respectively.

When examining the geo-screws of the connecting sections, the IC established that only those screws were loosened which were needed for the replacement of the track section, while the other screws were not. Therefore the so called 'breathing' of the track was not ensured. The neutral temperature of the track at the time of its construction was +20°C.

According to the interviews, some gaps were left between the connecting rail ends. Nevertheless, this was not sufficient to offer resistance to the significant temperature increase. There was no lateral support which could have resisted the pressure arising from the change of temperature in the rails. The stability of the track was not ensured. The sleeper ends were loose and free and there were not enough ballast chips between the rails. No measures were taken in order to prevent the deformation or shifting of the rails at the connecting points, therefore the rails were shifting from the untouched section towards the opened section. Due to the above reasons, the track shifted sideways and vertically. The extent of the shifting was as high as it lead to the derailment of the train. The final thrust to the shifting of the track panel was the centripetal force arising when the train was running in a bend.

**BA 27.1:** In order to maintain transport safety, the IC recommends MÁV Zrt. to take measures during construction work requiring dismantling of track panels without gaps - when weather conditions may affect the work - so that railway traffic shall not be started before ensuring the stability and sufficient transversal and longitudinal resistance of the reconstructed track section and before the bedding has temporarily or permanently been resettled.

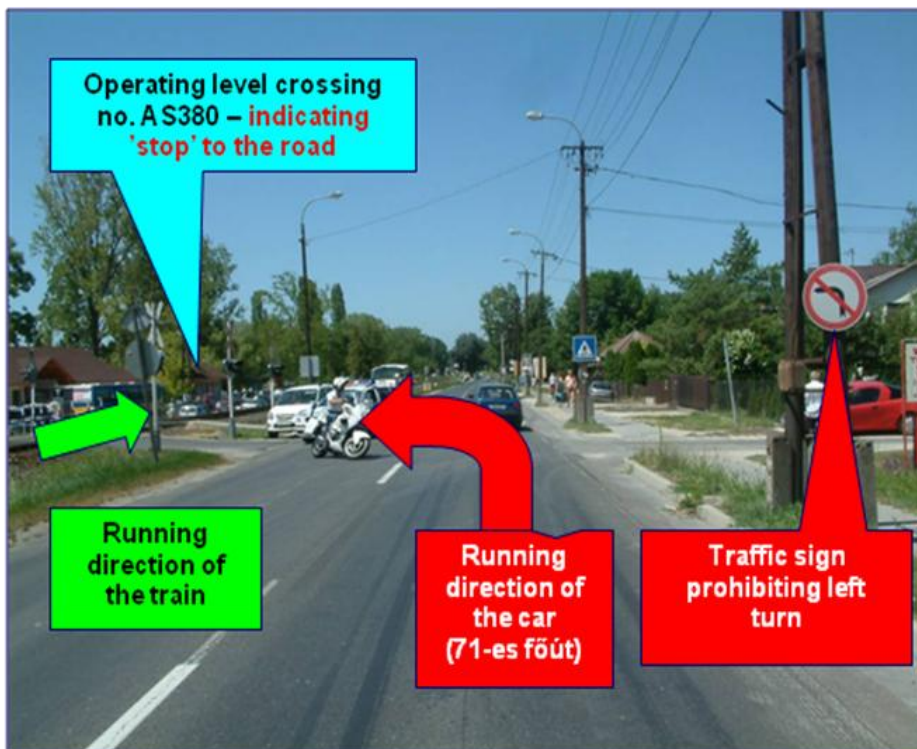
Three similar accidents occurred at LC no. AS380 in the space of almost a year. On all four occasions, the damaged cars were driving on main and turned left onto the LC regardless of the "No left turn" traffic sign. LC no. AS380 and its warning lights were operating normally in all cases.

The direct causes of the accidents were the non-compliance with road traffic regulations.

The investigation also established that there are two other considerably safer LCs in either direction, one 500 metres and the other 700 metres from the LC at which the accidents occurred. Both nearby LCs are not only protected with half barrier and warning lights but there are also turning lanes and acceleration lanes leading onto them.

**BA2006-0033-5-01:** The IC recommends the National Transport Authority that it should - together with the bodies concerned - re-examine the position of LC no. AS380. The NTA should also consider whether it is justified to maintain LC no. AS380 - taking into consideration that LC no. SR2 at Balatonkenese station approximately 500 metres away is secured with warning lights and half barrier, and LC no. AS373 approximately 700 metres away in the direction of Lake Balaton are much safer and there are turning lanes to both latter LCs - or whether the application of other technical instruments should be ordained.

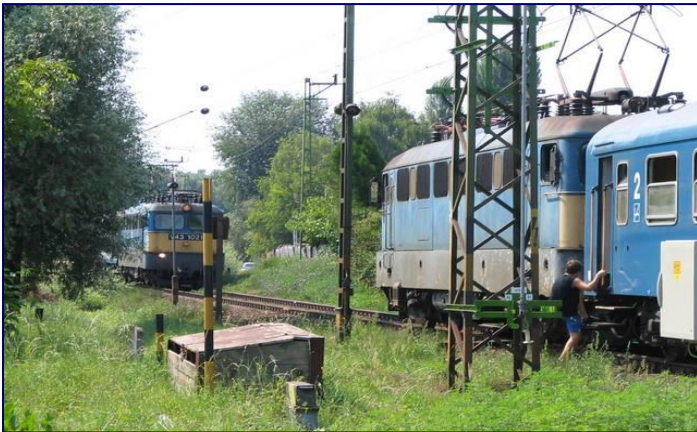
## **2006-040**

At Balatonmárfürdő station, the engine-driver of passenger train “A” started the train regardless of the “Stop” sign of the V2 exit signal after the indication of the chief ticket inspector. The Unified Train Control and Vigilance Warning Installation on the locomotive stopped the train with emergency braking. The train split point no. 3 open which had been set to deviating direction to give way to another train (“B”) approaching the station from the opposite direction. Train “A” then stopped at point no. 1. Having noticed train “A”, the engine-driver of train “B” entering into the station immediately applied the emergency brake and stopped approximately 50 metres from train “A” (standing opposite). No one was injured.

Train “A” was running behind schedule, therefore the other trains did not ‘meet’ according to schedule. According to technological regulations for Balatonmárfürdő station, passenger train “A” should arrive at the first track in bypassing direction. In the meantime, passenger train “B” arrived from Balatonszentgyörgy direction at the “Stop” entry signal of Balatonmárfürdő station and stopped according to regulations. Having returned from the engine bay to the driver’s cab, the engine-driver of train “A” noticed from the side view mirror that the platform was unoccupied (the passengers had got on/off) and the chief ticket inspector was signalling out the train, so he brought he train into motion. At the same time, a “Line Clear” (yellow-green) signal appeared on the entry signal for train “B”, and therefore the engine-driver started the train.

- The following facts could have contributed to the decreasing of the driver’s attention and made him prone to make mistakes: the engine driver was on his 6<sup>th</sup> shift within 8 days, he had always begun his work at night; and in the summer heat, the temperature in the driver’s cab was 38-40 °C with no air-conditioning.

**BA2006-0040-5-01:** The IC recommends MÁV Zrt. that the locomotive radio system should be made suitable for safe and reliable communication.

**BA2006-0040-5-02:** The IC recommends the National Transport Authority to check whether all members of traffic operation staff on railway line no. 30 have taken the examination on the current Executive Regulations on the line.

**BA2006-0040-5-03:** The IC recommends the NTA to authorize the personnel - who are not authorized at present to signal out trains - working at stations controlled by the Central Traffic Operation Control Office (KÖFI) to signal out trains (similar to the movements inspectors at bigger stations who are authorized to do so) as they have more possibility to ensure the safe departure of trains than those who work in the Central Traffic Operation Control Office.

**BA2006-0040-5-04:** The IC recommends MÁV Zrt. that during the modernisation of locomotives, they should work out a solution so that engine-drivers would be least affected by the outside temperature during their work.

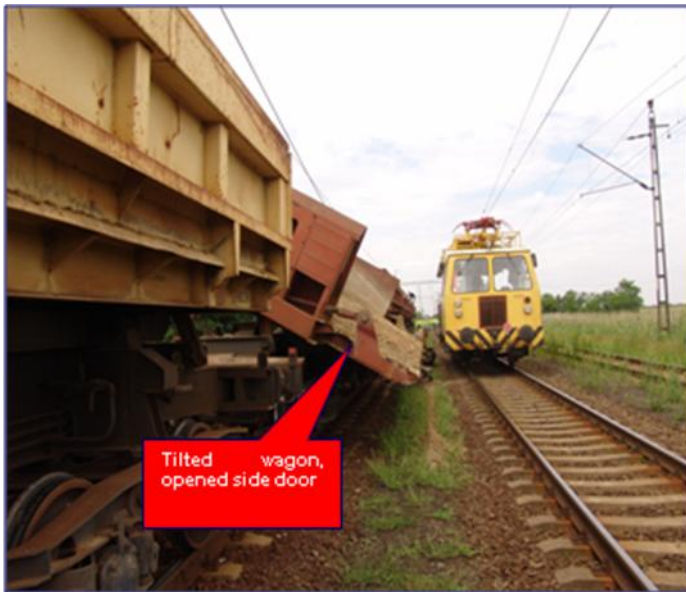
## **2006-044**

A freight train was running from Tiszatenyő to Pusztapó and its 16<sup>th</sup> wagon (self-discharging wagon carrying ballast chips) tilted to its side, its side door opened and damaged some installations and masts beside the track at Pusztapó station. The engine driver noticed the event from the rear-view mirror and stopped the train immediately by applying emergency brake.

The freight train was going to a place where a railway construction company was performing track reconstruction work during which the single-track main line was rebuilt into a double-track main line. Having left Tiszatenyő station, the train stopped on the open track for about 10 minutes and then it was approaching Pusztapó station. When the train arrived at Pusztapó station, the side door of the 16<sup>th</sup> wagon had already been open.

Based on the available information, the IC established that the most probable cause of the accident was the technical failure of the Ua type self-discharging wagon and the uncertain/insufficient operation of the levers. As there was no information on where exactly the side door opened, the IC had no possibility to examine other circumstances and contributing factors.

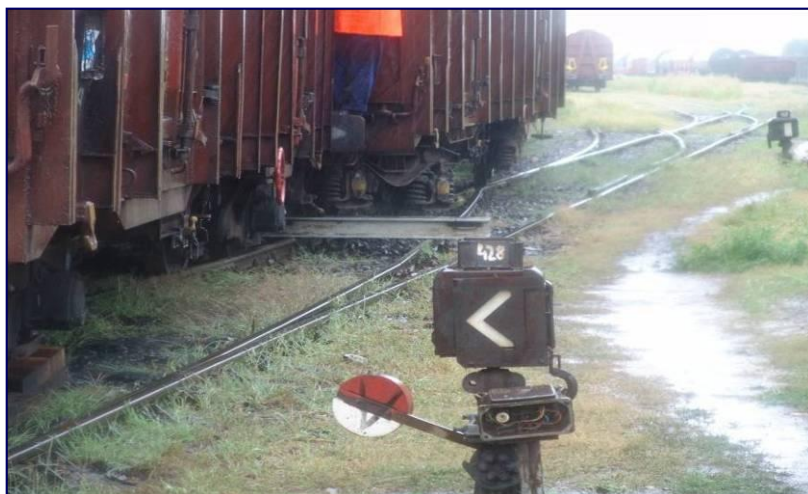
**2006-048**

A freight train of BRKS a. s. Slovakian railway undertaking was signalled out from platform no. XVI at Komárom marshalling yard in the direction of Komarno. The first freight car derailed with 4 shafts and the second freight car with 2 shafts at the common crossing of switch no. 428.

No one was injured in the course of the accident. The rail track was slightly damaged. Neither the locomotive nor the surface elements of the safety installation suffered damage.

The investigation established that the accident was caused by a scotch block left under the first pair of wheels of the first freight car. (While checking the train at the station, no one noticed or removed the scotch block from under the train.)

In the course of the investigation, the IC found - independent of the accident - that point 26 of Station Regulations is not in accordance with 5.1 and 5.2 of F.2. Traffic Regulations. Station Regulations of Komárom prescribes the use of a certain type of scotch block to secure the trains from braking away. On the contrary, F.2. Traffic Regulations permits the use of a different type (and shape) of scotch block.

**BA2006-048-5\_01:** The IC recommends the introduction of an instrument or sign which makes the scotch block clearly visible from longer distance as well.

**BA2006-0048-5-02:** The IC recommends that point 26 of Station Regulations of Komárom should be revised.

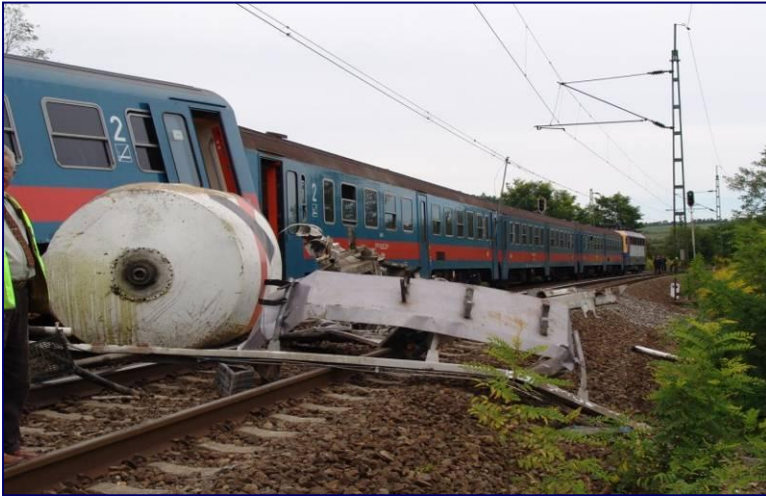
## **2006-069**

The control car of a passenger train collided with a concrete mixer lorry between Pécel and Isaszeg stations. The concrete mixer fell onto the rail track as a consequence of a road accident at Nagytartcsa junction.

- the driver of the lorry, the chief ticket inspector and a passenger suffered serious and another passenger minor injuries,
- the control car of the train derailed and sustained substantial damage,
- one overhead line mast broke and fell, and the shunting overhead line also broke,
- the left track sustained substantial damage on an approximately 30-metre-distance,
- the lorry was written off,
- the liquid concrete flowing onto the track and the wreckage of the vehicles blocked both rail tracks.

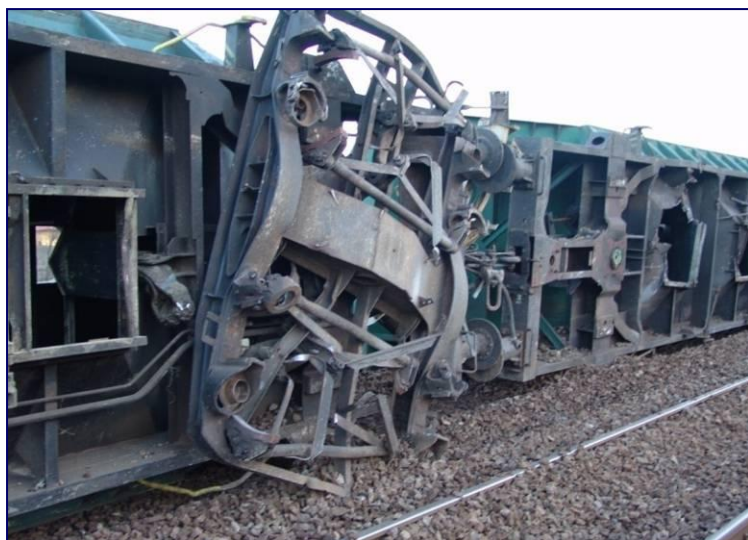
**2006-151**

24<sup>th</sup> wagon of a Romanian freight train derailed between Debrecen and Ebes stations on the open track. The train was running with the wheels of its 24<sup>th</sup> wagon running beside the rails on the concrete sleeper on an approximately 7-kilometre-distance until Ebes station. When running through the left (transit) main track of Ebes station, the derailed axle of the arriving train tore the trackage of point no. 3 which lay in the train's path. Subsequently, it broke the BODÁN plate of level crossing SR 1 in. As a consequence, the train separated between the 23<sup>rd</sup> and the 24<sup>th</sup> wagons, four more wagons derailed and two toppled onto their side. When the train separated, it stopped with emergency braking.

These types of wagons are suitable for transporting cereals, grains, crops or alum earth. The wagons are usually filled from silos through an opening ('mouth') on the top of the wagon and are emptied - by way of gravitation - through the hopper openings on the bottom of the wagons.

Some of the above mentioned iron plates were missing from the examined hopper covers. A

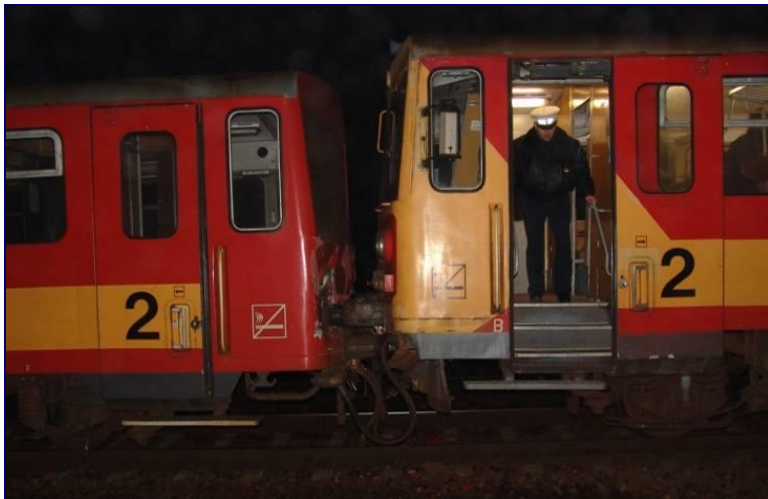
**2006-161**

Passenger train A - running from Szolnok to Jászapáti - collided into the rear of another passenger train (B) - running from Szolnok to Budapest Keleti pu - being stopped at entry signal "N" (indicating "Stop") at Szolnok junction, on the left track between Szolnok and Újszász stations.

The first train was about to depart at the moment of the collision as the "Line-clear" signal had appeared on the signal. The engine-driver had already released the brakes for departure. As a result of the collision, the train rolled 46 metres forward, and since the pressurised air system got damaged, the brakes were activated automatically.

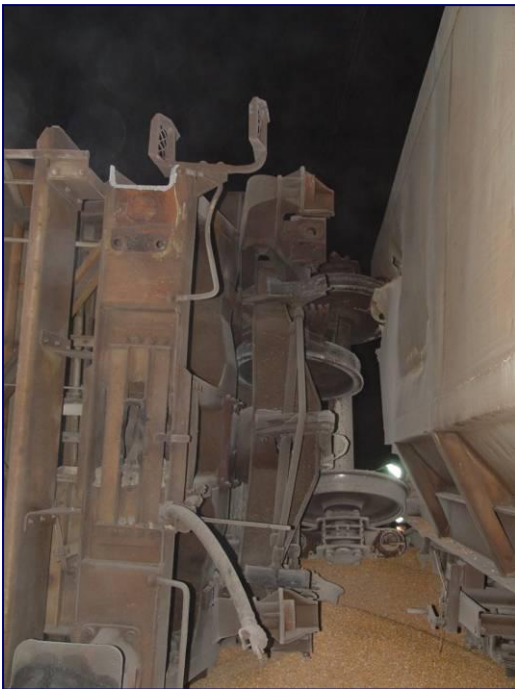
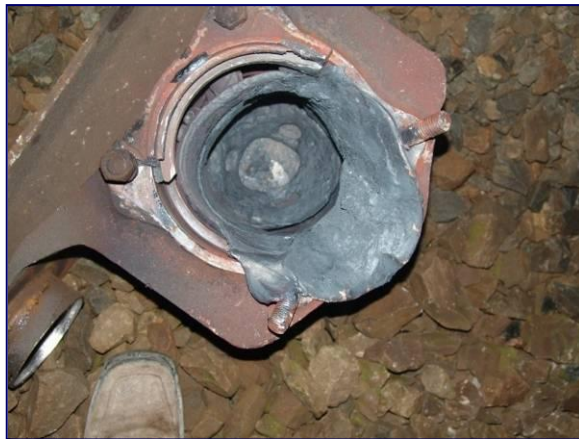
## **2006-175**

The 5th wagon of a freight train derailed, fell onto its left side, blocking both tracks between Lébény-Mosonszentmiklós and Kimle stations. Most of the sweet corn which the wagon carried flowed out of the wagon. As a consequence of the derailment, the concrete sleepers of the right track sustained damage on an approximately 1600 metre distance and had to be replaced. On a further 200 metre distance it was damaged to such an extent that the track had to be rebuilt.

The examination certificate of the freight wagon was valid at the time of the accident. Further data on the maintenance of the wagon was not available. The net weight of the wagon was 21 300 kg and the (admitted) weight of the cargo was 60 000 kg.

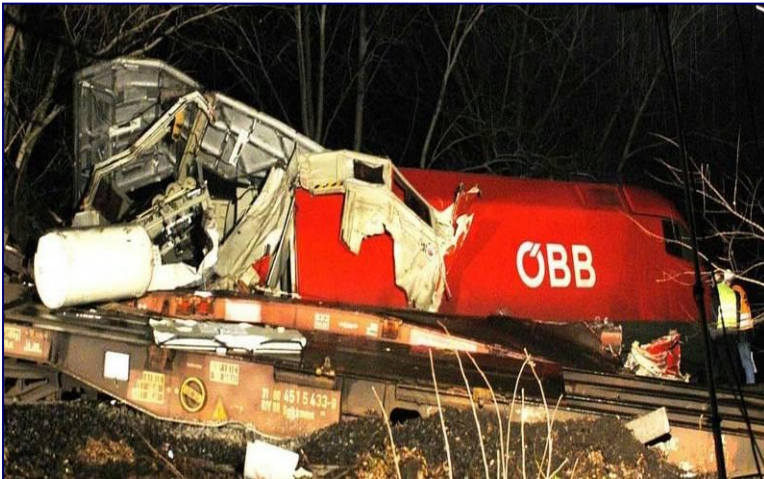
## **2007-047**

Between Almásfüzitő and Komárom stations at section no. 998+42, EUREGIO passenger train no. 9438 running from Tatabánya to Wien Südbahnhof (Vienna Southern Railway Station) with a speed of approximately 101 km/h collided with freight train no. 45224 which was running in front of the passenger train in the same direction with the speed of 9-10 km/h.

The engine driver of the passenger train died at the site of the accident, two passengers suffered serious injuries, another four passengers, the chief ticket inspector of the passenger train and the engine driver of the freight train suffered minor injuries.

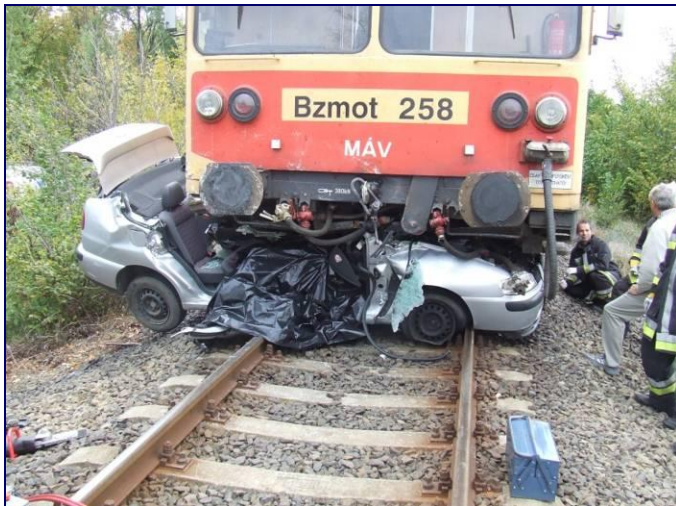
## **2007-371**

A passenger train collided with a car at a level crossing (with no barriers) between Mártély and Mindszent stations. As a consequence, the driver and one passenger of the car died at the site of the accident.

In the course of the site survey, the IC established that the so called “reduced visibility triangle” was assured. The speed limit for the road at the LC was 40 km/h. The car was driving on the road parallel with the rail track, in opposite direction with the train. Upon approaching the LC, the engine-driver gave out a “Warning!” signal. Having noticed that the car wouldn’t be able to stop before the LC, he applied emergency brake but could not avoid the collision.

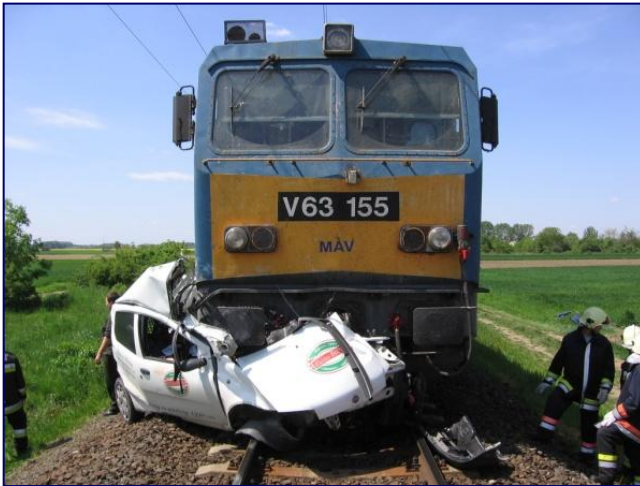
## **2008-201**

A train collided with a car at a level crossing protected with warning lights - operating normally - at Farád station. As a consequence of the accident, the driver of the car died at the site.

In the course of the investigation, the IC established that the so called reduced visibility triangle at the LC was not assured from one direction. It was also noted that there had been 2 fatal accidents and one with considerable material damage and minor injuries in the previous 18 months at this LC.
