TRANSPORTATION SAFETY
BUREAU

ANNUAL REPORT 2009

Transportation Safety Bureau

Hungary

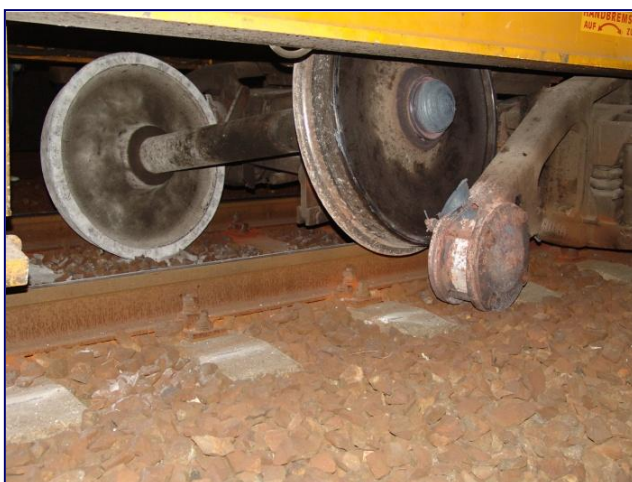
2006-103-5

On 28th October 2006 at 17 hours 20 minutes, the 5th wagon - a track maintenance vehicle - of a freight train derailed with 1 bogie at Pusztaszentiván stop, between Mende and Süllysáp stations.

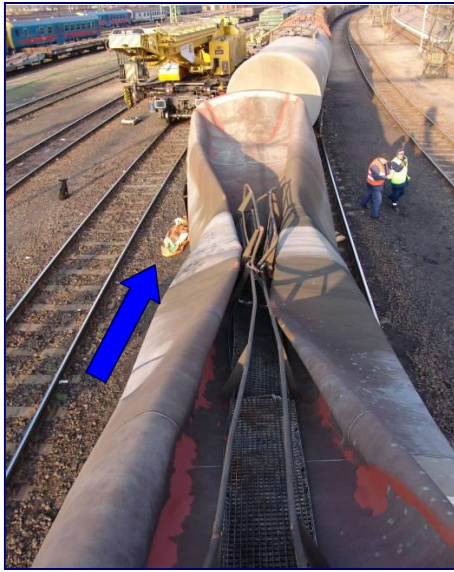
2007-034-5**Railway accident**

On 25 January 2007 a freight train was approaching Szolnok station, when the empty tank of a four-wheeled tank wagon imploded and the wagon derailed with all four wheels. The tank wagon running ahead of it also derailed with two wheels. The derailed wagons damaged the track.

BA2007-0034-5-01: The IC recommends Lesaffre Magyarország Kft to revise and amend the “Technology for loading and unloading molasses”. The current version does not contain requirements with regards to cooling down the tanks to ambient temperature and measures against vacuum-forming inside the tanks after unloading molasses. Furthermore, it does not contain regulations or procedures for measuring temperature inside the tanks and conditions for closing tank lids either.

BA2007-0034-5-02: The IC recommends the European Railway Agency to suggest railway undertakings and shipping companies which use similar technology for loading and unloading that they should revise and amend their procedures in order to ensure that the tanks are cooled down and to prevent vacuum-forming inside the tanks.

BA2007-0034-5-03: The IC recommends MÁV Cargo Zrt to notify its business partners which use similar technology for loading and unloading about the occurrence, its possible causes and recommended actions regarding procedures for measuring temperature inside the tanks and conditions for closing tank lids.

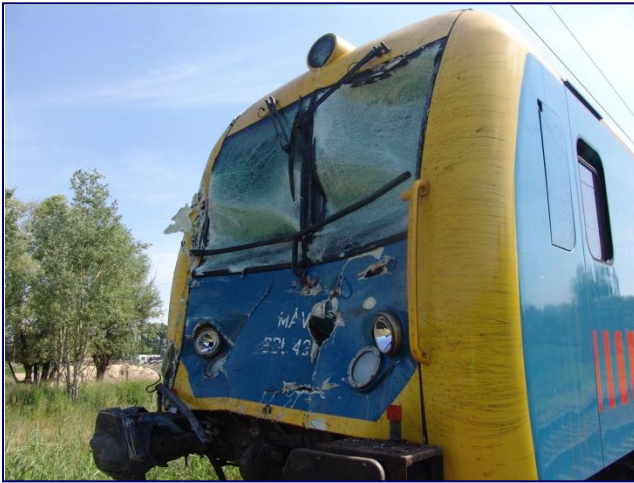
2007-211-5

On 19 June 2008, a passenger train collided with a lorry at a normally operating LC - protected with warning lights - between Pécel and Rákosszentmihály stations. As a consequence of the collision, the driver of the lorry died at the site.

The IC established in the course of the investigation that the accident was caused by human factors, by the behaviour of the lorry driver.

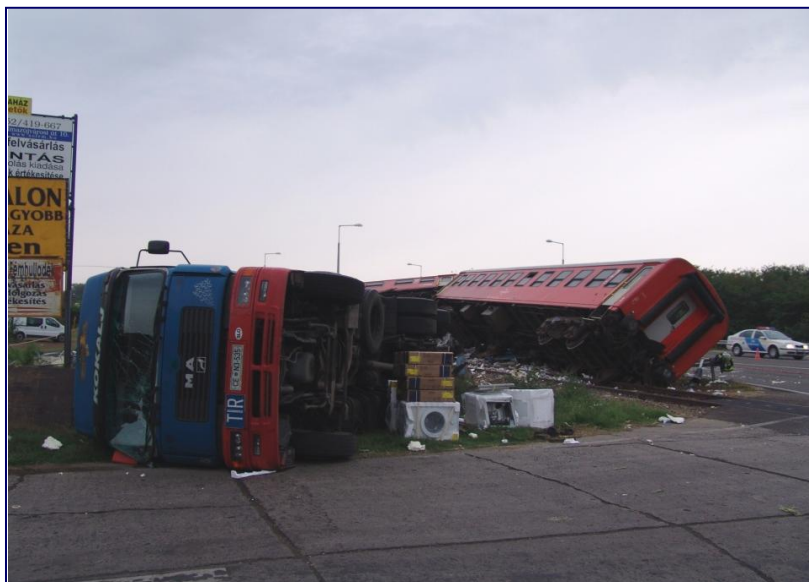
2007-323-5**2008-115-5****2008-191-5****2008-211-5****Railway accidents**

On 29th August 2007, a regional passenger train collided with a lorry at a normally operating LC - protected by warning lights - between Tócsövölgy and Balmazújváros stations. The engine-driver and three passengers suffered minor injuries as consequence of the accident. The control car of the train and one carriage derailed and toppled to its side.

2008-0191-5-01: With regard to the recurring accidents at LC AS 41, the IC recommends the National Transport Authority to review the design and construction of LC AS41 (between Tócsövölgy and Balmazújváros stations at railway section 41+16 hm) from transport safety point of view as well as to examine whether or not it would be necessary to improve the technical conditions of railway safety and to install a traffic control system which is integrated with the LC.

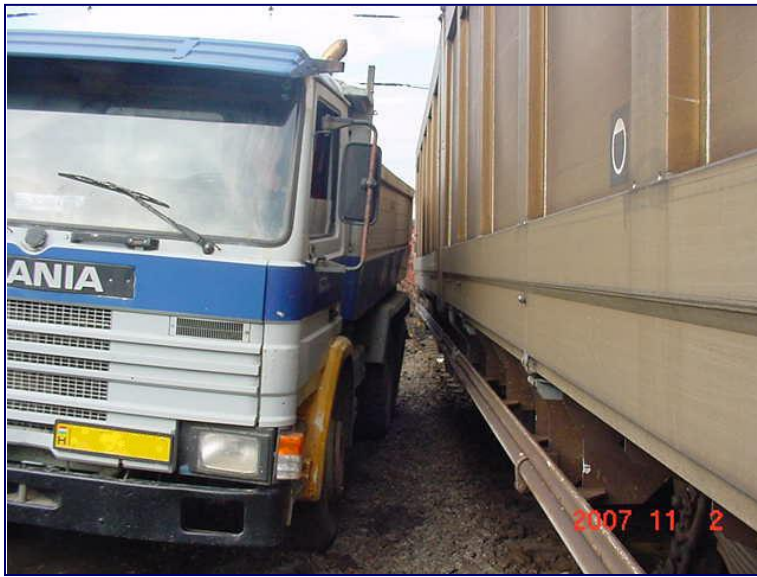
2007-400-5

On 2 November 2007 at Pestszentlőrinc station a freight train collided with a lorry which transported construction material for the rebuilding of the platforms. The lorry was moving in reverse between two tracks.

The construction site was restored and the work resumed. However, a few hours later, another accident occurred at the same location in similar circumstances.

BA-2007-0400-5-01: The IC recommends the National Transport Authority that it should conduct checks of railway track-building work more frequently.

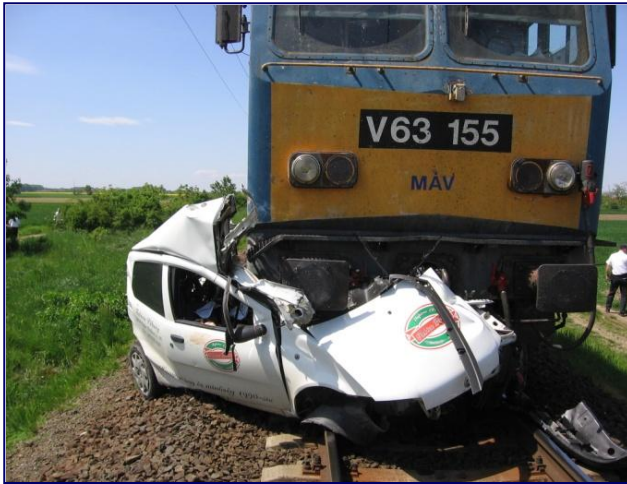
2008-201-5

On 8th May 2008, a passenger train collided with a car at an LC between Csorna and Rábatamási stations – at Farád stop. The LC was protected with warning lights and was operating normally. The driver of the car died in the accident.

BA2008-201-5-01: The IC recommends GYSEV Zrt. - as the infrastructure manager - to supplement LC no. AS 347 between Rábatamási and Csorna station in section 347+25 with half barriers.

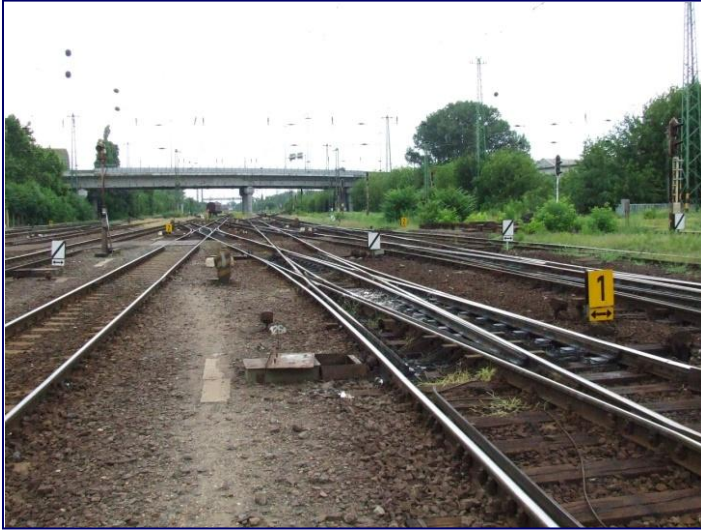
2008-302-5**Railway accident**

Two track repairers began to repair the track - with permission - at points early evening, in dark. While doing their work, a locomotive - running towards a depot - ran over them. One of them died at the site of the accident, the other suffered serious injuries.

When performing such work at the points, no vehicles should have been running on the given track, however, the track repairers had not asked for

The locomotive was permitted to run (shunt) on the points being repaired by the workers. The engine-driver was not informed about the repair work.

BA-2008-302-5-01: The IC recommends the NTA to obligate infrastructure managers to introduce a system at busy stations by which the permission and provisional entries of maintenance work can be done efficiently and reasonably, and the important information on track works is not lost.

BA-2008-302-5-02: The IC recommends the NTA to obligate infrastructure managers to prohibit setting the points towards track sections where works are in progress, with consideration to the characteristics of the different signal boxes.

BA-2008-302-5-03: The IC recommends the NTA to initiate - in cooperation with the infrastructure managers - the revision of regulations regarding the placing of low speed flags and to enforce compliance with them. Furthermore, the flags should also be in harmony with the actual speed restrictions (listed on a handout given to engine-drivers)

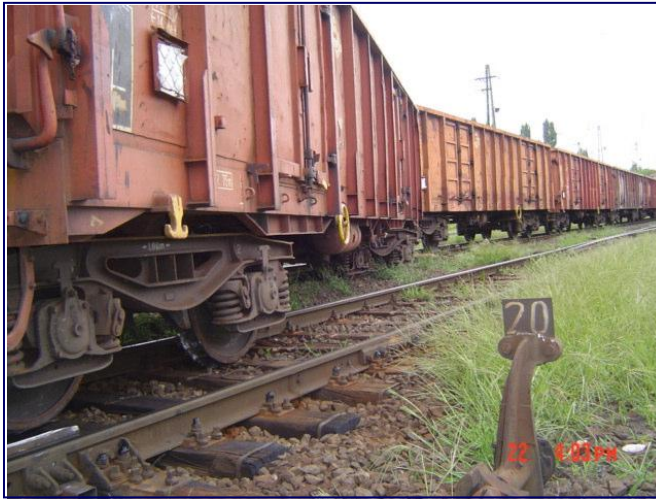
2008-315-5**Railway accident**

On 22 July 2008, two wagons of a freight train derailed when approaching Rákos station (under subsidiary signal).

the route set for the freight train was safely separated, while it actually remained open due to points failure.

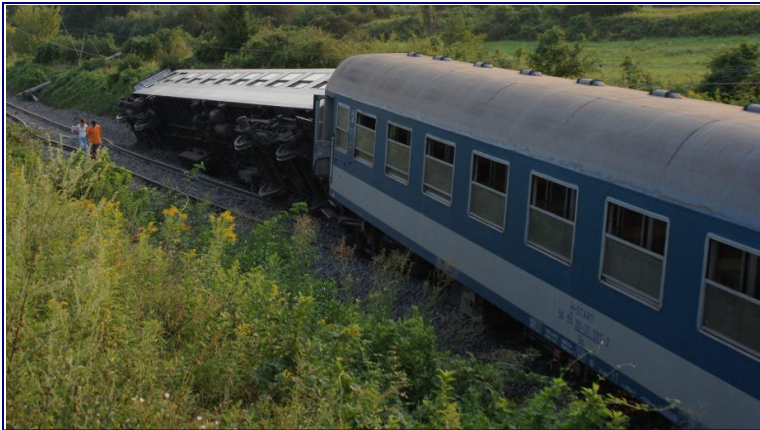
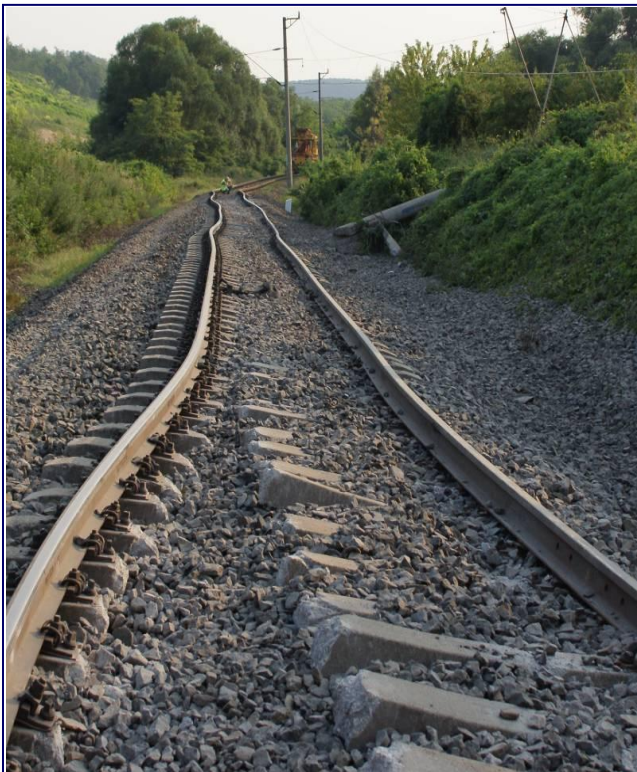
2008-335-5

On 2 August 2008, 4 carriages of a passenger train derailed between Kurd and Szakály-Hőgyész stations, one of which toppled to its side. The rail track sustained substantial damage on a 200 metre length.

- Prior to the accident, there had been more precipitation than usual, and then the weather was hot for a few days.

- There was no drainage at the site of the accident.
- The upper part of the bedding got soaked; its supporting capacity was significantly reduced.

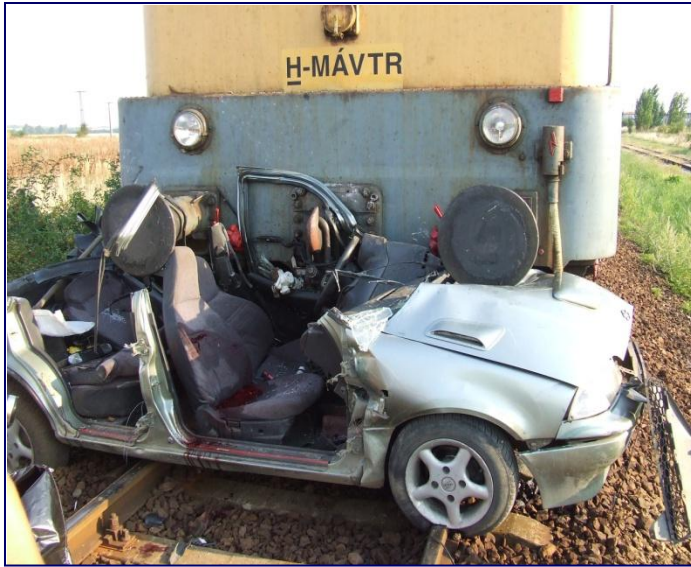
2008-351-5**Railway accident**

On 14 August 2008, a regional passenger train collided with a car at an unprotected LC between Vámosgyörk and Gyöngyös stations. As a consequence of the collision, four people travelling in the car died at the site and the fifth person lost his life in the ambulance car.

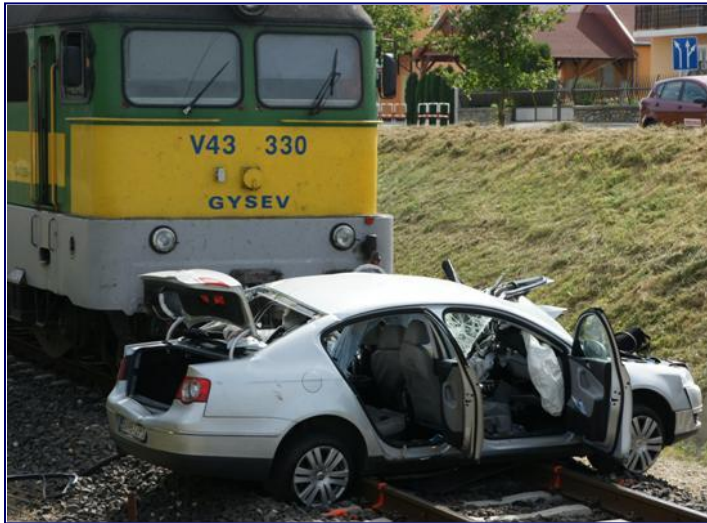
2008-401-5

On 6th September 2008 a regional passenger train - upon approaching Lövő station - collided with a car at an LC which was protected by warning lights and was operating normally. As a consequence of the collision, 4 of the passengers in the car died at the site and one was taken into hospital with serious, life-threatening injuries.

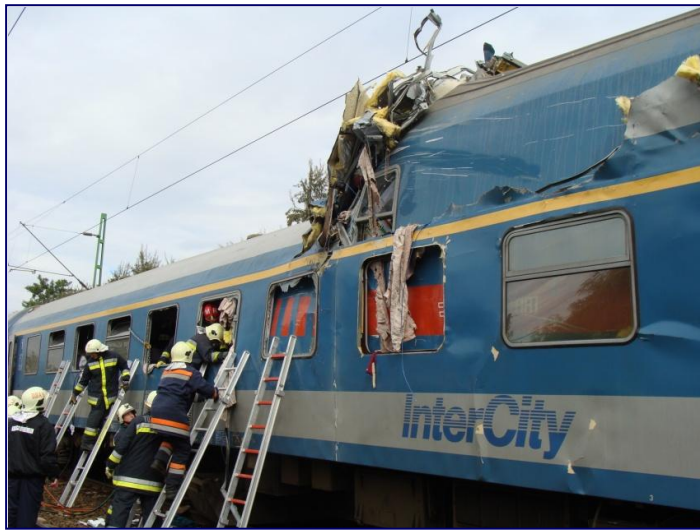
2008-446-5**Serious railway accident**

On 6 October 2008 a regional passenger train and an InterCity train running in the same direction, collided between Pilis and Monor stations. The control car of the passenger train crashed into the last carriage of the InterCity on an 11-metre-length. Four people died, four people were seriously injured, and forty people suffered minor injuries.

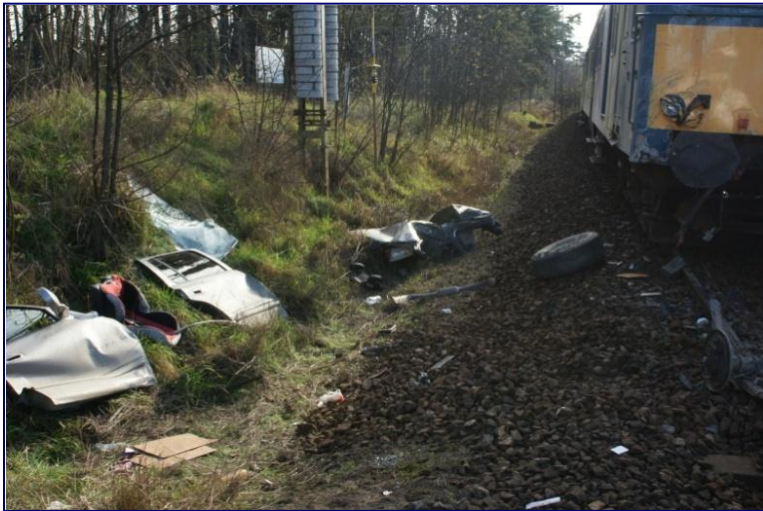
2008-510-5

On 18 November 2008, a regional passenger train collided with a car at an LC - protected with warning lights and half barriers - between Isaszeg and Gödöllő stations. As a consequence of the accident, the two persons sitting in the car died at the site.

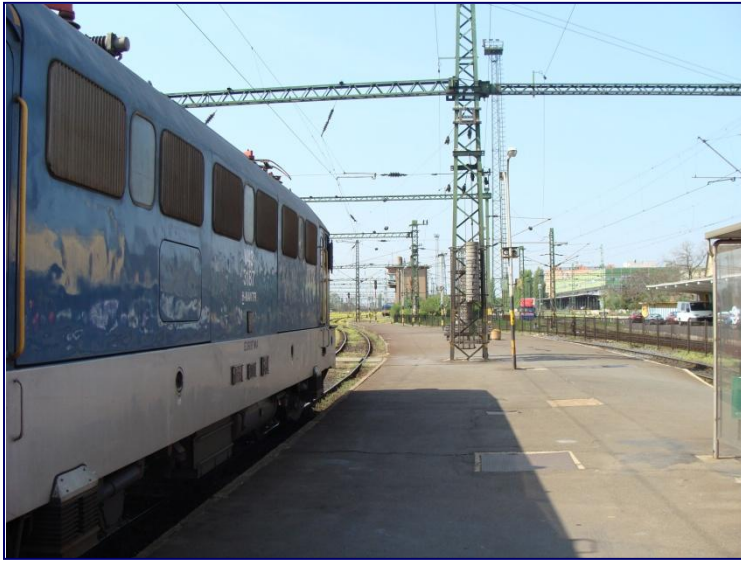
2009-148-5**Railway incident**

On 14 April 2009, scheduled Inter City train departed on permission of the controller and passed an inoperative exit signal. The train was stopped by manual signalling. There was neither injury to persons nor material damage.

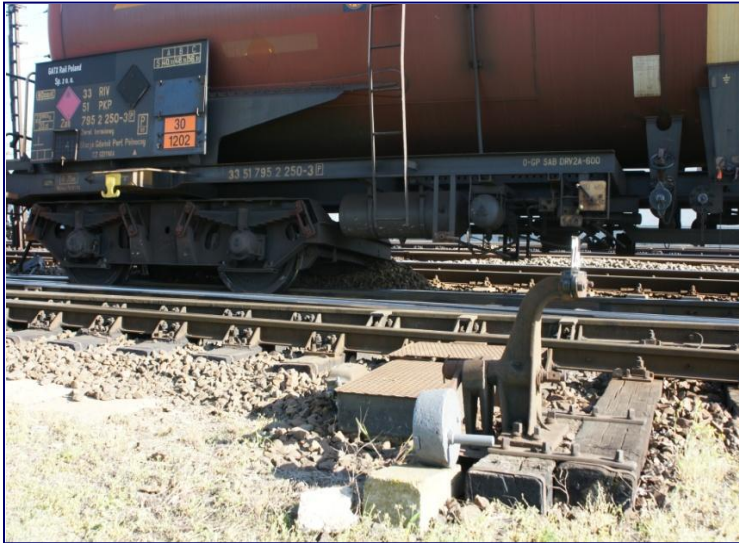
2009-157-5**Railway accident**

On 21 April 2009, the first two wagons of a freight train derailed when departing from Vámosgyörk station. No one was injured.

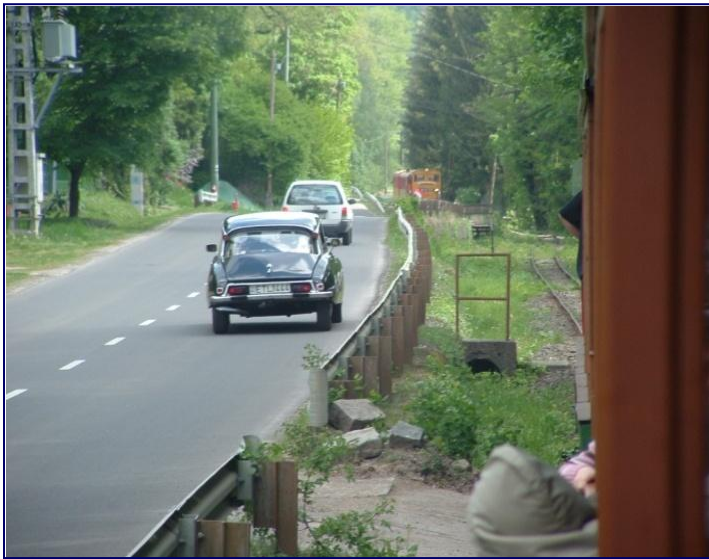
2009-187-5

On 2 May 2009, two passenger trains were running in opposing directions on the same track between Morgó and Hártókút stations on the Királyrét Forest narrow gauge railway line.

Having noticed one another, the engine-drivers stopped the trains approximately 450 metres from each other.

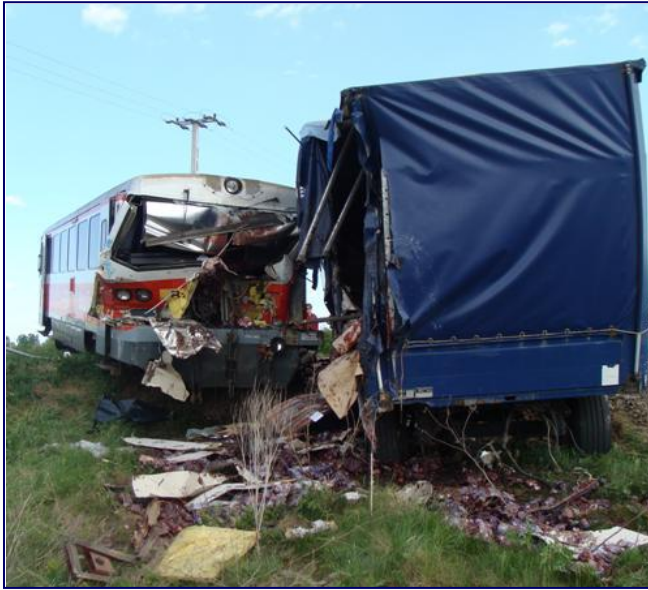
2009-190-5**Railway accident**

On 8 May 2009, a regional passenger train collided with a lorry at an unprotected LC between Vásárosnamény and Nyírmada stations. As a consequence of the accident, the chief ticket inspector of the train died at the site.
