# **ANNUAL REPORT 2010**

## **Transportation Safety Bureau**

### **Hungary**

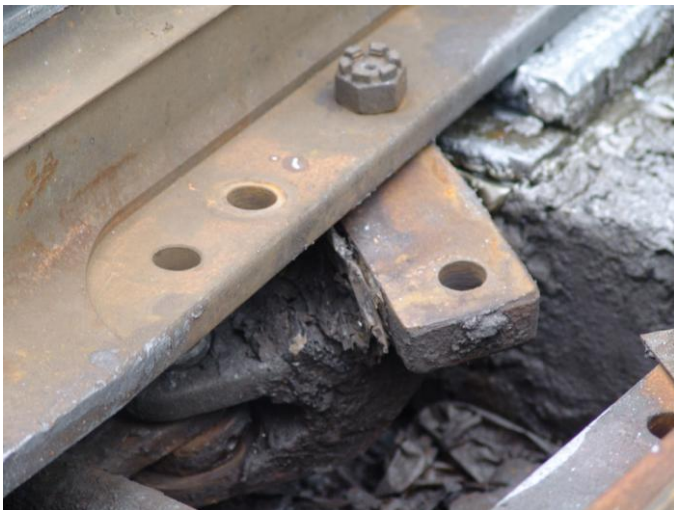
##### 2007-328-5

On 7 September 2007, four carriages of passenger train no. 3434 derailed on switch no. 6 (double slip) when departing from Budapest-Keleti pu.

No one was injured. The derailed carriages did not fall onto their side but sustained damage of different extent. The rail track also sustained damage and the occurrence caused some delays on the railway line.

The suspension tab of the connecting rod for one of the blades at no. 6 double slip got separated from the blade. Under its own flexibility and free of the retraction of the connecting rod, the blade got close enough to the main rail to derail the passing train. The IC noticed that the safety pin of the nut-and-bolt fastening of the suspension tab was missing, indicating the possible cause of the separation of the tab from the blade.

The nut-and-bolt fastenings were not secured at the last repair of the double slip and this fact remained unnoticed when accepting the work done.

The lack of equipment securing the nut-and-bolt fastenings and the loosening of the bolts remained unnoticed and unrepaired at the periodical inspection of the switch.

**BA-2007-328-5-01:** The IC recommends infrastructure managers to ensure that after the switch have been repaired, only professionally and adequately assembled equipment are accepted and released into service. Therefore the current practice of acceptance-release should be reviewed and if necessary, detailed guidelines/checklist should be compiled with regard to the aspects of inspection.

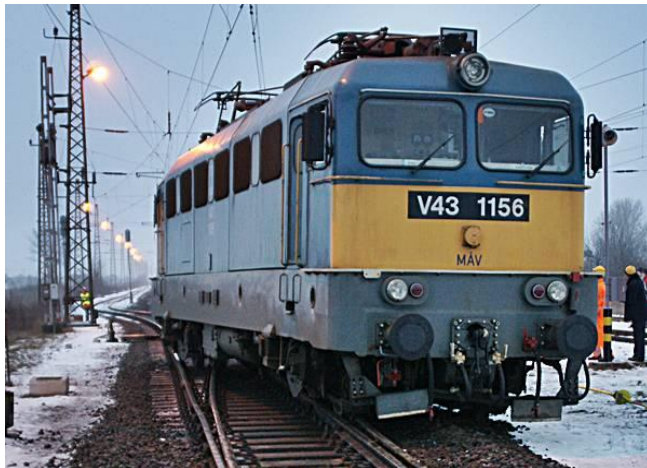
2008-0008-5

On 7th January 2008, locomotive (reg. no. V43-1156) of train no. 5122, upon leaving Tarcál station, derailed with one bogie and one axle between switch no. 17 and 11 on the open track after the exit signal.

After the report of the accident, the IC conducted a site survey. Based on the gathered data and information, the IC established that the cause of the accident was a defect in the rail track, i.e. the lack of vertical reinforcing on several sleepers on track III of the station at the small-radius arch before switch no. 11.

The IC established in the course of the investigation that the derailment of train no. 5122 was caused by the fact that the lateral rigidity of track III of Tarczal station was not sufficient.

The locomotive generated such a gauge widening that caused the derailment of the train when it was departing from the station at the small-radius arch before switch no. 11 - where several sleepers had previously become unstable due to the breakage of the rail bolts.

The IC established in the course of the site survey that some of the wooden sleepers had rotted away. The lower parts in a relatively good condition kept the seeping water in the holes. As a consequence, the bolts soon got corroded; their necks 4-5 centimetres below the head became thin due to the corrosion, and the bolts eventually broke under the excess load and pressure.

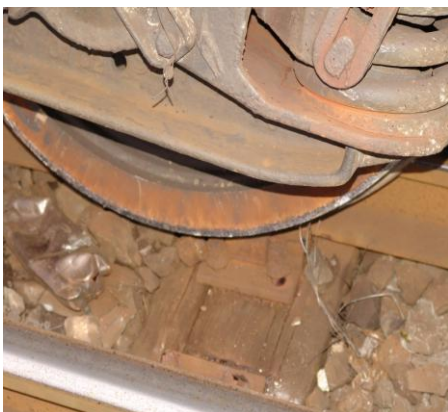
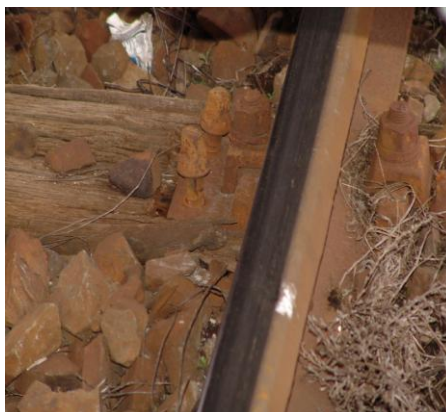
**2008-052-5**

On 7 February 2008 at 8:50 hrs, when leaving track VII of Budafok-Háros station, the 6<sup>th</sup> wagon (reg. no. 33 55 785 1029-9) - loaded with petrol - of freight train no. 83521 derailed in section no. 64+15 and after stopping it fell onto its side.

The accident occurred due to the gauge widening which can be attributed to the bad, worn away condition of the rail track.

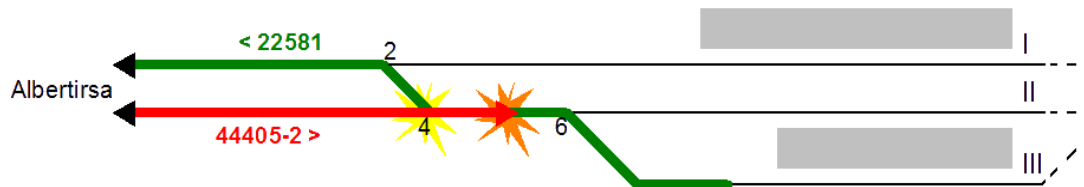
On 30 August 2008 at 11:25, having passed entry signal 'A' indicating 'Stop', freight train no. 44405-2 split switch no.4 open and then collided with wagon no. FMK-002 of work train no. 22581 departing from platform III of Ceglédbercel-Cserő station. No one was injured.

The accident was attributed primarily to human factors (SPAD). However, the IC believes that another contributing factor was the too frequent duty service of the engine-driver who, besides, spends approximately 6 hours commuting to work.

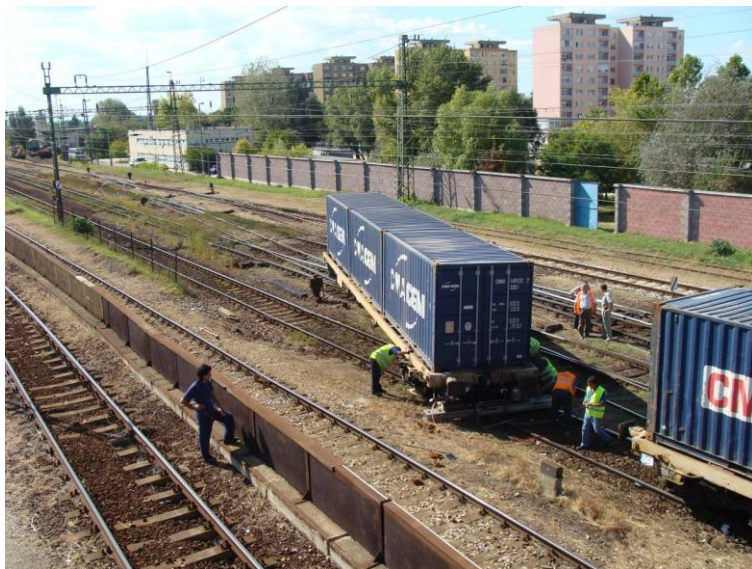
- Significant gauge defects and rail distortions were found on the track where the train derailed.
- The wheel loads of the derailed vehicle were asymmetric exceeding the permitted value.

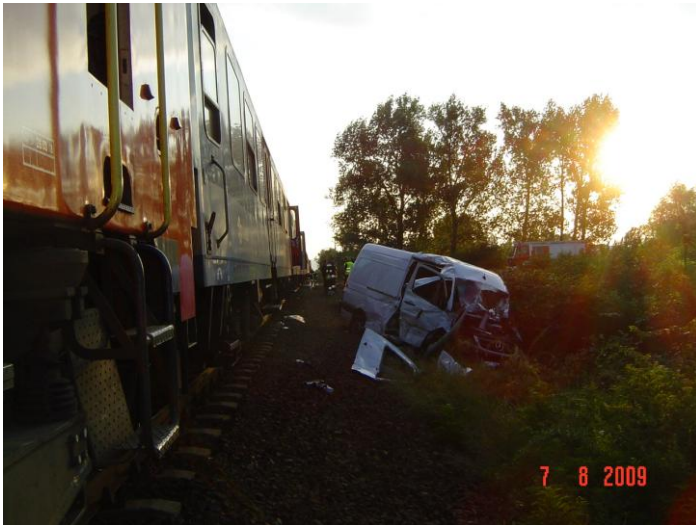
**2009-382-5**

On 7 August 2009, fast train no. 529 departed from Sátoraljaújhely station at 03:51 hrs to Budapest-keleti pu according to schedule. Upon leaving the station, it collided with a Mercedes Sprinter 318 CDI Ukrainian bus at LC no. SR-2 - protected with warning lights - in section no. 443+70. As a consequence of the collision, one of the passengers of the bus died at the site, 2 suffered serious and 6 suffered minor injuries.

The locomotive (reg. no. M 41-2334) became inoperative. Entry signal 'A', mast 'c' of the LC and one end of the insulated rail section sustained damage. The bus was written off.

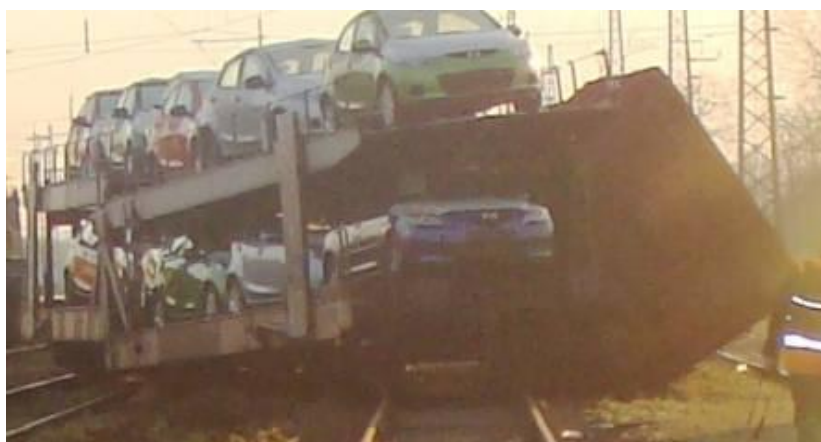
### **2008-136-5**

On 26 March 2008 at 01:18 hrs, the 15<sup>th</sup> and 16<sup>th</sup> twin wagon (nos. 23 80 435 1919-4 and 25 80 436 805-5, carrying cars) of train no. 44405-2 derailed at switch no. 22 when approaching track XIII of Kőbánya-felső station. The second half of the 15<sup>th</sup> wagon was running towards track XIV and collided with an Eas wagon (scrapped) standing on the track.

The railway vehicles sustained minor damage and the rail track was damaged on an approximately 200-metre length.

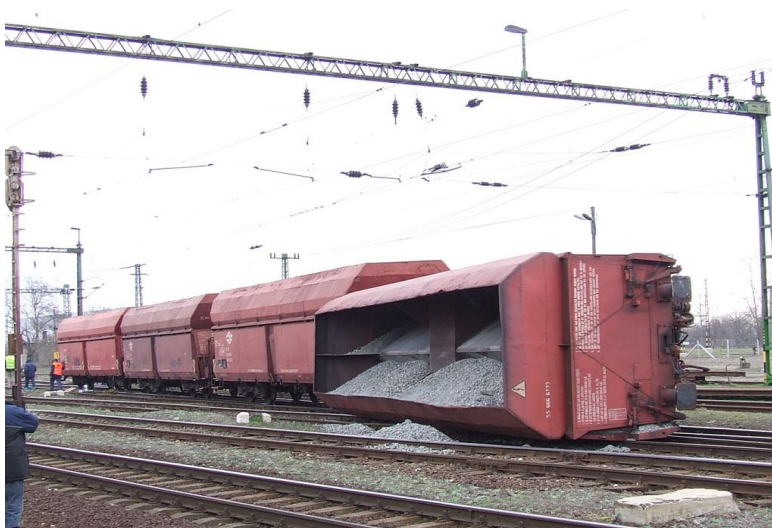
**2009-113-5**

On 23 March 2009, the first wagon of freight train running from the Vác factory of DDC to its Beremend factory (carrying cement bricks) derailed and tipped to its side when departing from track VIII of Pusztaszabolcs station. Further two wagons derailed with one axle. The rail track and the signal box sustained damage. When the still standing wagons were trailed away, there was a similar derailment at the other end of the station.

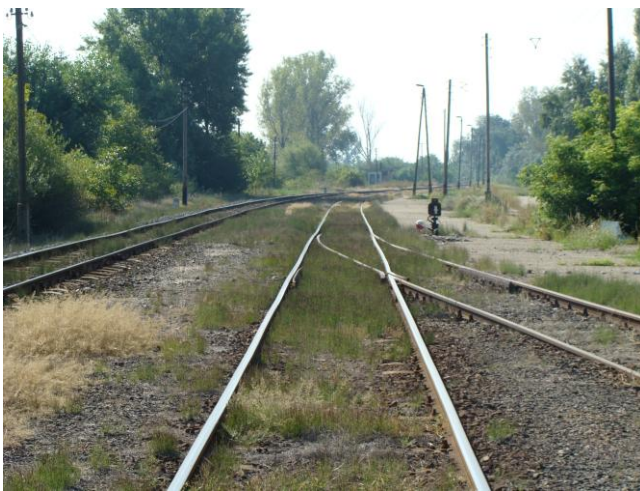
**2009-413-5**

On 23 August 2009 at 21:18 hrs, freight train no. 98658 - running from Veszprém to Paks and carrying stone - approached the main transit track (III) of Aba-Sárkeresztúr station and ran through it without previous authorization. It travelled on the same track as passenger train no. 38421 - which departed from Sárbogárd station at 21:13 hrs with permission - in opposing direction. The traffic controller notified the engine-drivers (through the locomotive running foremen) via mobile phone to stop the trains. The two trains then stopped approximately 3400 metres from each other on the open track.

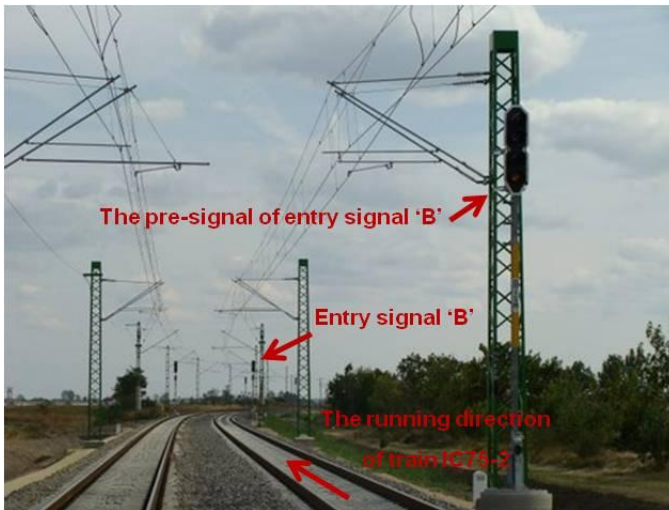
## 2009-0443-5

On 5 September 2009 at 09:23 hrs, train no. IC 75-2 passed entry signal 'B' signal at danger at Nagylapos crossover and approached the track of Nagylapos station on which train no. 7442 was standing. The movements inspector noticed the occurrence and gave a 'Stop' signal to train IC 75-2 (which was running with approximately 10 km/h speed). Train IC 75-2 stopped 150 metres from the rear of train no. 7442.

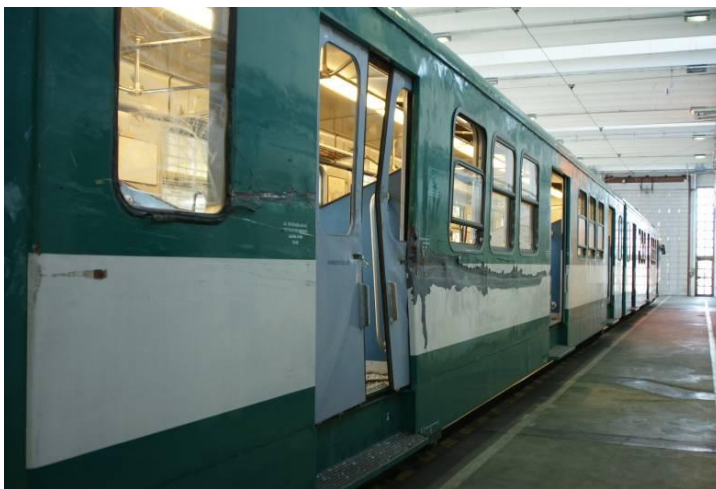
#### 2009-0503-5

On 4 October 2009 at 11:29 hrs train no. 2042 collided with a tractor at an unprotected LC between Tököl and Szigetcsép stations, at railway section no. 267. As a consequence of the collision, 3 passengers of the train suffered injuries and the first and second carriages of the train sustained damage.

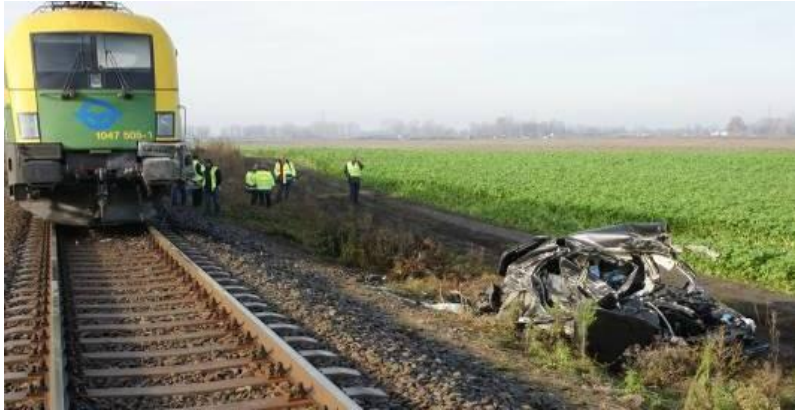
### **2009-583-5**

On 19 November 2009 at 7:10 hrs train no. 999 collided with a car between Ikrény and Enese stations at Rábapatona stop at LC no. AS137 protected by half barriers and warning lights.

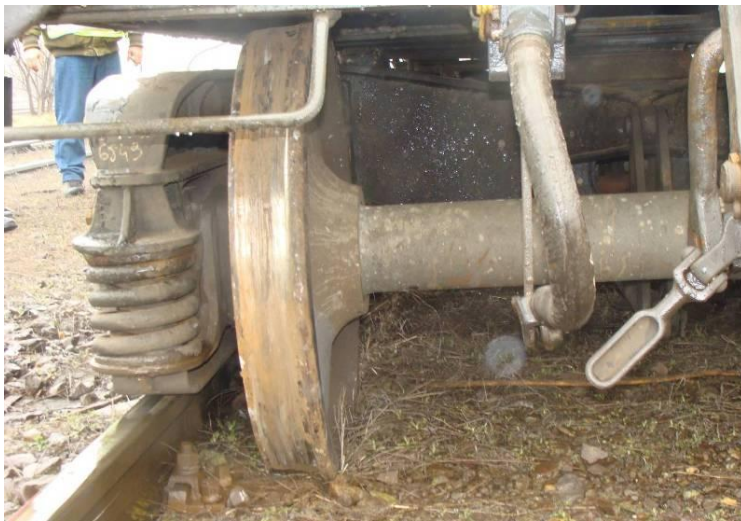
### **2009-052-5**

On 4<sup>th</sup> February 2009 at 8 hours 45 minutes, the fifth wagon (reg. no. 33 87 787 6849-3) of train no 45213 running from Slovakia derailed with 4 axles on track X while approaching Rajka station. As a consequence of the derailment, the rail track and the derailed wagon sustained minor damage.

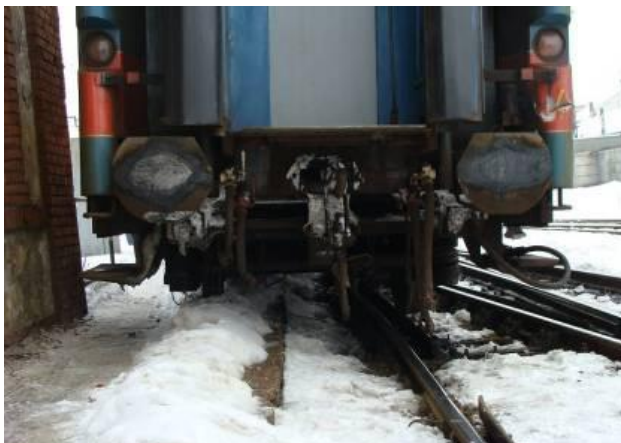
**2010-069-5**

On 9 February 2010 at 08:27 hrs, 2010, one carriage (the penultimate) of train no. 2759 derailed with four axles between points no. 13 and 19 when approaching track XIV of Budapest-Nyugati station.

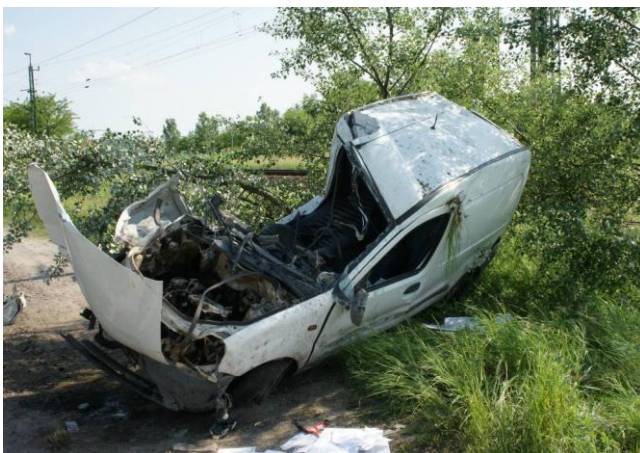
### **2010-229-5**

On 25 May 2010 at 14:00, the locomotive (reg. no. V 43-1128) of train IC 704 collided with a car at LC SR2 - protected with warning lights - at Szatymaz station.

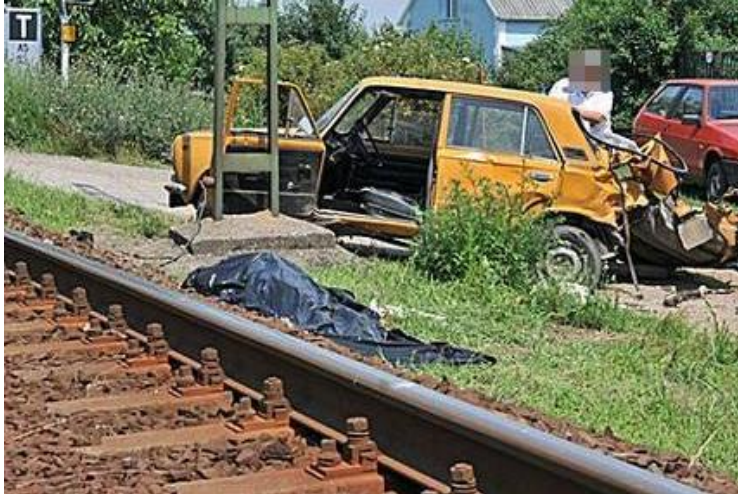
### 2010-0304-5

On 16 July 2010 at 10:25 hrs, train no. 35045 collided with a car at LC AS13 between Nyékládháza and Hejőkeresztúr stations. The LC is protected by warning lights which were operating normally at the time of the accident. As a consequence of the collision, the driver of the car lost his life at the site, his passenger suffered minor injuries. Two trains were cancelled and one train was delayed by 35 minutes.

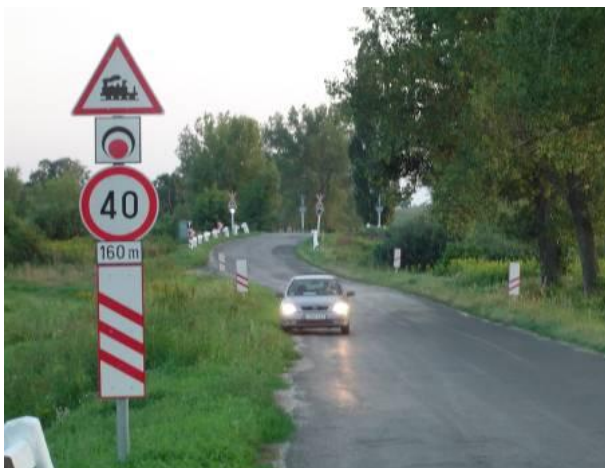
## **2010-354-5**

Train no. 9235 collided with a motorbike at LC AS386 (protected with warning lights) between Pápa and Vaszar stations.
