TRANSPORTATION SAFETY
BUREAU

ANNUAL REPORT 2011
Transportation Safety Bureau
Hungary

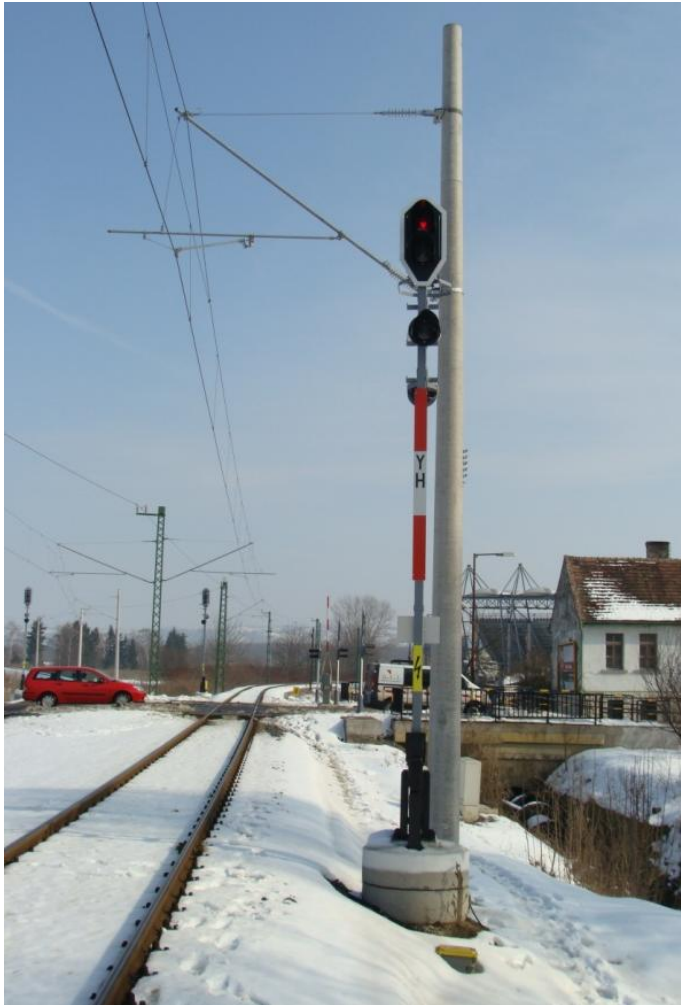
2010-074-5

On 11th February 2010 at 12:15 hrs, train no. 1247 passed the signal YH at danger, the locomotive and the first carriage of the train passed the open level crossing protected with warning lights and half-barriers SR4. No one was injured.

Based on documents and the analysis of videos and pictures taken on the site, the IC established that the SPAD was caused by the fact that the engine driver had not been able to notice the red light (Stop indication) of the YH in time. When noticing the Stop indication, he immediately applied the emergency brake, but the train, not having enough room to stop, passed the signal and stopped on the open level crossing protected with half-barriers, with its locomotive and first carriage passing over it.

Therefore, Transportation Safety Bureau (TSB) recommends the National Transport Authority (NTA) to revise, in cooperation with the railway undertakings operating the infrastructure, the regulations in effect and take the necessary measures for the harmonization of these.

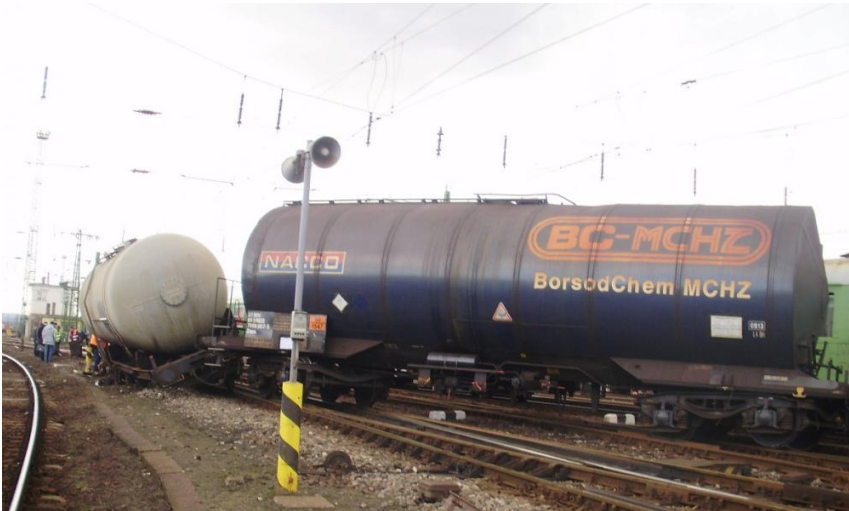
2010-128-5

On 15th March 2010 at 09:30 hrs, 3 wagons of freight train no. 53410 derailed when departing from Miskolc - Rendező station to Bánréve - first the 24th wagon, used for transport of dangerous goods, but empty at the time of the accident, after which the 23rd and 25th wagons derailed. The 24th tank wagon (Zas) had a Polish owner. The rail track and the derailed wagons sustained damage.

The investigation established that the 6th spindle of the wagon had already been faulty, had fallen apart and the bearing box had fallen off the wagon right before the occurrence, which resulted in the derailment of the wagon.

The IC considers that faults of this kind could be revealed and prevented by proper maintenance, on the operating train the fault cannot be detected.

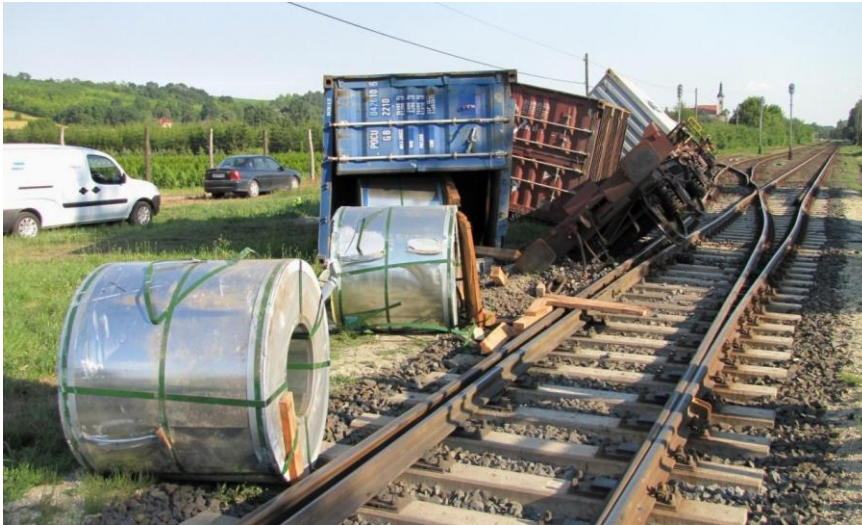
On 11th July 2010 at 16:10 hrs, when freight train no. 45220-1 (M62-307) was departing from track III. at Búcsúszentlászló station, the last wagon (no. 33 54 496 0992-4) of the train derailed, broke from the train and fell over blocking the track on

the last track section before points no. 4. The engine driver, realizing the occurrence of the accident, used the emergency brake, this resulting in the rupture of the screw coupling of wagon no. 83 35 549 6518-2 and the split of the train. The IC

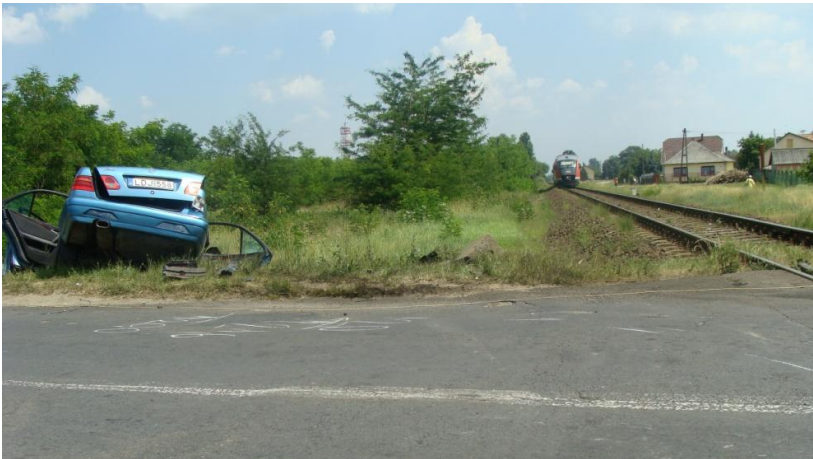
2010-297-5

On 14th July 2010 at 12:26 hrs, on the level crossing SR2 protected with warning lights operating properly a car crashed into the left forefront of train no. 2842 (motor train set no. 95 55 34 2001-2) arriving to Örkény station with all signals operating properly.

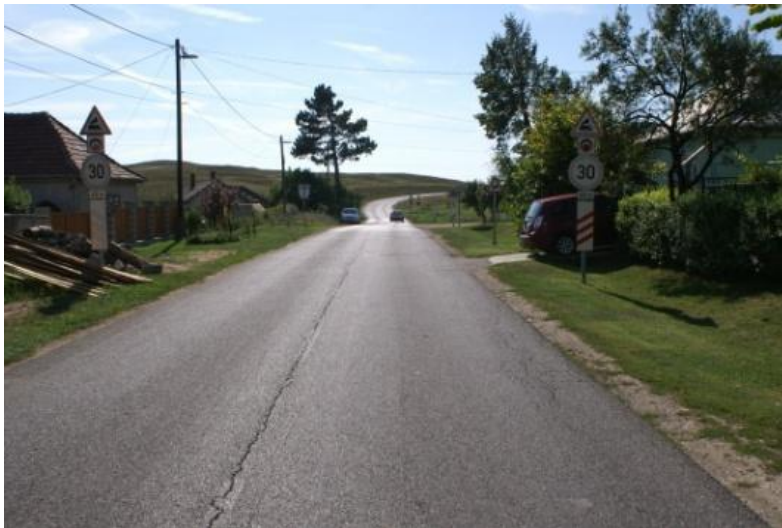
2010-383-5

On 21st August 2010 at 16:50 hrs, between Hajmáskér and Pétfürdő stations near settlement Öskü, passenger train no. 9053 struck a cyclist on the level crossing protected with warning lights no. AS316 operating properly. The cyclist died at the site. No one of the passengers or personnel of the train was injured.

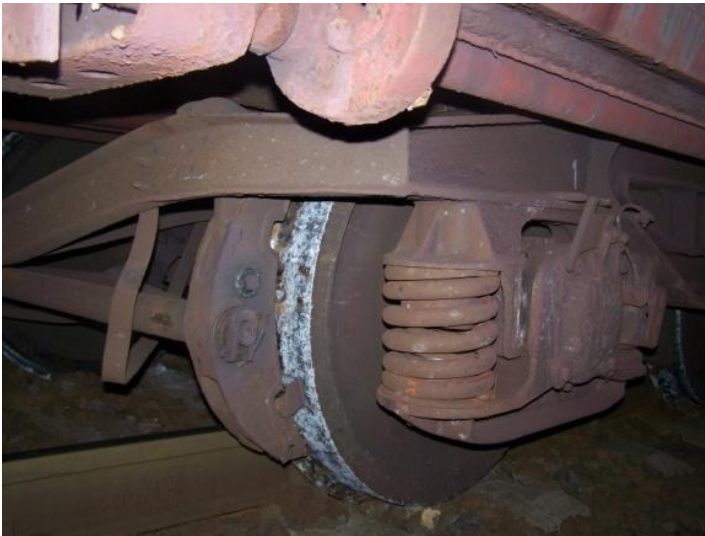
2010-443-5

On 27th September 2010 at 03:40 hrs, 2nd wagon (a 4-axle wagon) of freight train no. 68215-2 arriving to Adony station with signals operating properly, derailed with 2 axles in the curve before the enter signal. The wagon derailed was hauled by the train on a further 500 m distance.

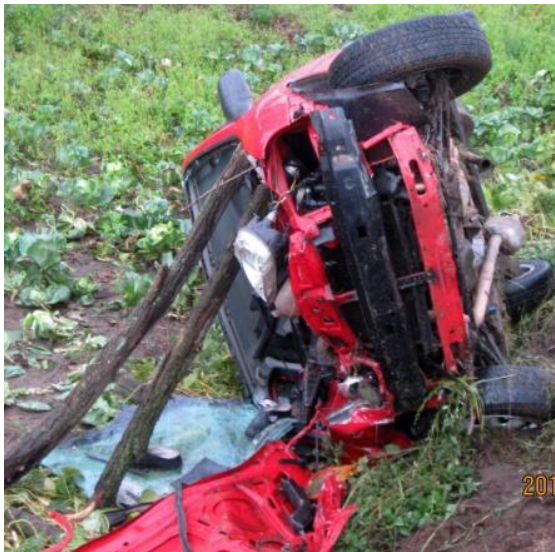
2010-455-5

On 5th October 2010 at 11:00 hrs, train of locomotive no. 6381 collided with a car of type Opel Corsa on the non-protected level crossing between Nyírgelse and Nyíradony stations in railway section no. 313+59. The driver of the car was seriously injured and transported to the hospital by an emergency helicopter. There were minor damages to the locomotive, no one of the personnel of the train was injured.

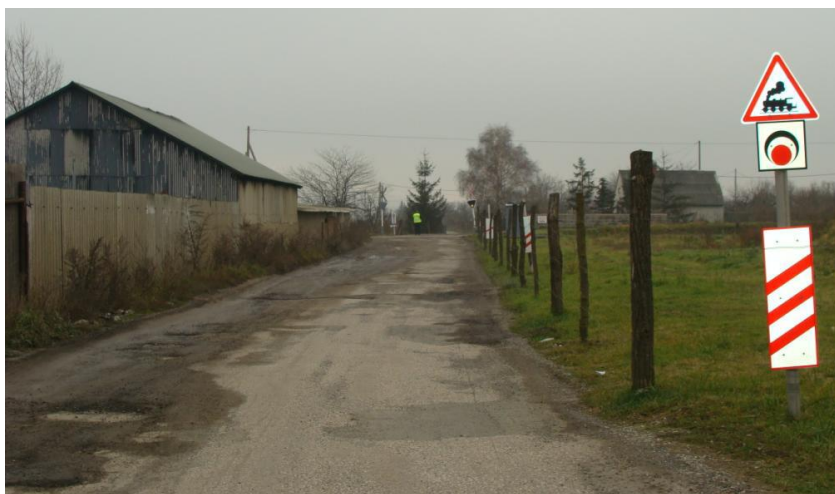
2010-533-5

On 23rd November 2010, passenger train no. 9626 collided with a car between Tapolca and Lesencetomaj station on the level crossing AS438 protected with properly operating warning lights. The car driver entered the level crossing ignoring the “Stop” indication of the

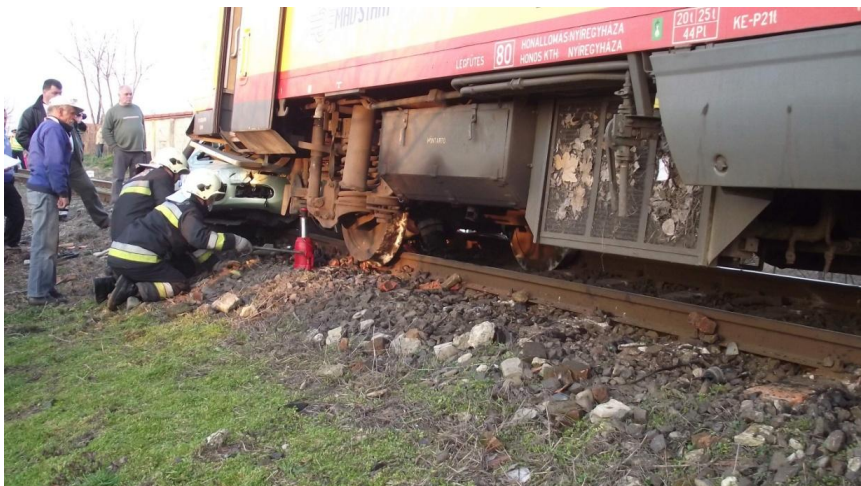
2011-145-5

On 29th March 2011, passenger train no. 6346 collided with a car between Mátészalka and Vásárosnamény stations on the level crossing AS341 protected with warning lights. The driver of the car died at the site. The power car of the
