**TRANSPORTATION SAFETY
BUREAU**

ANNUAL REPORT 2012
Transportation Safety Bureau
Hungary

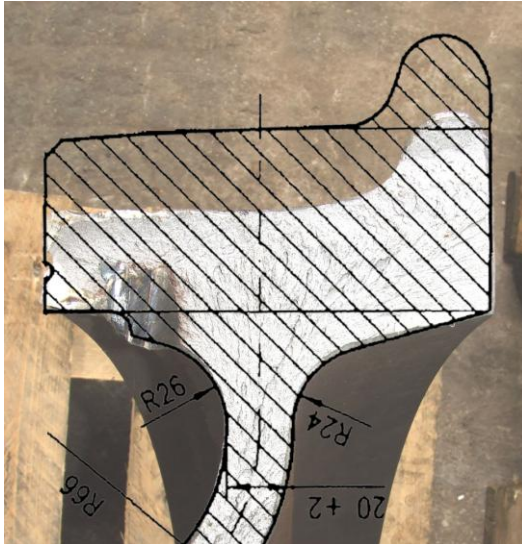
2010-186-5

On 19th April 2010, the monobloc wheels of one of the carriages of express train no. 9408 from Budapest-Keleti station to Hegyeshalom station broke between Tatabánya and Tata stations, while the train was running at a speed of near 140 km/h.

As a result, the carriage derailed with one axle. No one was injured. The track and the vehicles were damaged.

The IC established that the applied shoe braking technology has a significant thermal effect on the surface of the wheel, this being increased on points as well by possible slipping movements of the wheels. Due to the thermal and point load effects, a crack was formed in the wheel, this not being revealed in the wheel control process, and the crack turned into fracture during the run.

Due to the thermal effect of the braking and the point load effects, a crack was formed in the wheel, this not being revealed in the wheel control process, and the control process did not cover the control of the wheel centre. The crack turned into fracture during the run, the train derailed because of the broken wheel and the train running on the other track also became damaged.

The composition of the material of the broken wheel complied with the requirements of the standard, but the actual composition in the temperature interval attainable during operation results in the rigidity of the material. The standard did not specify the lower limit for the alloying addition to decrease this effect, but the actual value was significantly lower than the upper limit.

The applied braking technology (pneumatic brake applied in the full range of speeds, frequent stops and decelerations) has a significant thermal effect on the wheels. Possible slips increase this in points as well, creating the possibility of the wearing in patches.

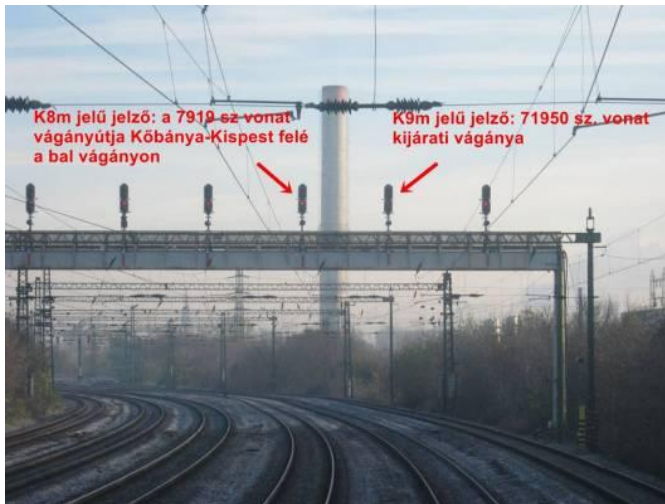
2010-459-5

On 7th October 2010, train no. 71350 passed exit signal K9m at danger at the station Budapest-Ferencváros, and split points no. 32 after this. The locomotive was not equipped with Unified Vigilance Warning and Train Control Device, for this reason the train was not automatically stopped after passing the signal at danger. After splitting the points, the train travelled further to Kőbánya-Kispest station instead of Rákos station. When receiving oral notification, the train stayed at Kőbánya-Kispest station and waited for further instructions.

The accident is considered as caused by human factors.

Transportation Safety Bureau recommends the National Transport Authority to revise in cooperation with the railway undertakings concerned the rules regarding 'junction freight service running', take effective measures for the accurate determination of stations served by a junction freight service running, in order to ensure that running with no train protection system conforming to the infrastructure requirements would be allowed only in justified cases.

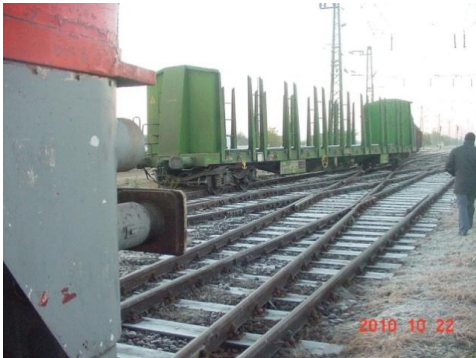
**Picture 1: The derailed vehicle
(source: VBO)**

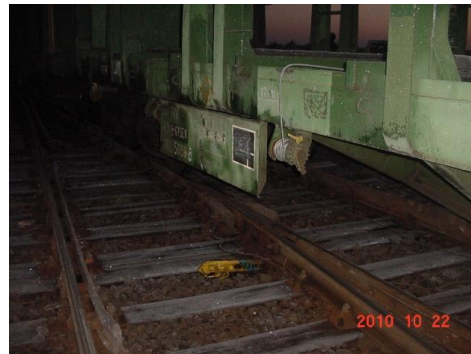
**Picture 2: Drag shoe found on the site
(source: VBO)**

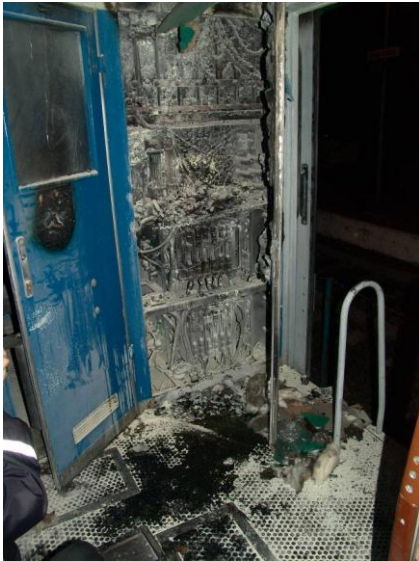
2010-529-5

On 19th November 2010 at 21:14 hrs, a fire occurred in the case no. 2 in the driver's cabin of the power car no. MX/A 1101, last wagon of train no. 4788 entering Rómaifürdő station. After stopping the train, the engine driver started the evacuation of the passengers and the extinction of the fire immediately. He also took the necessary measures for the forthright notification of the fire department, who, after arriving to the site, extinguished the fire. The driver suffered slight carbon monoxide poisoning and received treatment by the ambulance arrived on site.

The spring tensioning screw of the unit switch no. 6 in the case no. 2 of power car no. 1101 broke. The broken piece fell on the high voltage contact block of the reverser, causing short circuit and, as a consequence, a fire.

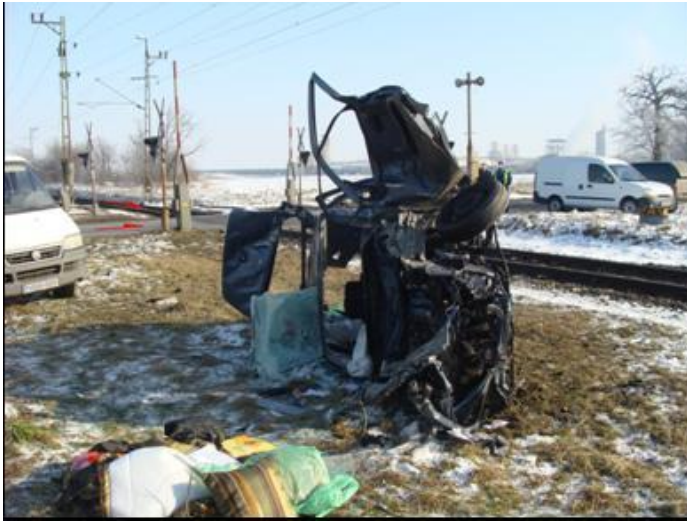
2011-044-5

On 28th January 2011 at 08:47 hrs, passenger train no. IC802 of MÁV Co., travelling on railway line no. 40 on the route Budapest-Pécs, collided with a car at the level crossing protected with warning lights and half-barrier SR2 at Szabadegyháza station.

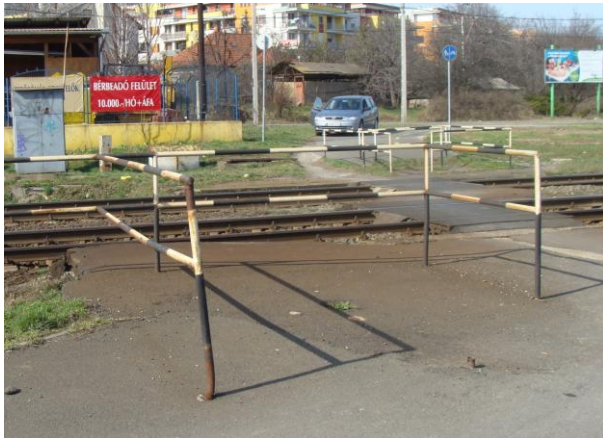
2011-124-5

On 20th March 2011 at 15:08 hrs, power car no. 5341-001-5 of train no. 4544 collided with a motorcyclist between Háros and Nagytétény-Diósd stations at the level crossing protected with warning lights and half-barriers no. AS87.

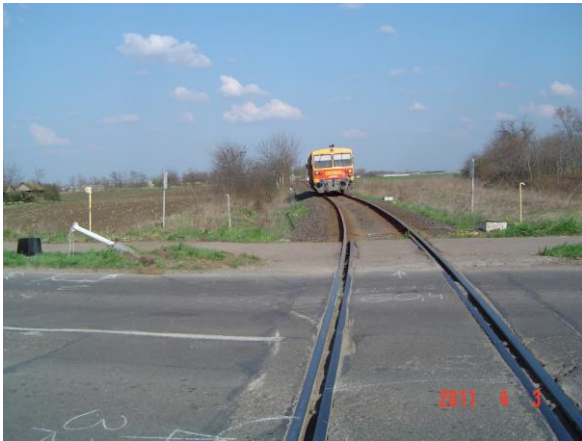
2011-153-5

On 3rd April 2011, a passenger train collided with a car at the level crossing protected with warning lights AS 399 between Szentes and Gádos stations. The car entered the LC ignoring the 'Stop!' indication of the warning lights. The driver of the car and his passenger were injured.

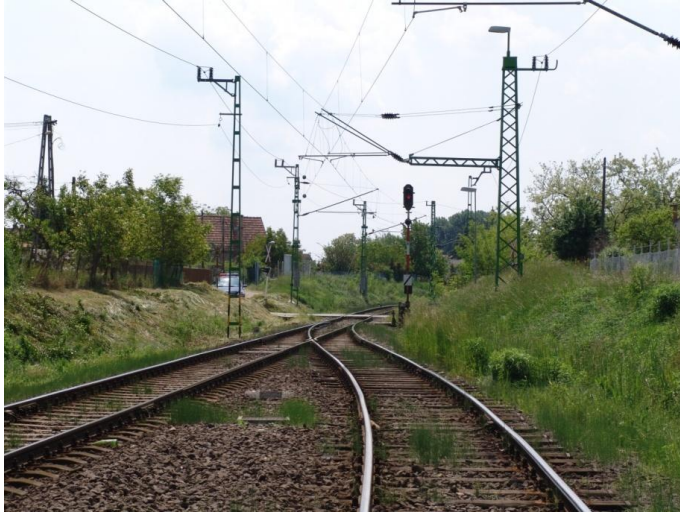
On 10th May 2011 at 23:52 hrs, contact line maintenance machine no. 2391 running from Vác to Csomád station passed at Órbottyán station the exit signal K at danger, split points no. 2, ran out to Órbottyán-Veresegyház line section and travelled without permission up to Veresegyház station.

The splitting of the points was not signalled to KÖFI-fszt. (Central Traffic Management) on the panel ILTIS of the safety installation because the gear broke out from the timber sleepers and for this reason the safety installation did not detect the points splitting.

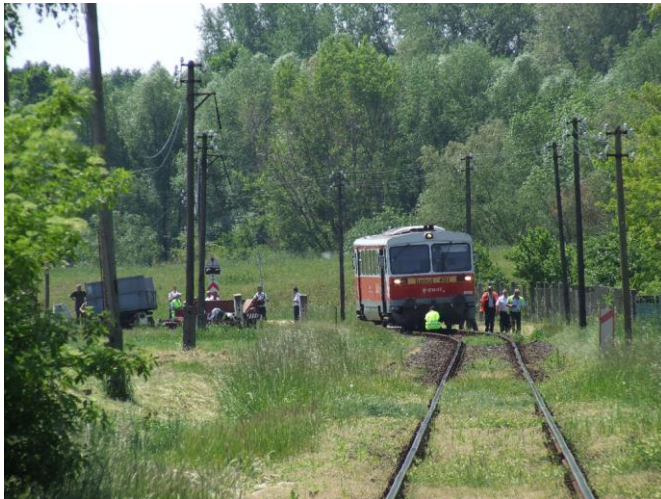
2011-213-5

On 18th May 2011, passenger train formed of power car no. 402 collided with a motorcycle at the unprotected level crossing (unpaved road crossing the railroad) after Tiborszállás mrh. The motorcyclist died at the site.

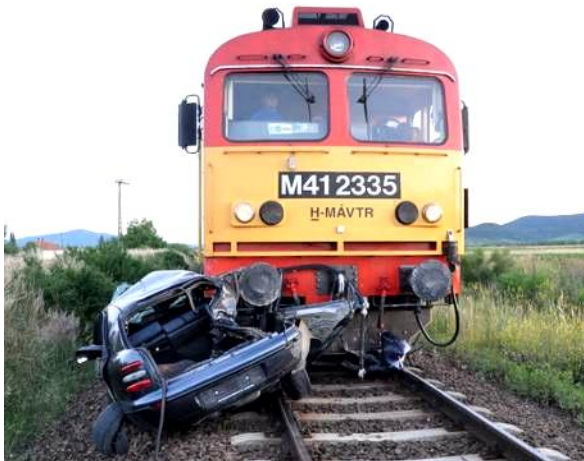
2011-279-5

On 20th June 2011 at 18:55 hrs, passenger train no. 5226 collided with a car at the level crossing protected with warning lights no. AS199 on the open line between Bodrogkeresztúr and Olaszliszka-Tolcsva stations.

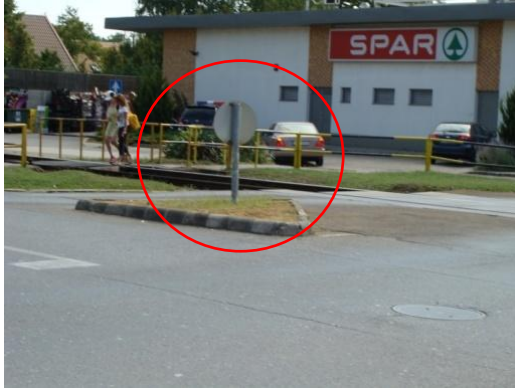
Traffic sign in wrong position

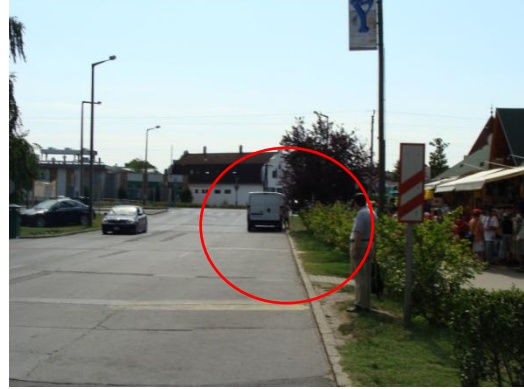
Parking car near the warning lights

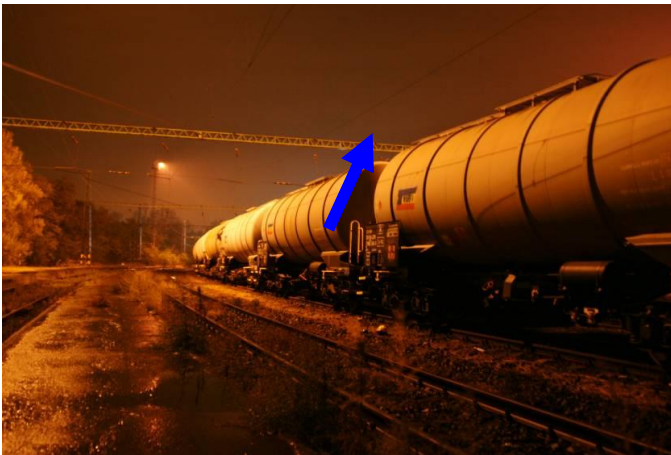
2011-470-5

On 19th September 2011 at 20:47 hrs, an employee of MOL Plc climbed on the top of the tank wagon no. 31 53 798 5304-3 of train no. 45111 waiting for departure at Dunai Finomító station, approached the high voltage contact line above the track and suffered serious electric shock.

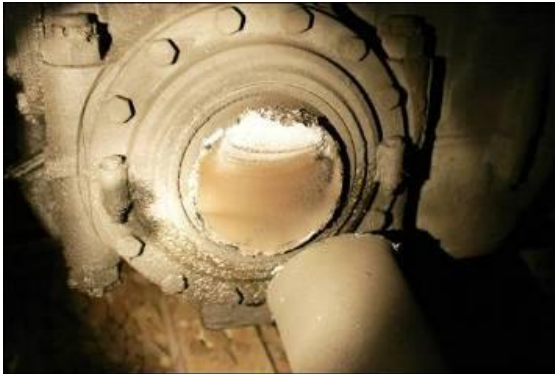
2011-537-5

On 26th October 2011 at 17:35 hrs, the 3rd axle of the power car no. M41-2324 of train no. 526 broke and the vehicle derailed with one axle between Mezőzombor and Bodrogkeresztúr stations in railway section no. 67+83. By applying emergency braking, the train stopped on a 146 m distance. No one was injured.

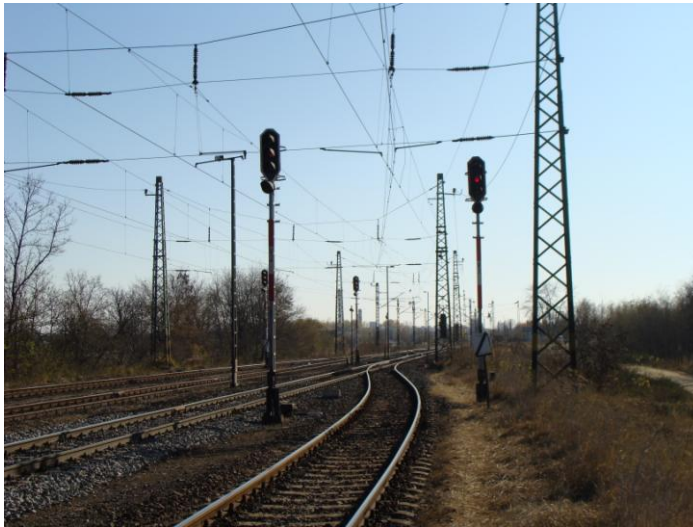
2011-539-5

On 27th October 2011 at 04:45 hrs, train no. 56500 entering Nyíregyháza-Északi-kitérő to track I passed individual exit signal V1 at danger at a speed of approx. 7 km/h, split points no. 11 and stopped on points no. 9 in railway section no. 466+49. At the same time, train no. 5129 approached Északi-kitérő from Nyíregyháza station and the traffic controller set for the train 'Clear' indication on entry signal B. When train no. 56500 reached the route of

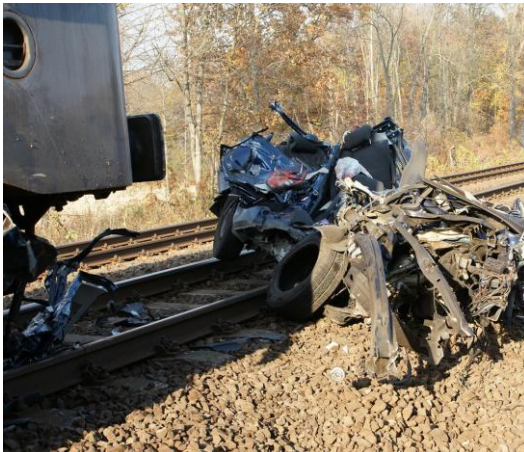
2011-560-5

On 7th November 2011, train no. IC 622 collided at the level crossing protected with warning lights and half-barrier no. AS35 with a car that by-passing the closed barrier entered the LC. The driver of the car died at the site, there were no other injuries. The locomotive derailed with one axle.

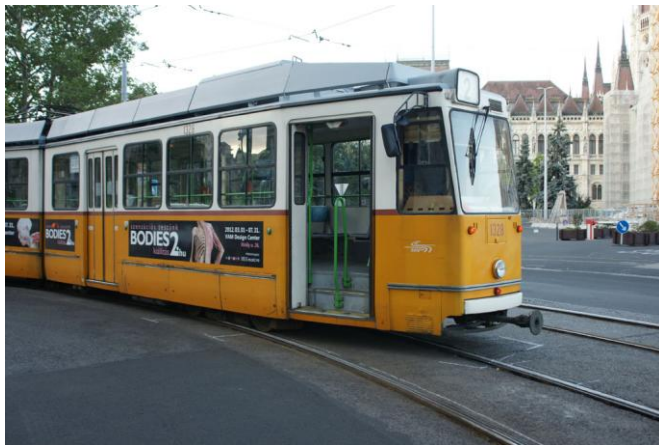
2012-471-5, 2012-475-5

On 17th July 2012, a tram on line no. 2 derailed while running at low speed in the curve after Szalay utca stop (towards Jászai Mari tér). After restoration, the first tram next morning derailed on the same spot on 18th July 2012.
