**TRANSPORTATION SAFETY
BUREAU**

ANNUAL REPORT 2013
Transportation Safety Bureau
Hungary

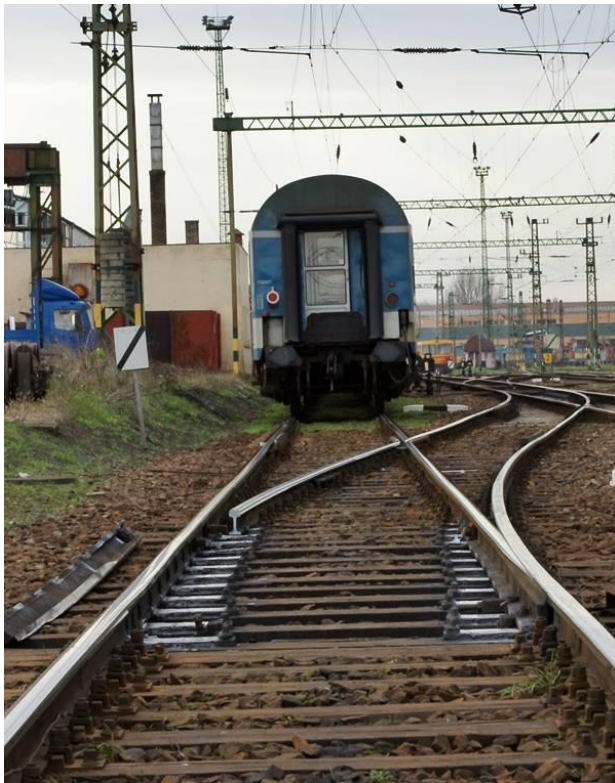
Occurrence No. 2011-062-5

On 6 December 2010 at 06:53 hours, the engine driver of the train No. 87941, approaching Dombóvár station, perceived the break of the clinging switch tongue prior to entering the points No. 17, and stopped the train by emergency braking. In the course of the stopping process, the assisting locomotive and the lead locomotive as well as the first wagon stopped after the points, while the second wagon (No. 31 55 599 3506-1) of the train stopped, in derailed position, on the points. No one was injured in the occurrence.

In both cases, the IC concluded that the break of the switch tongue caused the occurrence, however, no similarities were found as regards the circumstances which had led to such breaks.

Occurrence No. 2010-558-5: as a consequence of a previous material defect invisible with the unaided eye, a crack was formed in the left rail of turnout No. 17 at Dombóvár station, which became visible before the arrival of the freight train No. 87941. Despite emergency braking, the engine travelled onto the crack, and broke the rail, and due to its position, the rail broke at one more location, too.

Safety recommendation was not issued.

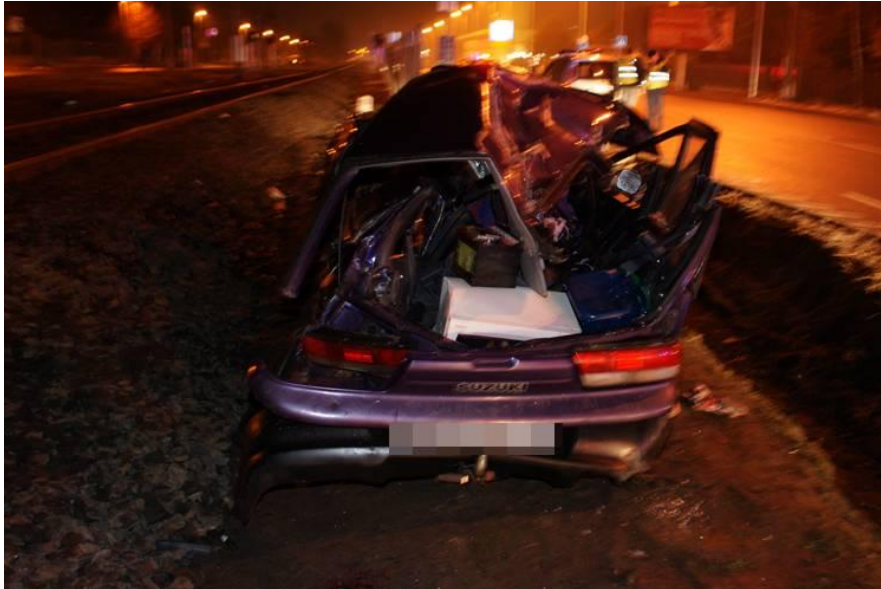
On 9 January 2011 at 16:54 hours, the train No. 2935 collided with an automobile at the unprotected level crossing in Section 135, between Pestszentimre and Kispest stations. The driver of the automobile died, one of the passengers suffered serious, and two suffered mild injuries in the accident.

The driver of the automobile entering the level crossing while in a left turn from Vasút street towards Eke street did not ensure that crossing would be safe prior to entering the level crossing; thus, the occurrence of the accident can be attributed directly to human factor relating to the driver.

Safety recommendation**BA2011-011-5-01A**

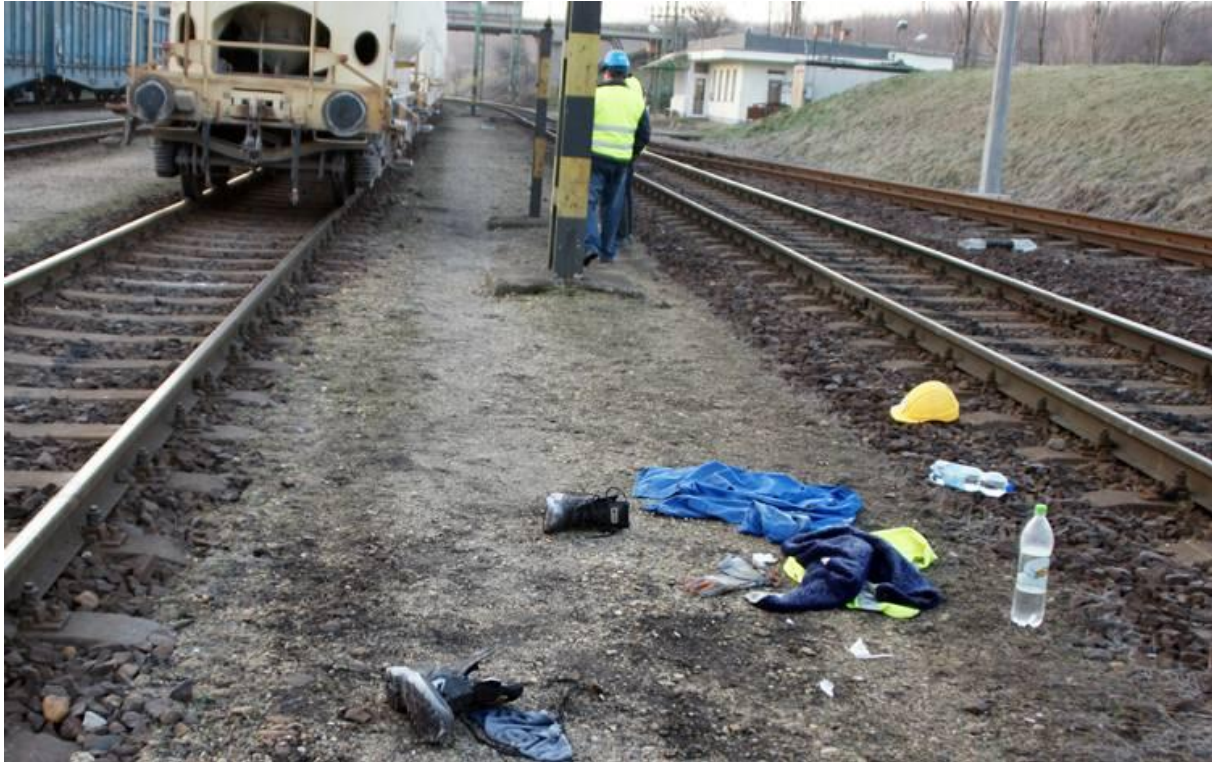
After start of shunting in ME Co.'s own rail network, the foot of the yardman staying at the tail end of the shunting unit got under the last bogie of the last wagon, and suffered a serious mutilating foot injury.

The yardman tried to remove the brake block of the moving wagon from the wheel by foot. In the course of the operation, his foot slipped off the fastening clamp of the brake block, he lost his balance, and his right foot got under the wheel of the wagon.

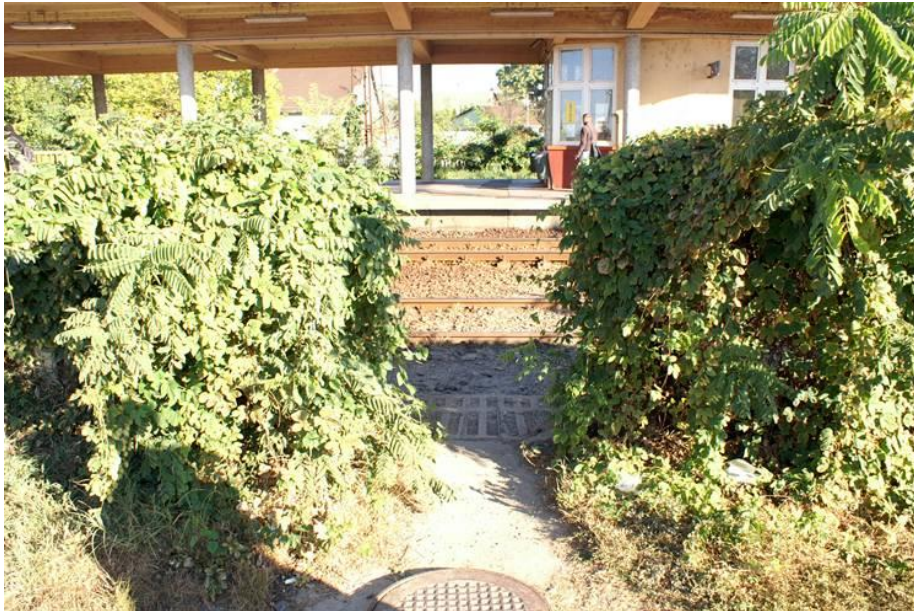
On 20 April 2011, at Gyömrő station, after handling the emergency opening system, a passenger tried to get on the train No. 3258 at the side opposite the side assigned for passengers to get on. In the meantime, the train started, and the passenger's hand was caught by the automatically closing door. The passenger freed his hand, but, as a consequence of that movement, he fell under the train, and suffered severe injuries.

The injured person tried to get on the train No. 3258 at the side opposite the side assigned for passengers to get on, after opening the closed and locked door using the emergency opening system, and tried to get on the train when it was already moving.

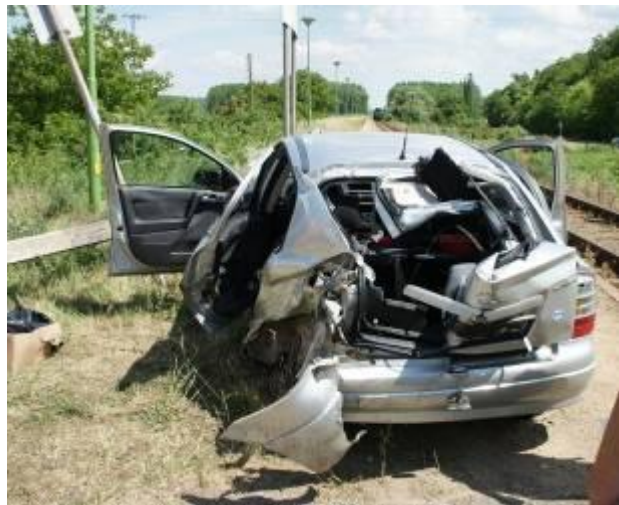
On 6 July 2011, at the stop Mórágypályaudvar between Hidas-Bonyhád and Bátaszék, the light engine No. 38796 collided with an automobile at the level crossing No. AS556 protected by a properly working warning light. As a result of the collision, one of the 5 occupants of the automobile died, 2 suffered serious injury, and 2 suffered mild injury.

- The protective warning light No. AS 556 worked properly at the time of the accident.
- The IC established no excessive speed relevant to the light engine involved in the accident.
- The automobile entered the level crossing, neglecting the operable warning light which was displaying flashing red light in the direction of the road, and thus the cause of the accident can be attributed to human factors related to the driver of the automobile.

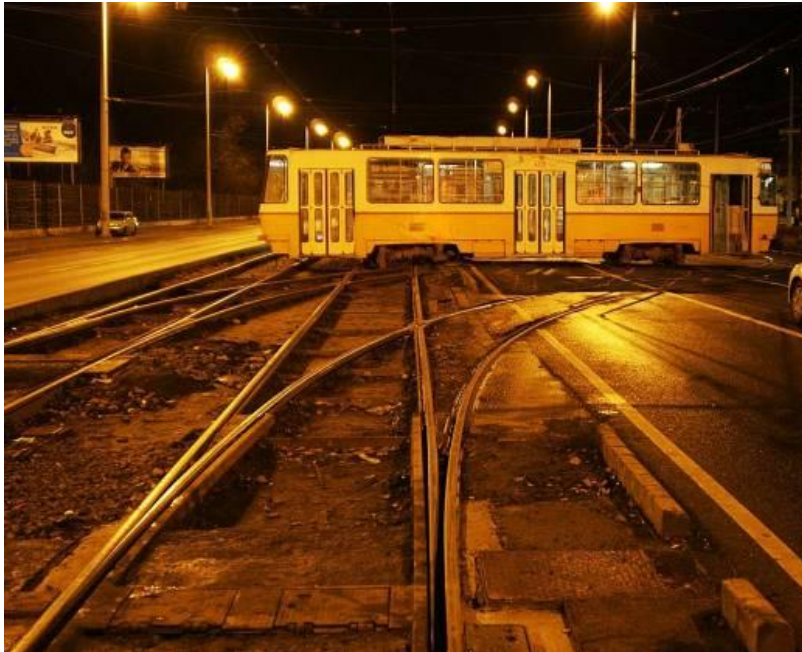
On 5 December 2011 at 19:14 hours, after departure from its stop at Ferencváros railway station, the (last) car, track No. 4220 of the line No 1 (between Rákóczi Bridge and Bécsi Road) derailed with both bogies over the points (in front of the building at 5 Könyves Kálmán Bld., District 5 Budapest) leading to the entry of the Ferencváros Shed, then turned crosswise, and fully blocked road traffic at the right-hand side.

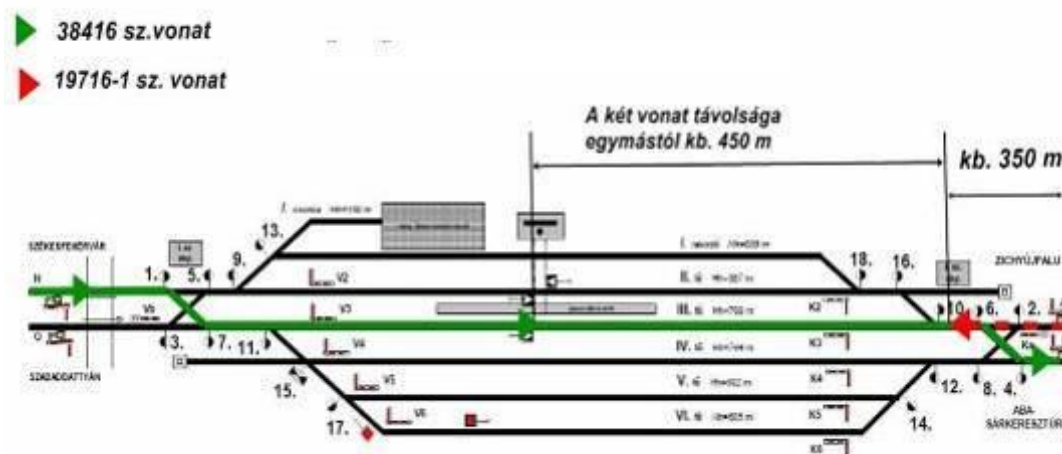
At Börgönd station, a track was set for the train No. 38416 running through, the signal was set up for it, when the pointsman in service at the signal box No. 2 realized that the train No. 19716-1 failed to stop at in front of the entry signal. He set the exit signal, which had previously been set to open position for the train No. 38416, to “Stop!” position, and then ran down outside the signal box, and displayed a manual “Stop!” signal to the train No. 19716-1. In the meantime, the station inspector stopped the train No. 38416 at the traffic control office. The driver of the train No. 19716-1 perceived the manual signal and the inappropriate position of the points No. 6, and used the emergency brake, but could not stop before the points No. 6 and split it open, and finally stopped at a distance of approx. 450 m from the other train.

The case of going past the entry signal A at danger at Börgönd station can be attributed to human factors.

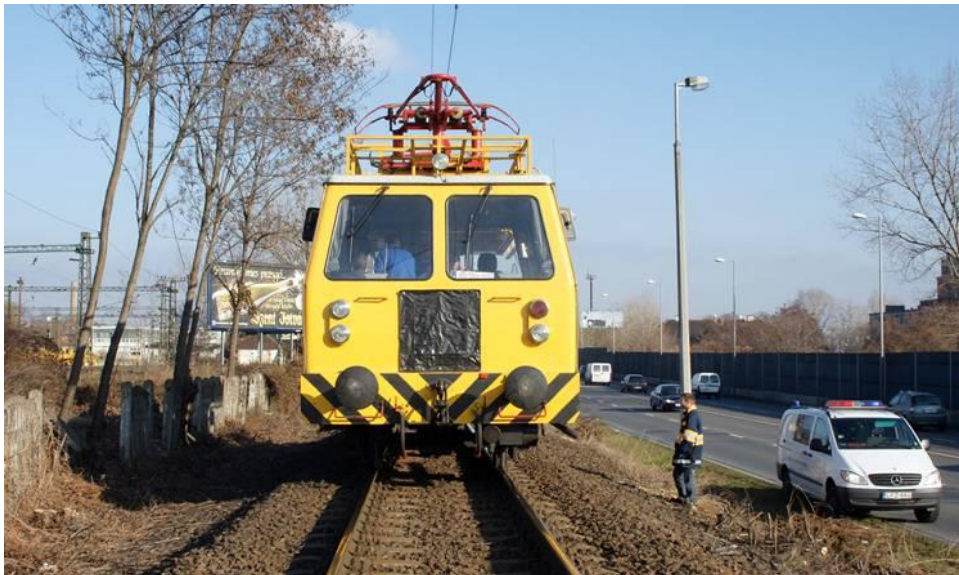
On 13 December 2011, at Albertfalva station, the overhead contact wire maintenance vehicle with track No. 99 55 9436100-9, travelling under train No. 14789-2, passed the exit signal displaying “Stop!” without permission, split the points No. 5 (which was in the straight position) open, left the station, and entered the single-track open line. As a result, it faced the passenger train No. 4657 which was travelling towards the station. The crew of the train No. 14789-2 recognized the danger situation, stopped in the open line section, and gave light signal towards the driver of the train No. 4647 coming from the opposite direction. The driver of the train No. 4647 perceived the danger situation owing to the change in the displayed image on the block system signal, and the two trains stopped at a distance of 1100m between them.

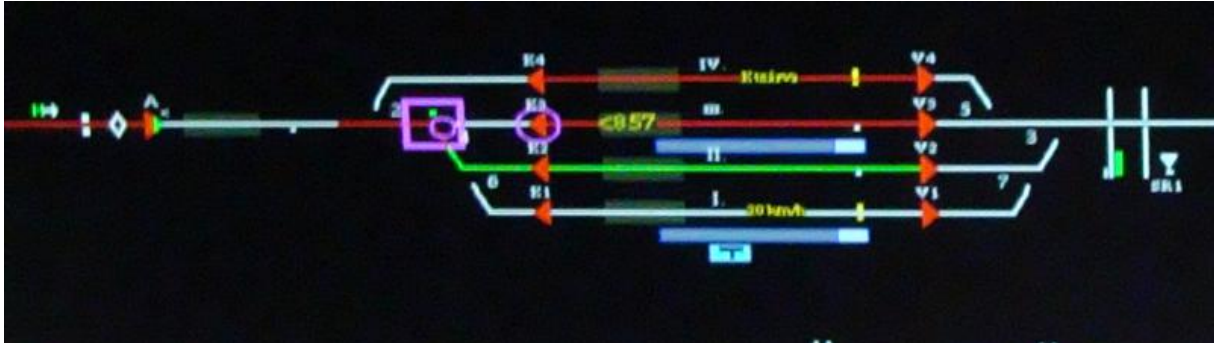
On 25 January 2012 at 10:01 hours at Balatonfenyves station, the train No. 857 passed the exit signal K3 indicating danger along track 3 of the station, and split open the points No. 4 the position of which was inappropriate for this train.

The engine driver perceived the Stop signal on the exit signal K3 from a distance of 20 to 30m. He applied emergency braking immediately, and at the same time, he perceived the points No. 4 the position of which was inappropriate for his train, but his train passed the exit signal K3 and split the points No. 4 open. The train No. 857 stopped at a distance of approx. 490m from the train No. 850 which was staying in front of the arrival signal displaying Stop.

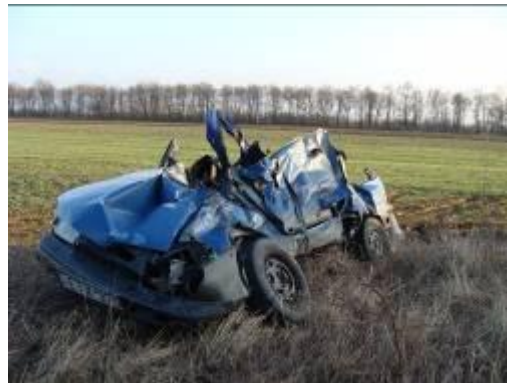
As a consequence of the accident, the driver and a passenger of the automobile died at the site of the accident, and another passenger was taken to hospital with life-threatening injuries. The fourth person in the car suffered mild injuries healing within 8 days.

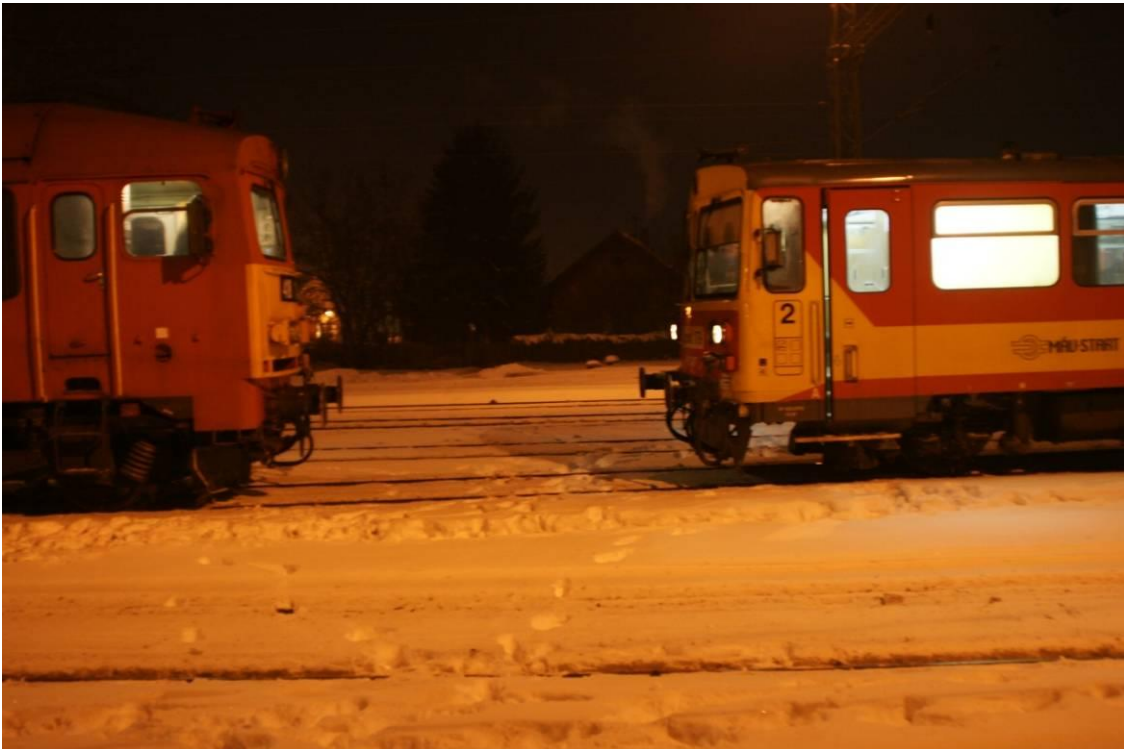
The occurrence caused no personal injury, but the points split open were damaged.

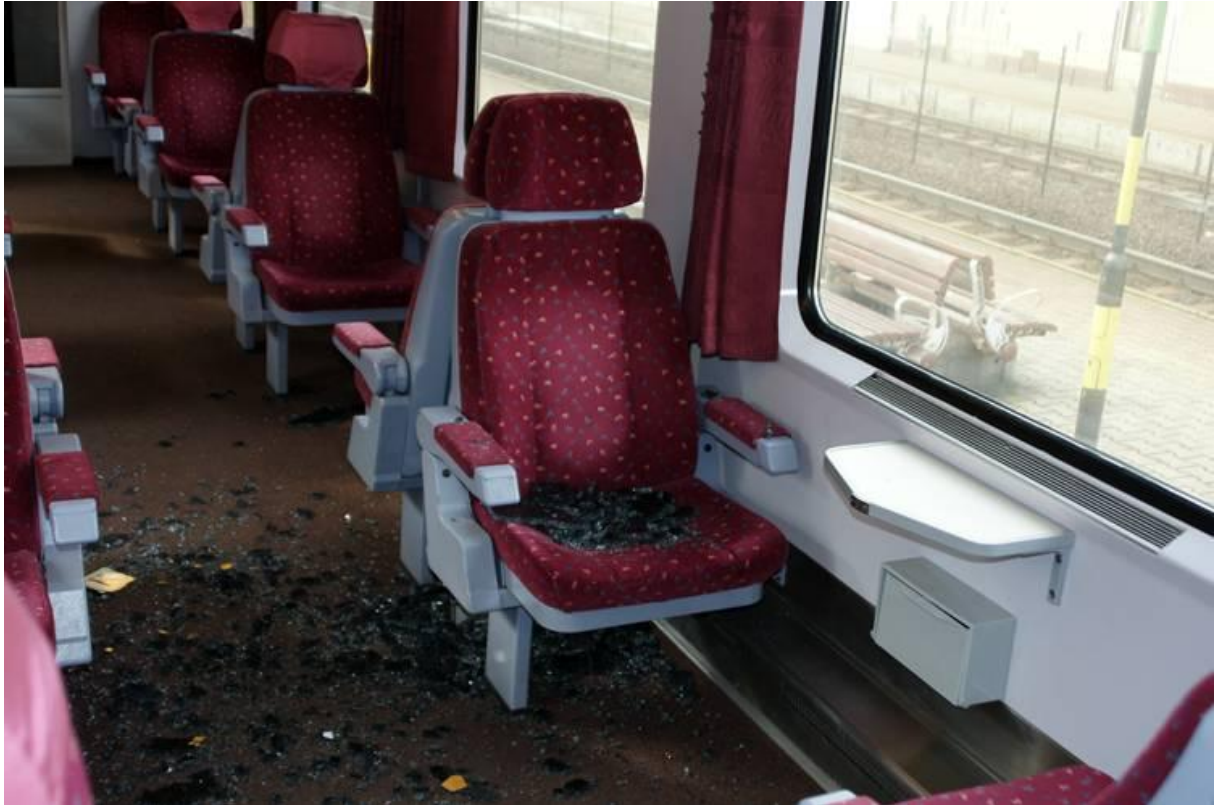
On 19 February 2012 at 09:57 hours, the train No. IC937 collided with the train No. IC917 saying on track No. 5 at during their joining at Csorna station. As a consequence of the collision, 11 passengers were injured, of whom 8 were given care on-site by the ambulance units, and 3 people were taken to hospital for monitoring.

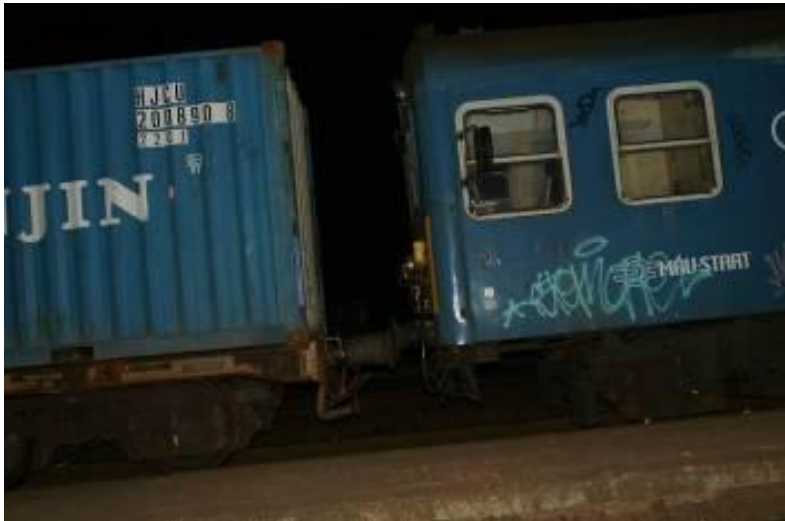
On 15 March 2012 at Tárnok station, the freight train No. 42030-1 shunting from the open track without permit split the points No. 4 open, continued its travel at low speed, and collided with the control car of the passenger train No. 4511 which was staying on track 2. There was no personal injury.

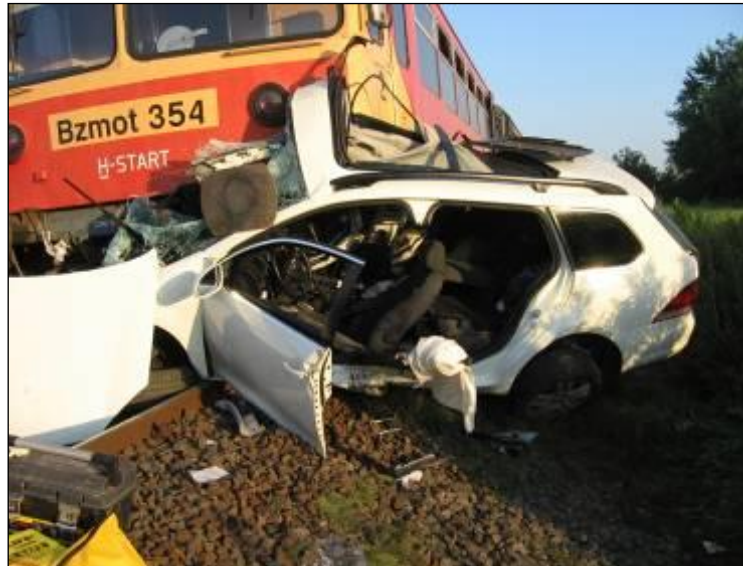
As a consequence of the accident, three of the seven occupants of the automobile died, three suffered severe injuries, and one suffered mild injuries. The car was damaged beyond repair.

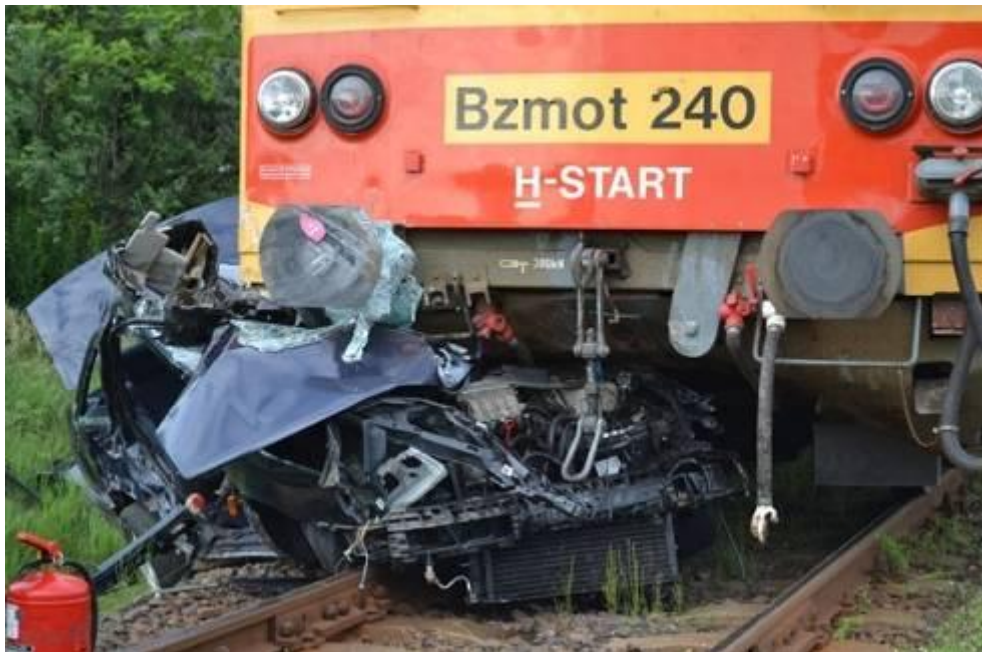
On 26 May 2012 at 16:14 hours the railcar (type Bzmot) with track No. 90 55 5429 240-9 of the train No. 37214 collided with an automobile at an unprotected level crossing in the railway section 624+80 between Lakitelek and Kiskunfélegyháza stations. As a result of the collision, the driver of the automobile died on the spot, and the passenger travelling on the front left seat suffered severe injuries healing beyond 8 days. The automobile got stuck under the railcar, and was damaged beyond repair. None of the passengers on the train was injured.

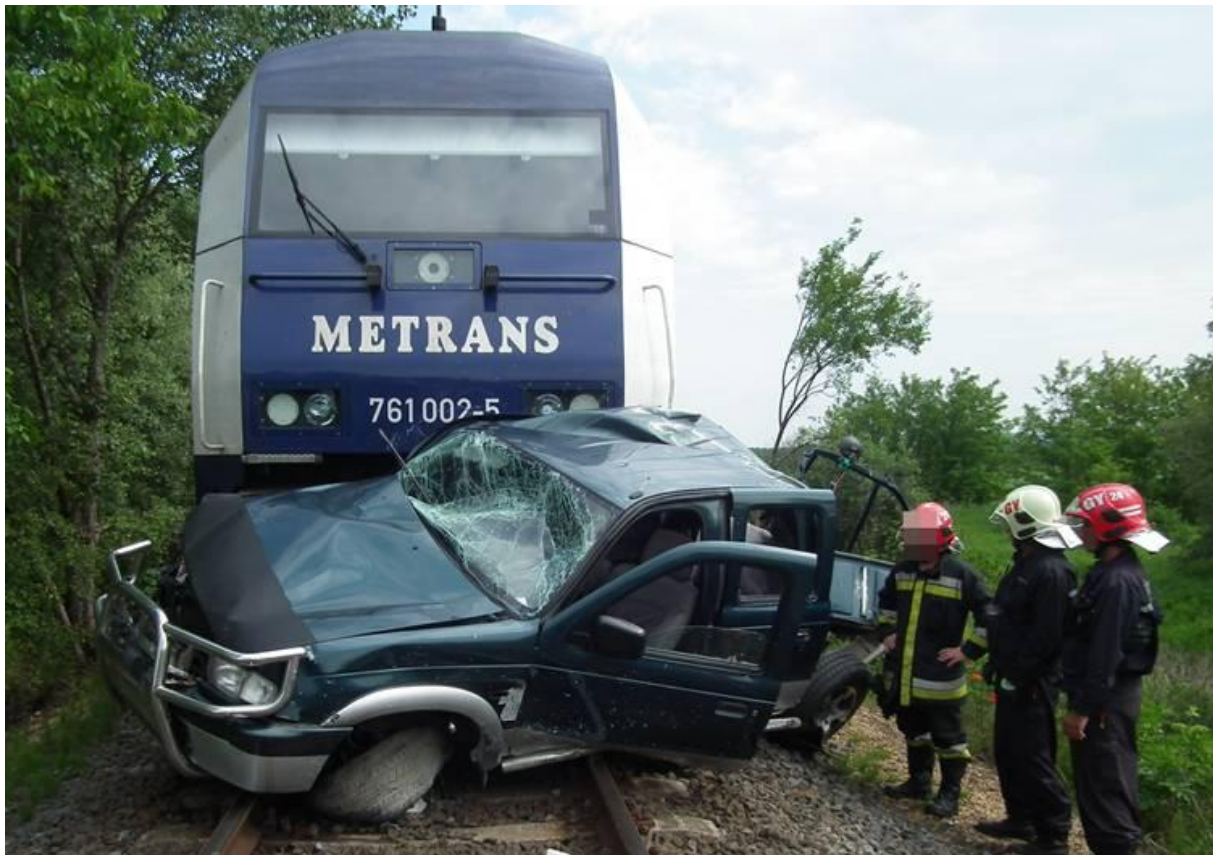
On 31 May 2012 at the level crossing No. AS 175 protected with warning lights between Győrszemere and Gyömöre stations, a freight train collided with an automobile. The driver of the automobile died on the spot.

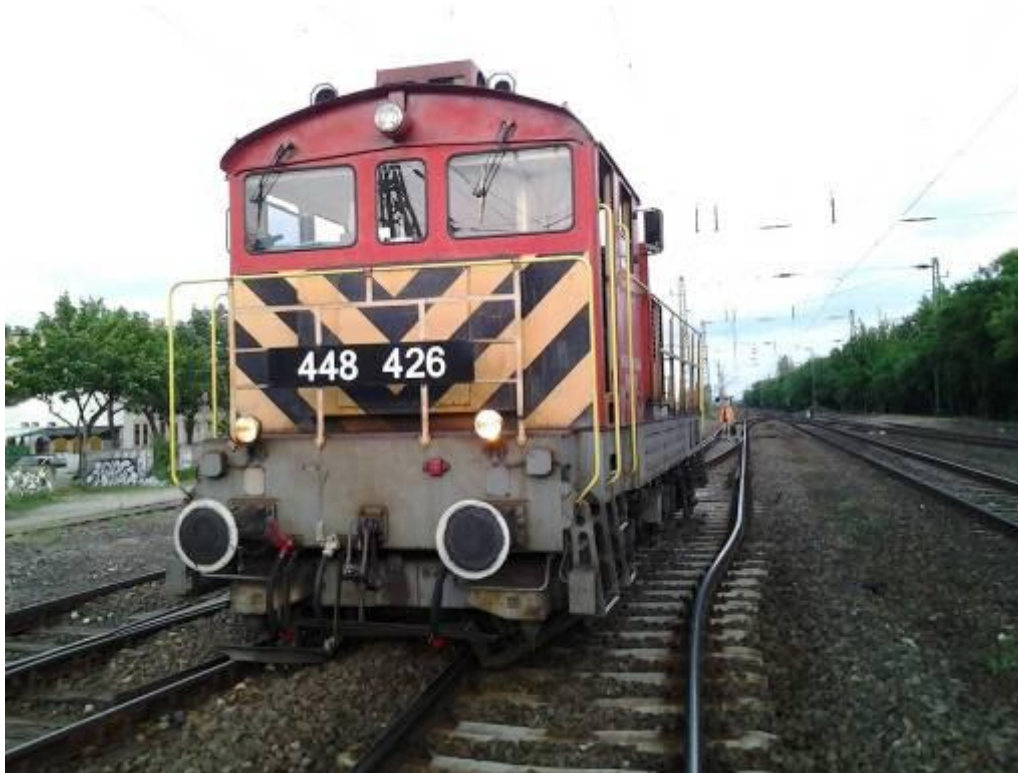
On 05 June 2012, at about 20:12 hours, the locomotive No. 21661 (track No.: 98 55 0448 426-5) arriving at track 7 of Kőbánya Freight Yard derailed with all four axles at points No.7 set to turnout direction.

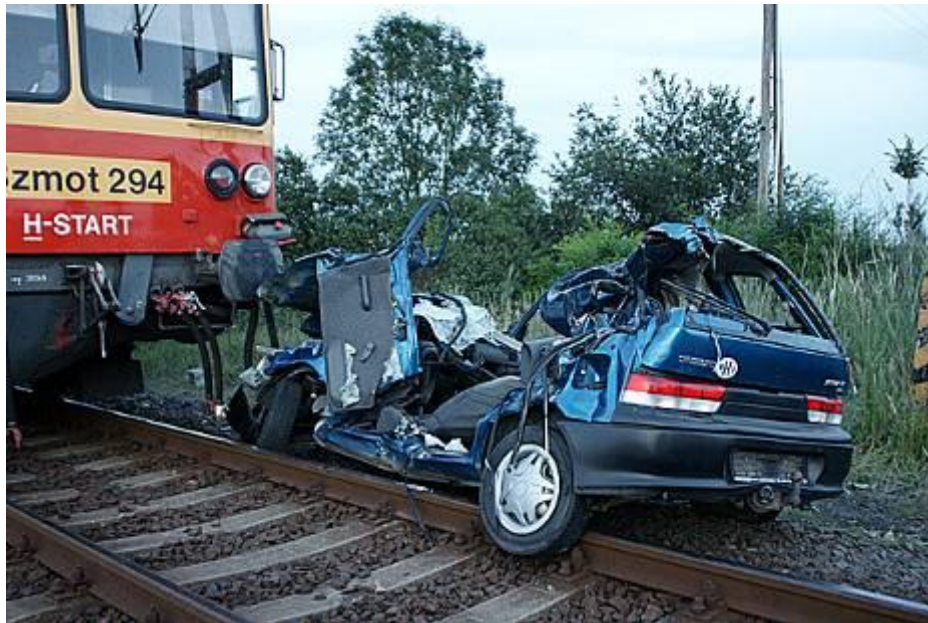
Due to the accident, the driver and the passenger of the automobile died on the spot. None of the occupants of the train were injured.

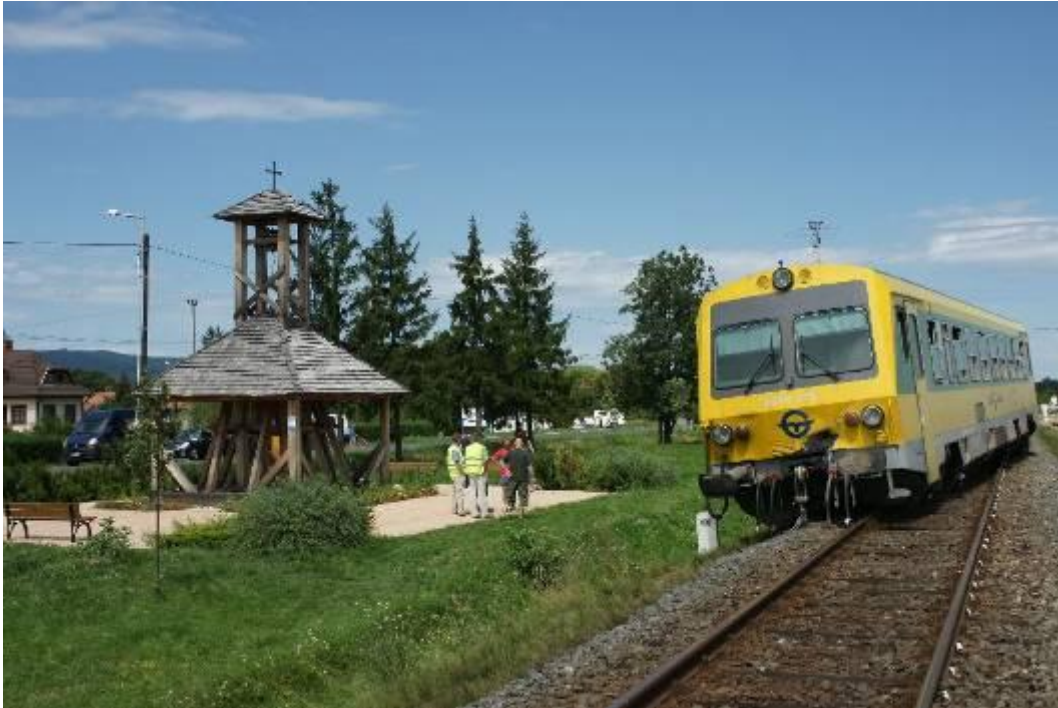
The driver of the grader and a passenger of the train suffered severe injuries, and another passenger had milder injuries.

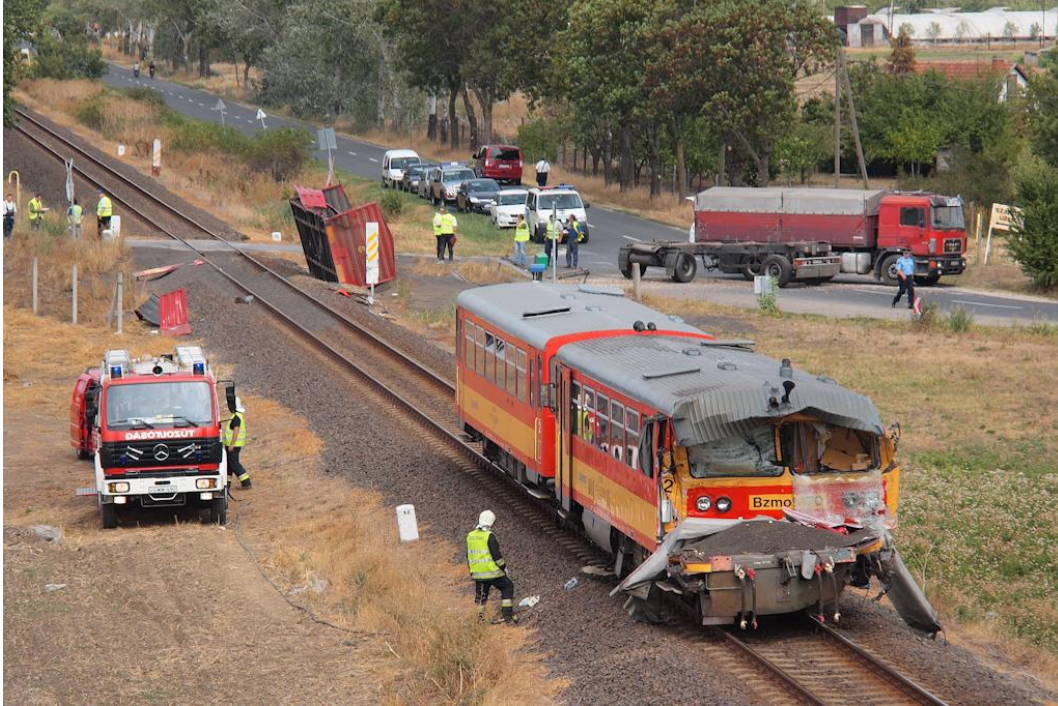
Due to the accident, the ticket inspector in charge and three passengers of the train suffered mild injuries.

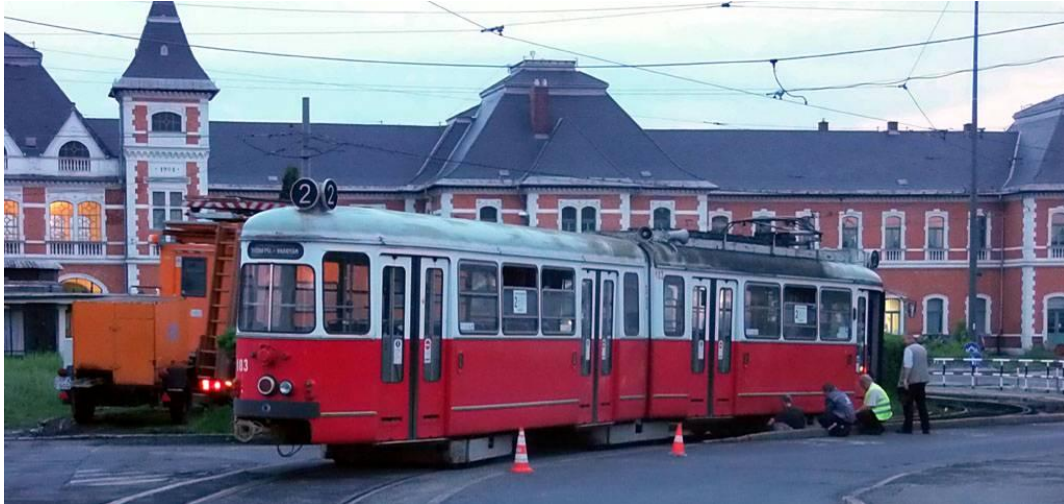
On the evening of 25 February 2013, and again on the morning of 26th, the tram type SGP E1 (track No.: 186) derailed, at the same location, in the arrival curve of the Tiszai station, at its terminal station in the Miskolc network; the same incident occurred again on 07 May with another tram (track No. 183).

As the affected track section (which very probably is a unique location according to the investigation) will be reconstructed in the near future, and the affected vehicle type will be withdrawn from service, it is unnecessary to issue a safety recommendation in connection with the occurrence.

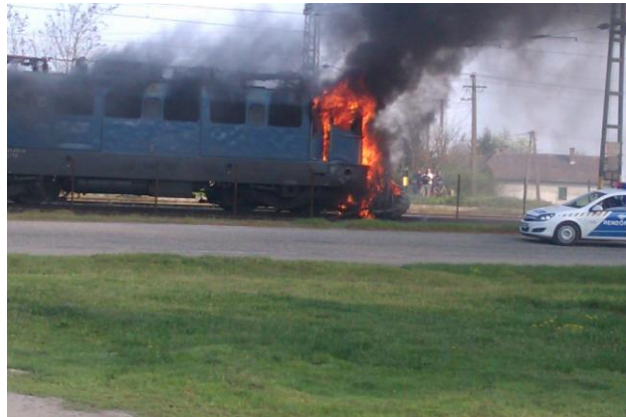
The train No. IC 806, approaching Sárossd station, collided with an agricultural tractor at the correctly working level crossing (No. SR2) of the station. As a result of the collision, the driver of the agricultural tractor died, and the driver of the locomotive of the train suffered mild injuries. The agricultural tractor caught fire and was destroyed, and the fire spread onto the locomotive, and the locomotive was damaged beyond repair. The first four passenger wagons were also damaged.
