**TRANSPORTATION SAFETY  
BUREAU**

**ANNUAL REPORT 2015**  
**Transportation Safety Bureau**  
**Hungary**

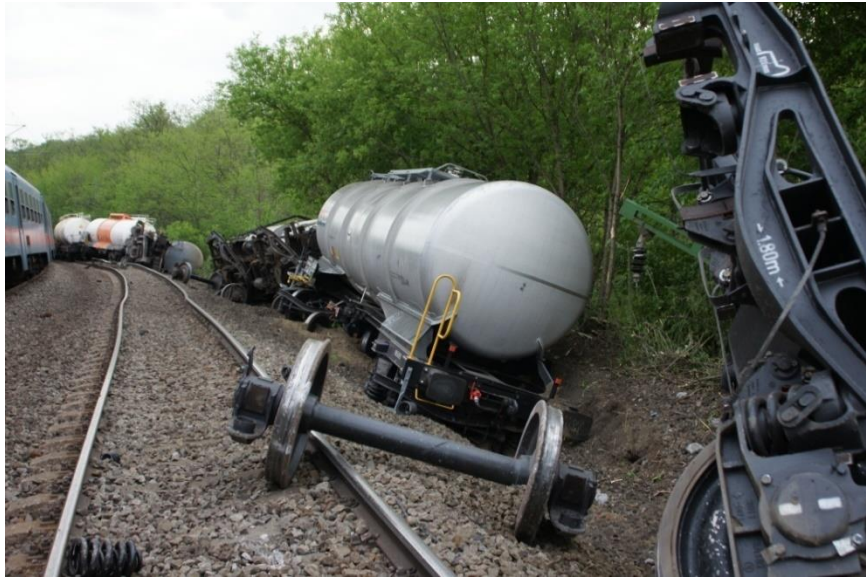
### 2012-315-5:

The last six wagons of the train No. 90552 running between Ferencváros and Miskolc derailed on the right-hand side track in section 398+80 between Gödöllő and Aszód stations; five of them left the track and tipped to their side. No one was injured.

The derailed wagons had carried hydrochloric acid; they were empty but uncleaned at the time of the accident. The IC attributed the accident to a combined effect of track defect, the system of introduction of speed limits, and human factors.

Based on the facts explored, the IC issued a safety recommendation relating to the revision of the track maintenance system.

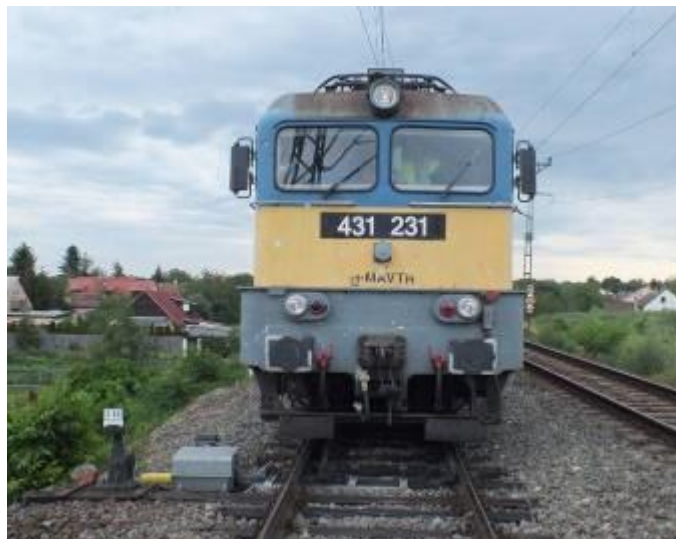
**The train that stopped on the points**

The train No. 4560 running the line Budapest-Déli pályaudvar – Érd Felső – Székesfehérvár passed the Stop! signal displayed by the entry signal F at Tárnok station, then went on, burst the points No. I/14 open, and stopped on the points. At the time of the incident, an entry route was set for the train No. 19712 arriving from the direction of Érd Alsó. When realizing the occurrence, the traffic manager at Tárnok station issued a Stop! signal to the entry signal for the train No. 19712, so the train stopped in front of the signal.

The IC attributed the occurrence to human factors on the part of the locomotive driver and the senior ticket inspector, but also mentioned indirect causes such as the role of a human factor related to the traffic manager at Érd-elágazás and Tárnok station, the poor visibility of the signal in Section 14, and some shortcomings of the notification to locomotive drivers.

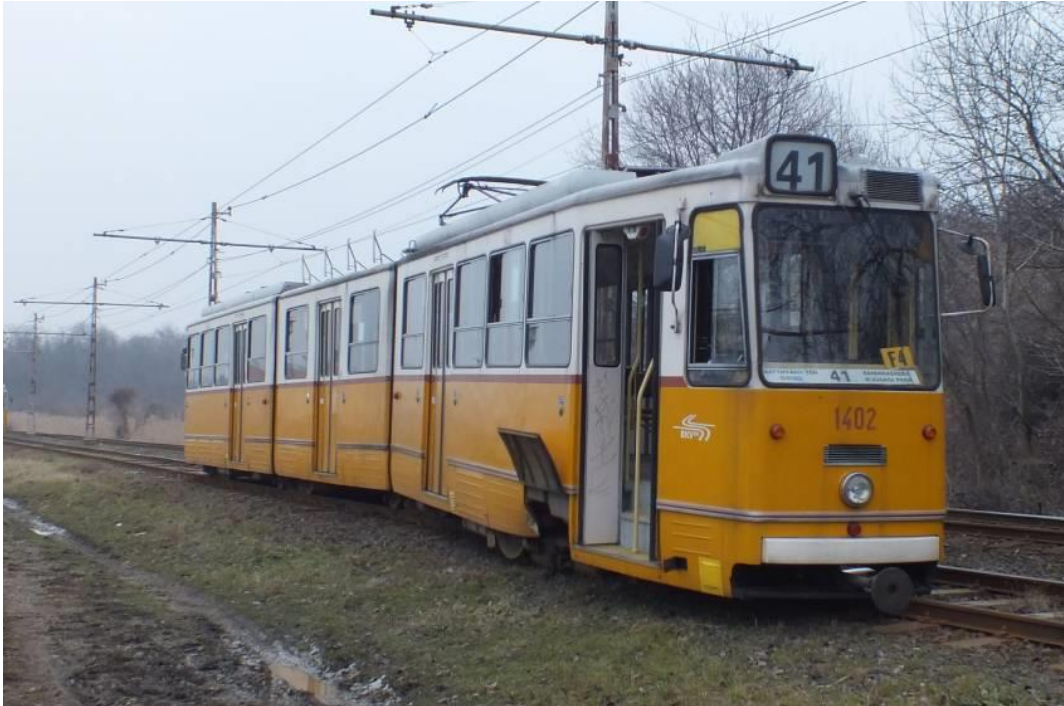
The investigation could not find clearly the reason why the rim came off the wheel, but probable contributory factors were the material of the rubber elements in the wheel, and the irregular fluctuations of the deflective forces and the driving and braking momentums acting on the wheel.

The IC also concluded that the tasks of traffic management, reporting of technical malfunctions and service organising are commingled. The crew receiving notifications of technical defects do not have the necessary technical knowledge, which contributed to the distortion of the information on a starting hazardous defect, and so no action could be taken in time. Relating to that, the IC reaffirms a safety recommendation issued earlier.

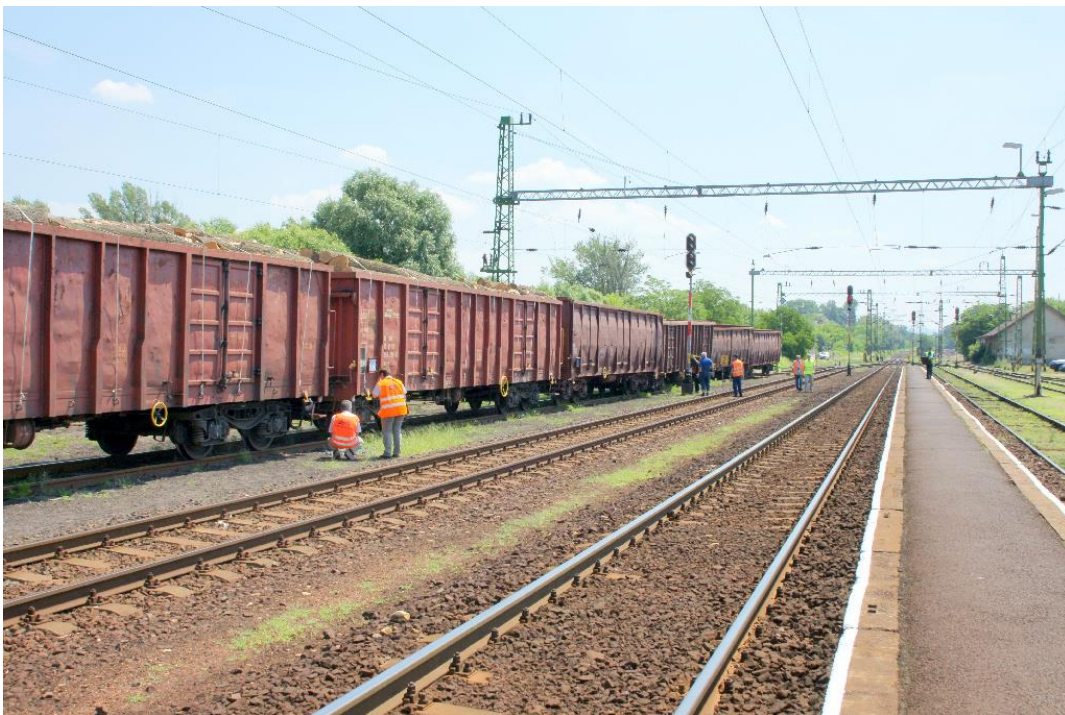
There had been a gauge widening in the rail track at the location of the derailment, and the track structure could not resist the impacts which caused additional flexible gauge widening. The wheel dimensions of the wagon complied with the requirements.

TSB upholds an earlier safety recommendation relating to the dimensional specifications for turnouts, and issues a new recommendation relating to the inspection of the operation of the safety management system.

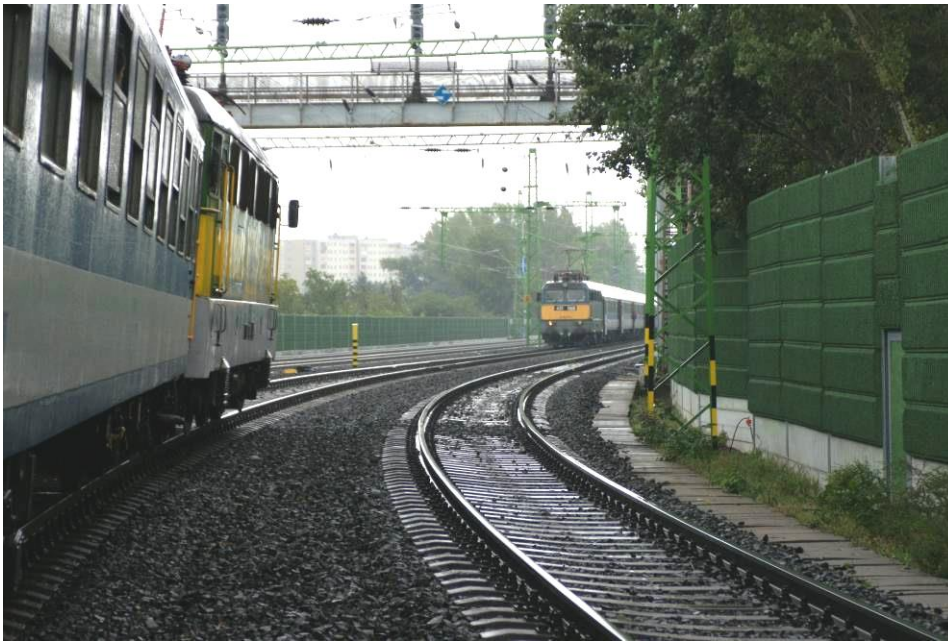
Factors contributing to the occurrence were the lack of reduction of the track capacity to the extent justified by the current traffic situation, the inappropriate traffic management at Kelenföld Station, as a result of which subsidiary signals were issued (or issuance was ordered) to three signals (two exit signals and one home signal) almost simultaneously at the down side end of the station, which is not allowed.

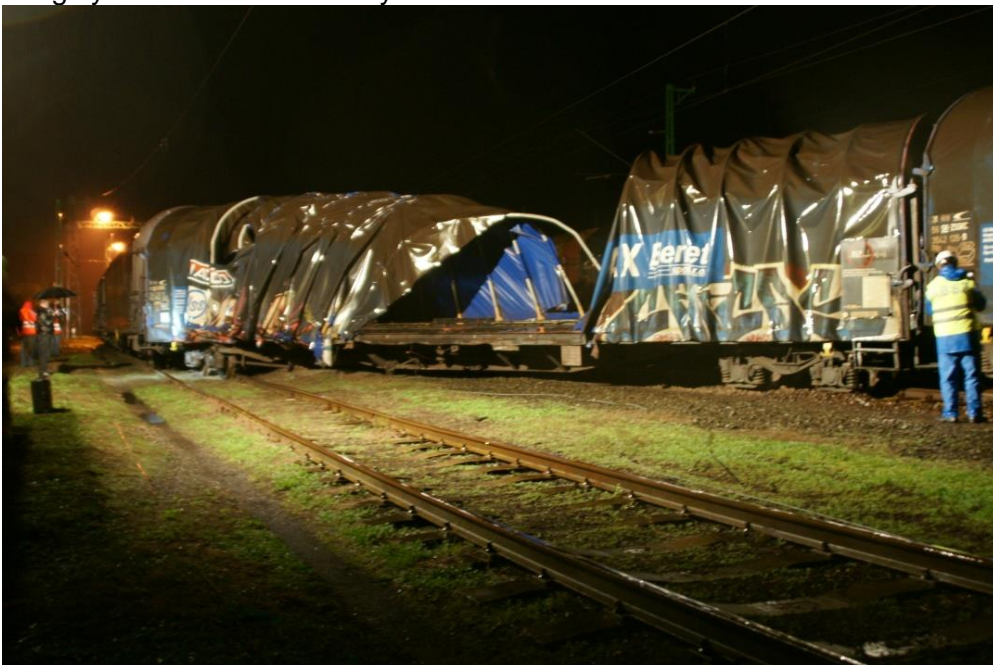
The IC attributed the occurrence to human factors on the part of the pointsman, as he did not wait for the train to arrive completely but started the process earlier using the safety installation, so the points finally began to work under the running train.

The IC found it unnecessary to issue a safety recommendation but the occurrence offers several lessons to learn, so the IC suggests that it should be included in the training syllabus as a case study.

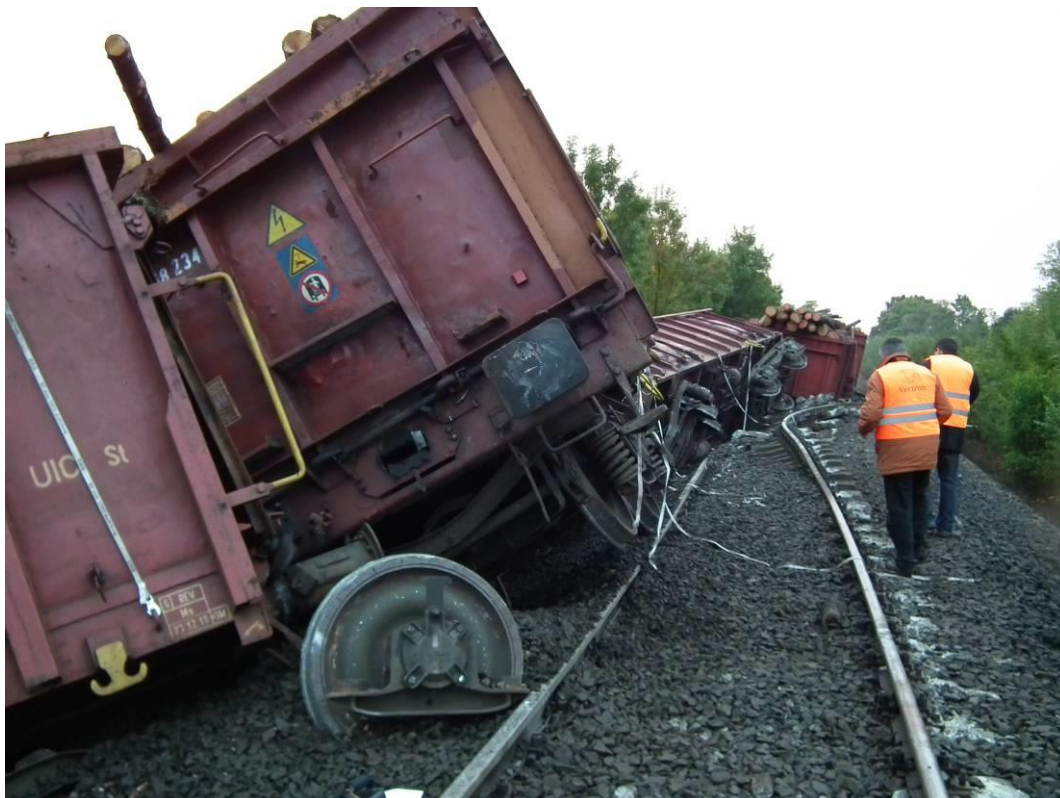
A further precondition of the actual derailment was the irregular operation of the running gear of the freight wagon: the turning motion of the bogie was hindered.

There was excess cant beyond the limit in the rail track at the location of the derailment, plus a plane distortion with an extreme value of ca. 40 mm which could actually be measured against the bogie pivot pitch of the derailed wagon.

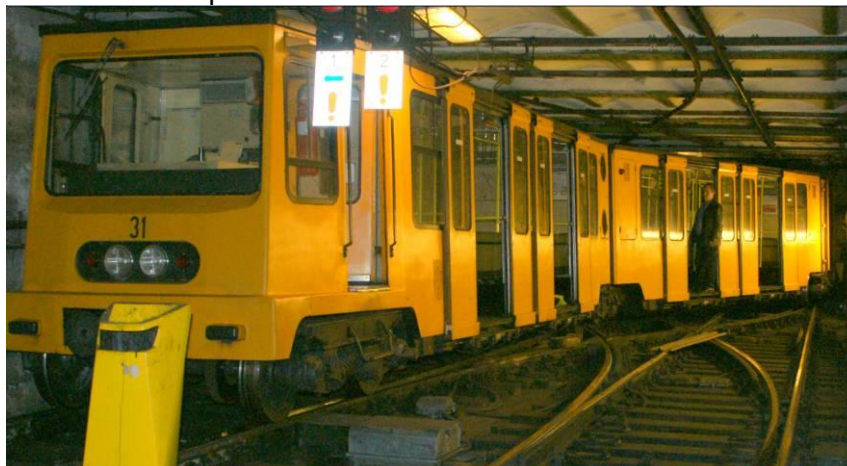
Due to its design, the wheel flange lubrication equipment installed on the Millfav vehicles is ineffective in the switching zone of Vörösmarty square.

National Transport Authority disagreed with the contents of the safety recommendation issued, but BKV Ltd. implemented it. No more derailments have occurred.

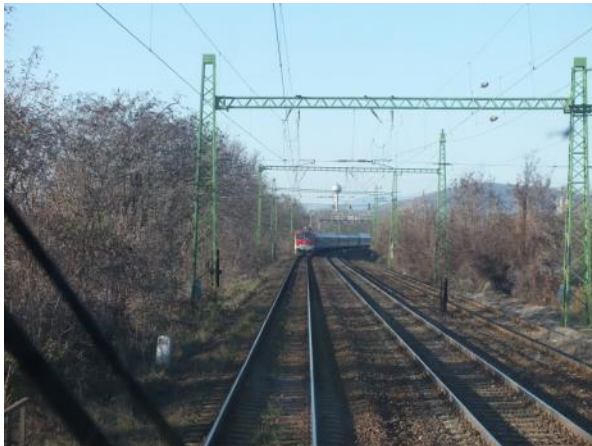
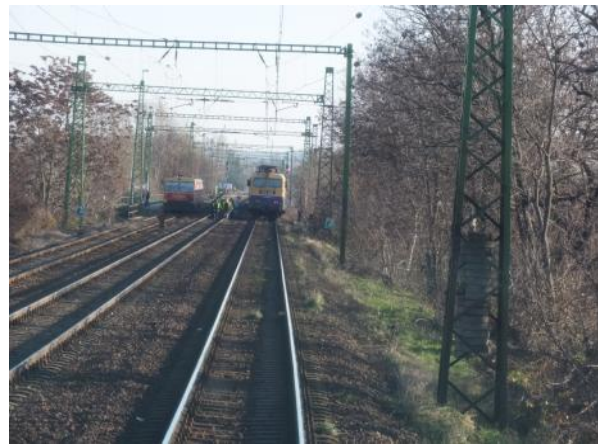
The employees working on the track evoked an apparent occupation signal by moving their manual vehicles improperly.

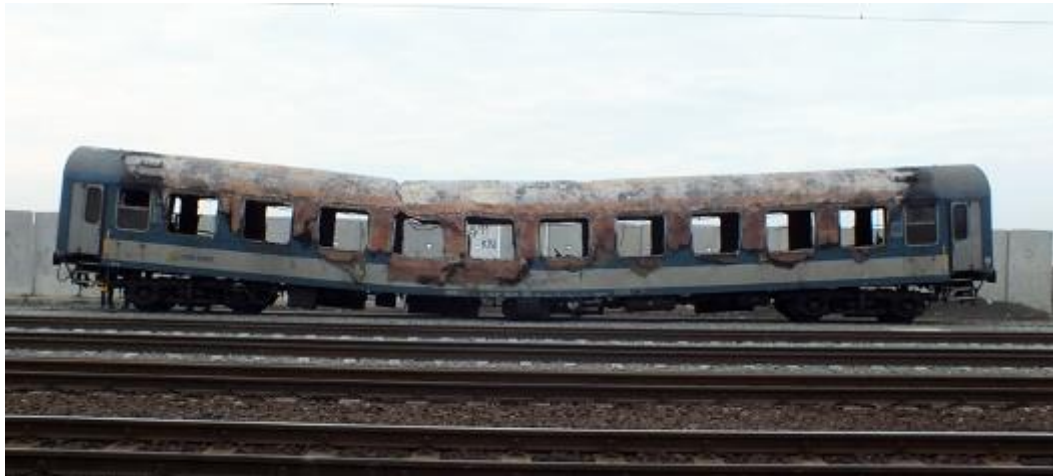
Deliberate fire-raising cannot be fully excluded but the investigation found no evidence to support this suspicion.

The condition of the safety system of the heating system of the wagon affected in the occurrence probably was not good enough before the occurrence to efficiently intervene into the operation of the system in the case of a possible malfunction of the heating system.

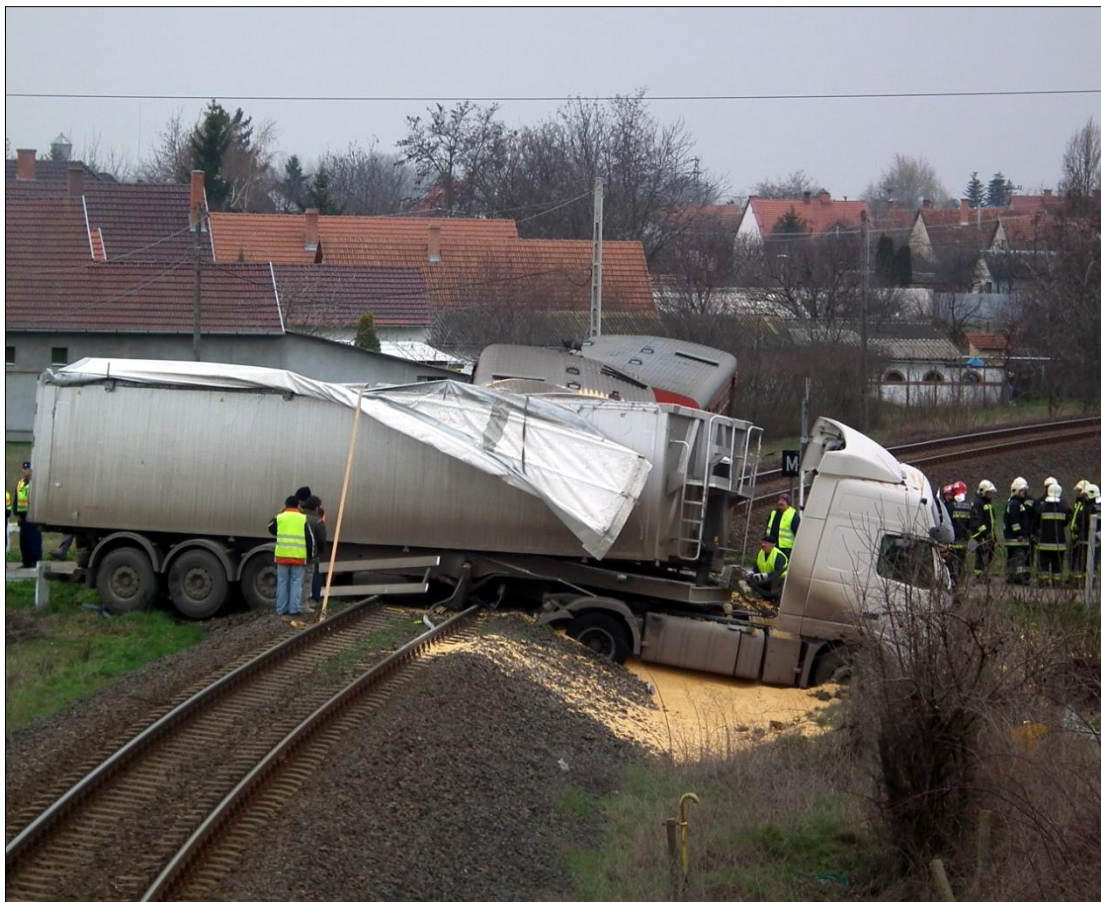
The layout of the road relevant to elevation allows a low structural element of a road vehicle to get caught on it.

During the technical investigation, the TSB issued a safety recommendation to the Inspectorate of Transport of Csongrád County Government Office. The Inspectorate had taken action to have the level crossing repaired and provide the sight triangle independent of this. The Government Office ordered the affected parties to perform the aforesaid measures.

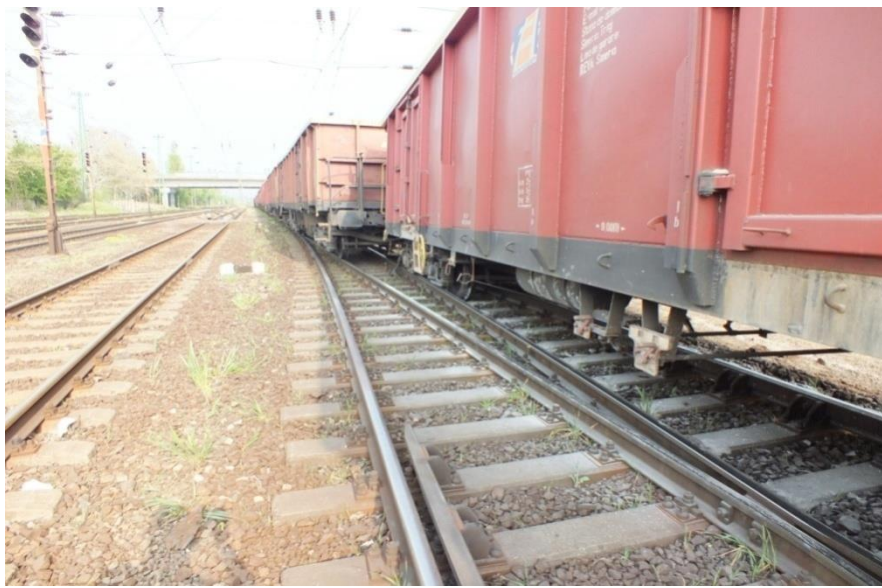
During the investigation, the IC found that, as a consequence of incompliance with the rules of electric arc welding, the load-bearing surface of the bearing was damaged, as well as the rolling elements. Those damages were not explored, and the process of wearing became faster during subsequent use, which led to extreme heating and malfunction of the bearing and, as a consequence, to breakage of the axle journal.

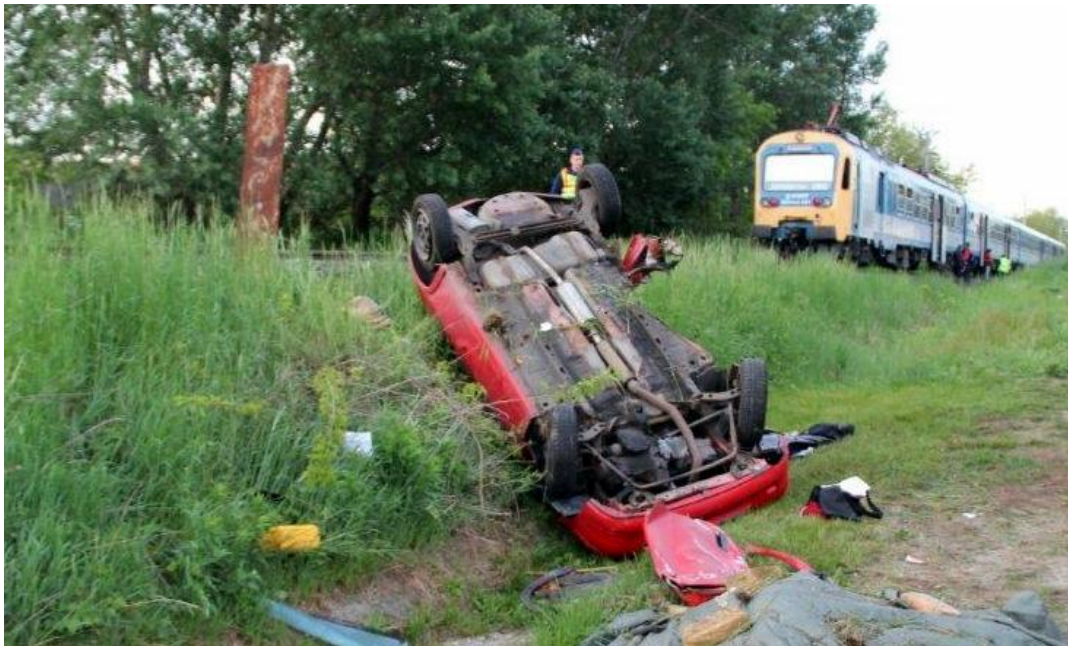
The IC revealed shortcomings in connection with the layout of the level crossing which did not contribute directly to the accident but implies safety risk in itself; for this reason, during the investigation, the TSB issued a safety recommendation suggesting immediate action.

Despite the fact that a train was approaching and it could have been seen from appropriate distance, the car accessed the level crossing and could not leave it before the train arrived there.

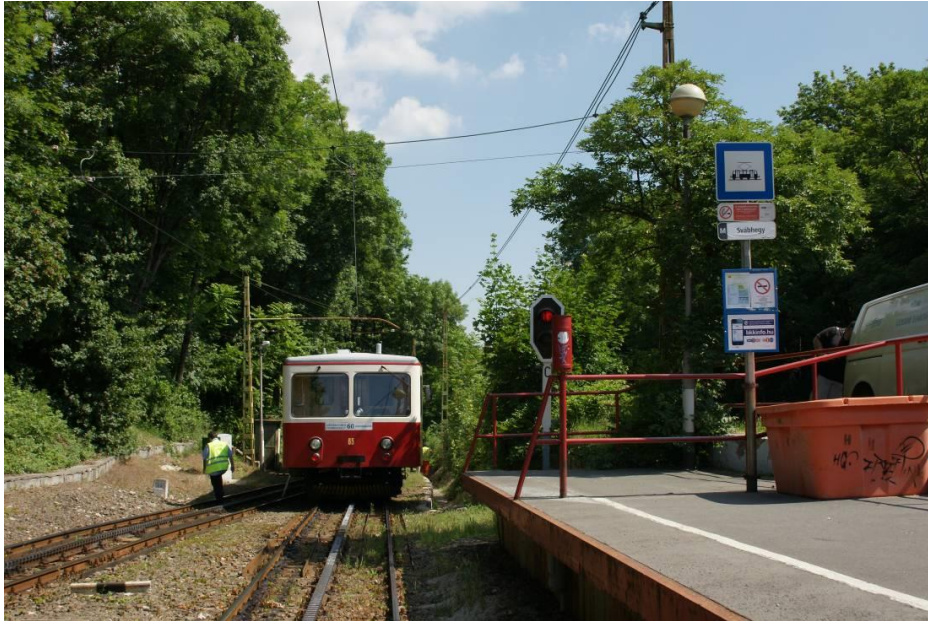
The IC found that the said departure was also influenced by the fact that, after the arrival of the train from the opposite direction, the screen of the FUTÁR equipment displayed the instruction “Kérem induljon” (Please start”). In the meantime, however, the Signal C protecting the block section showed the danger aspect, and the Point No. 2 situated in the path of the train had not been set up for the train No. 2-08 yet.

The driver started the train without checking the “Stop” aspect of the light signal or checking the position of the points.

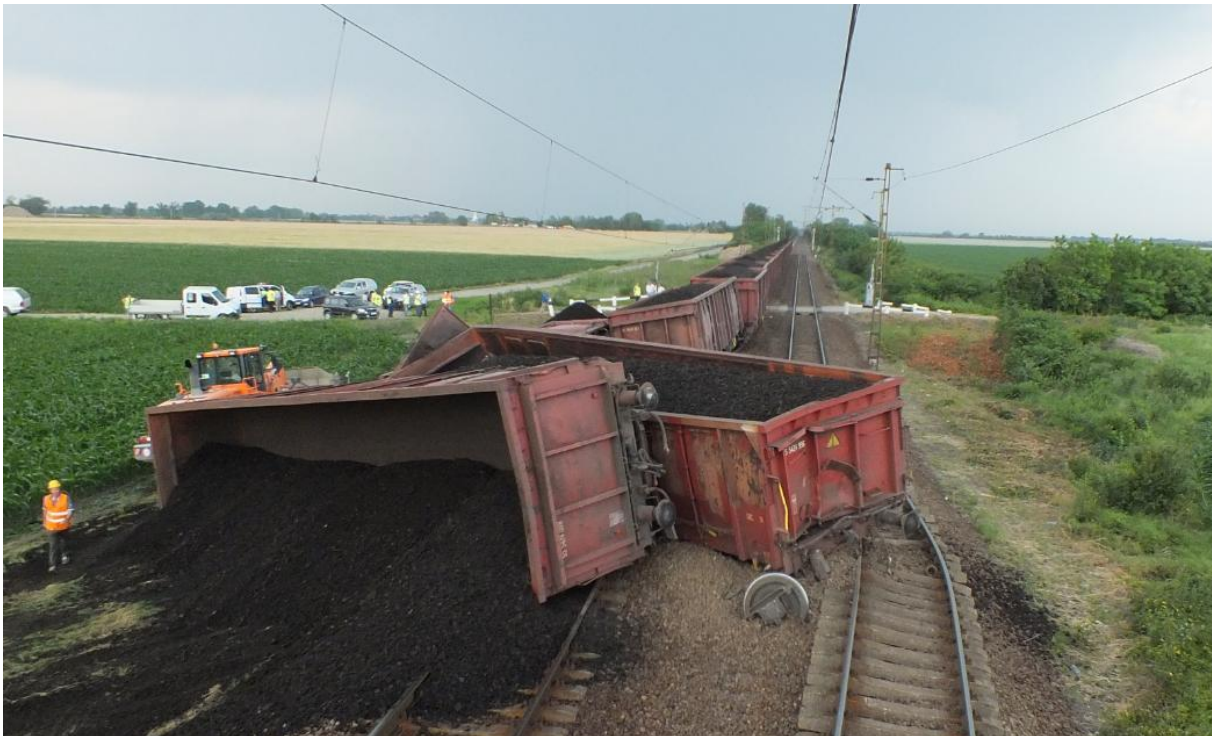
The investigation performed by the IC found that the axle journals and the inner rings of the associated wheel bearings were not fitted properly. It was clearly seen with the occurrence No. 2014-0572-5 that pitting formation occurred on the tread surface and rolling elements of the bearings due to non-compliance with the requirements of electrical arc welding performed during maintenance sessions. As a result, the wearing process became faster, which led to malfunction of some bearings.

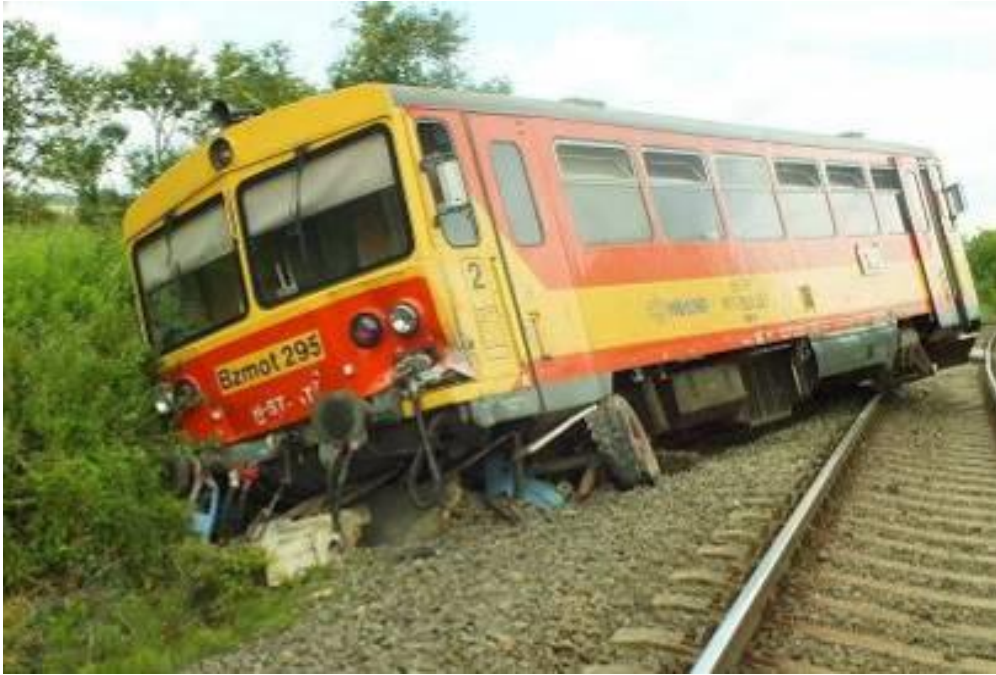
In the course of the technical investigation, the IC concluded that the reduced sight triangles are not available at the scene of the accident. The length of the road combination vehicle and the lack of the sight triangle did not provide safe crossing at the level crossing. The agricultural tractor entered the level crossing when a train was approaching, and was not able to leave the level crossing before the train arrived. The lack of sight triangles increased the danger of accident, and made crossing impossible for a longer combination vehicle.

The agricultural tractor accessed the level crossing when the train was approaching, and the tractor was not able to leave the crossing before the train arrived.

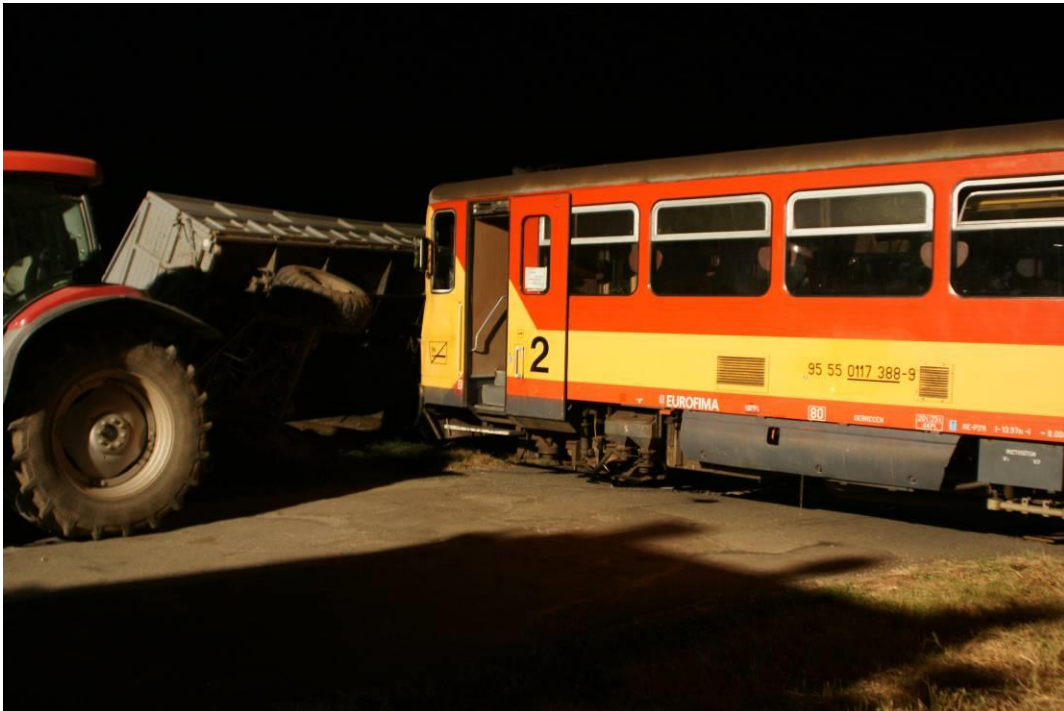
The motor car of the train no. 36913 running between Karcag and Kunmadaras was on its way to Karcag when it collided with the trailer of an agricultural tractor at an unprotected level crossing in section No. 35. The motor car derailed due to the collision, and its driver had mild injuries. None of the road vehicles was damaged. The IC attributes the occurrence to human factors on the part of the driver of the road vehicle. The layout of the level crossing complies with the relevant rules, but the traffic signs, warning of the level crossing from the direction of the arrival of the road vehicle, as well as the “Start of level crossing” sign, do not comply with the applicable regulation.
