MINISTRY OF
NATIONAL DEVELOPMENT
TRANSPORTATION SAFETY
BUREAU OF HUNGARY

ANNUAL REPORT 2016
Transportation Safety Bureau
Hungary

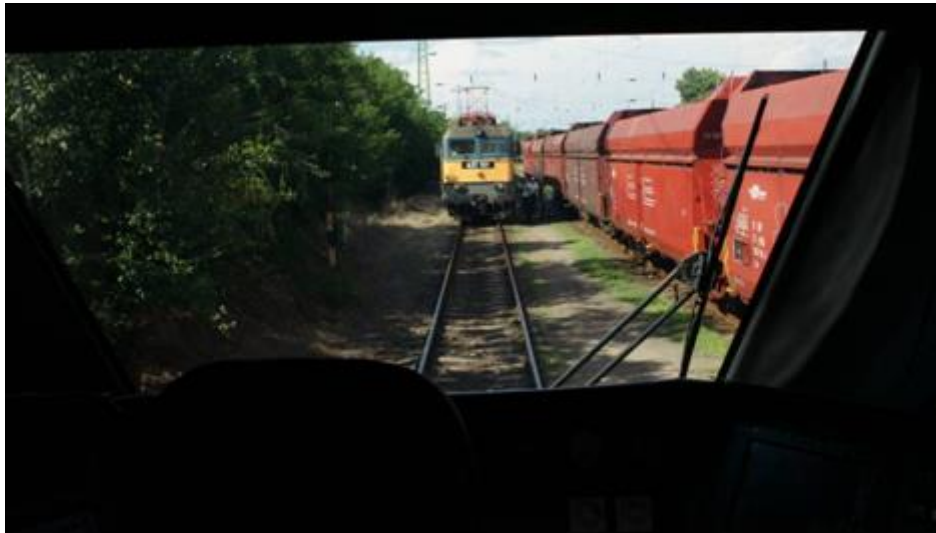
Figure 1: The train № 2135 as photographed from the locomotive driver's cabin of the train № 2364

The IC attributed the occurrence to human factors on the part of the locomotive driver of the train № 2135, to the operation of the train control system of the locomotive of the train, and to human factors on the part of the traffic manager personnel.

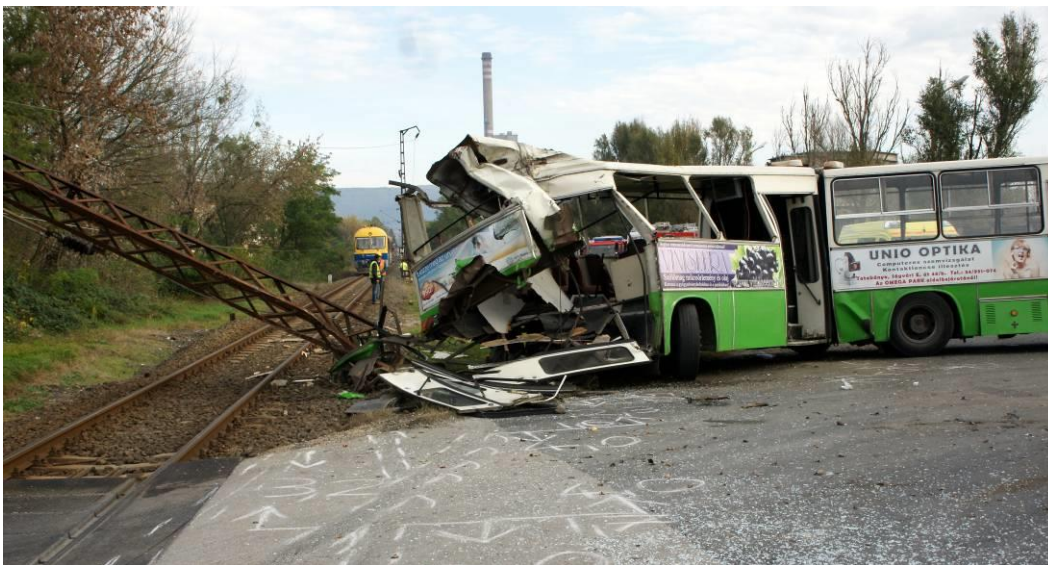
Factual statements directly related to the occurrence of the event

The IC attributed the occurrence to human factors on the part of the bus driver, because he entered the level crossing with the warning lights giving alternating red signals, and was not able to leave the level crossing before the train arrived.

TSB Hungary recommends the Mayor's Office of Tatabánya City of County Rank as operator of the road infrastructure to reconstruct the bus turn-around in Környei street, as well as its pattern of traffic in such manner that the drivers of the vehicles arriving from there should not be forced to check the conditions of safe crossing of the main road and the level crossing concurrently.

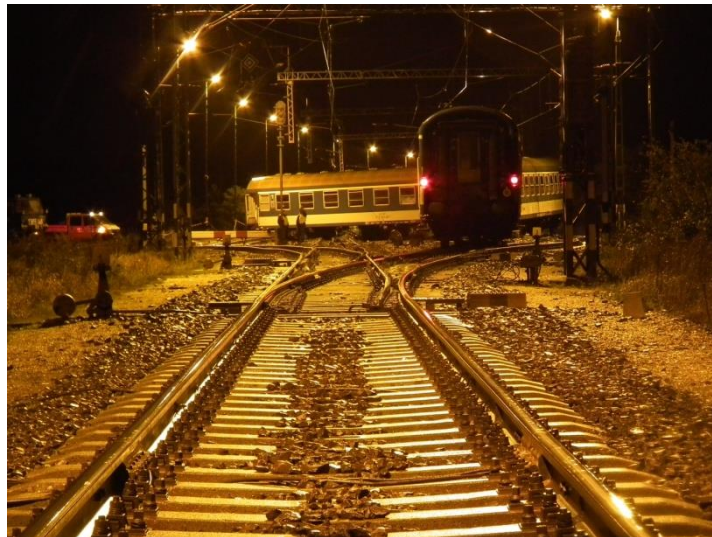
The IC found that the primary cause of the occurrence was a collision with a wild animal. Inadequate maintenance of the locomotive as the direct cause led to the derailment accident which had significant consequences; otherwise it would probably have been an incident with negligible consequences. Shortcomings of maintenance were also found in the track maintenance area, and those also contributed to the incident indirectly. The collision with the wild animal would have negligible consequences in the case of proper maintenance.

Factual statements directly related to the occurrence of the event

The IC attributed the occurrence to the following direct causes:

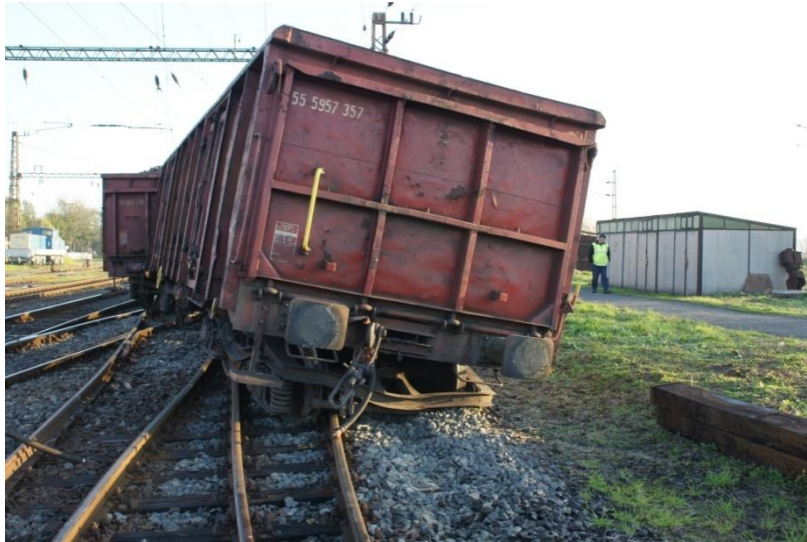
The investigation found that the derailment of the wagon (Reg. №: 31 55 5977 357-3) in the freight train № 63871-2 was caused by the fatigue breakage of its leading axle.

Factual statements directly related to the occurrence of the event

The IC attributed the occurrence to the following direct causes:

the breakage of the axle pin was the consequence of a fatigue process caused by the cyclically repeated mechanical load.

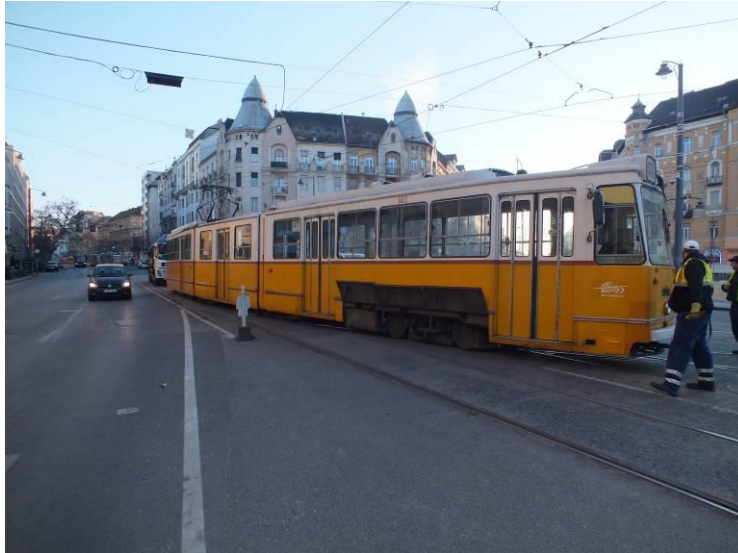
Factual statements directly related to the occurrence of the event

Due to the worn-out condition of the railway track, the groove of the left (inner) rail was worn, weakened, and broke along the track which had been providing a widened tread for a considerable time, and consequently, both wheels of the tram became unguided, and the tram derailed.

The reconstruction of the track section involved in the occurrence is scheduled to commence in 2016.

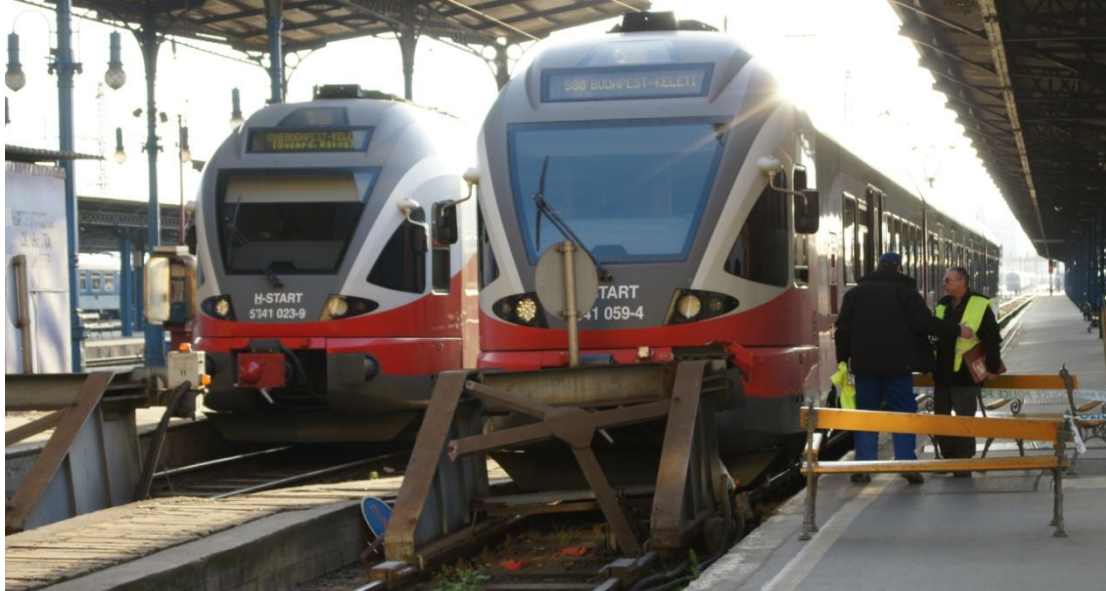
Factual statements directly related to the occurrence of the event

The IC attributes the occurrence to human factors on the part of the locomotive driver who very probably fell asleep for a short time during the approach and before the stop, and thus, he failed to stop the train in front of the buffer stop.

The IC proposed a safety recommendation relating to a review of the design of buffer stops.

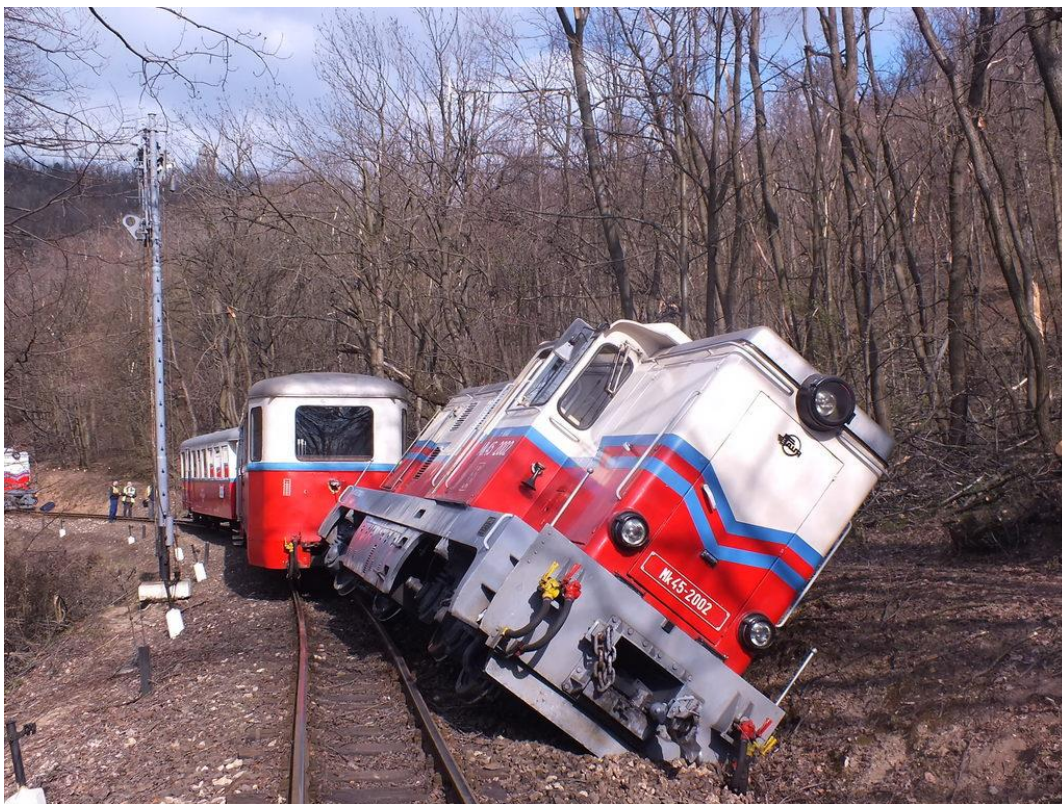
The IC found that there was a minor plane distortion in the railway track, and there was a significant directional error, the rails were worn out at the side, with a rough surface. The wheel load on the critical wheel of the locomotive was lower than expected, and additionally, the movement of the bogie was slightly obstructed.

Factual statements directly related to the occurrence of the event

The wheel load of the locomotive dropped at the moment of derailment

As the maintenance of the railway track is performed on the basis of a set of outdated and incomplete rules issued 54 years ago, the IC proposes a safety recommendation relating to a revision of the track maintenance rules.

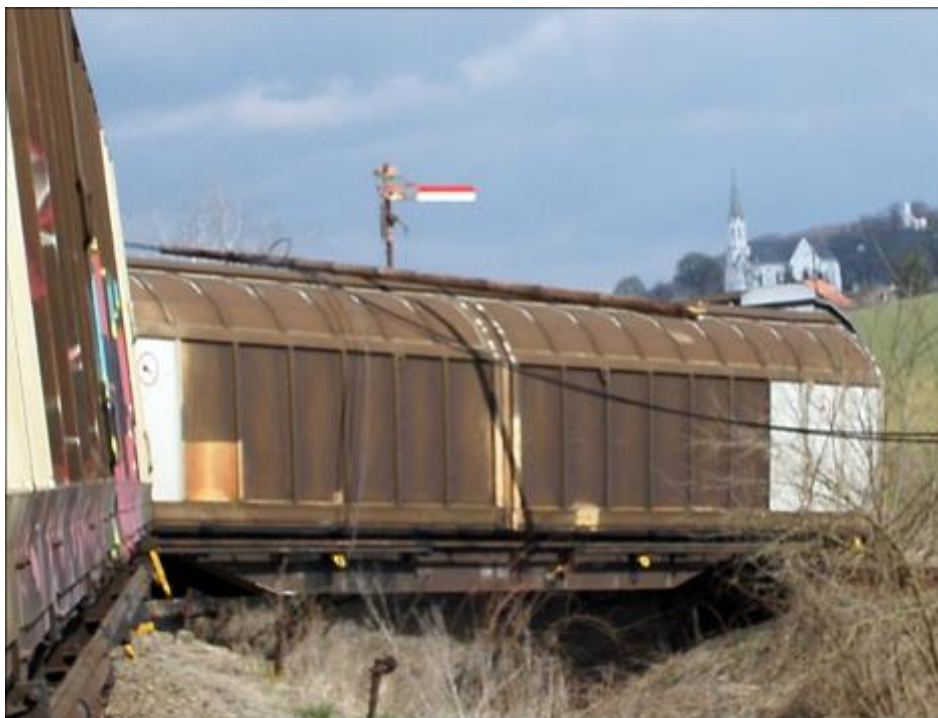
Factual statements directly related to the occurrence of the accident

In the opinion of the IC, the occurrence may be attributed to human factors, as the switch No. 1 of Nógrádszakál station was set to straight direction position before the train No. 83331 left it, and without an authorisation given to the pointsman, and as a result of that, the bogies of the last but one wagon in the train set ran on different tracks, and the wagons derailed.

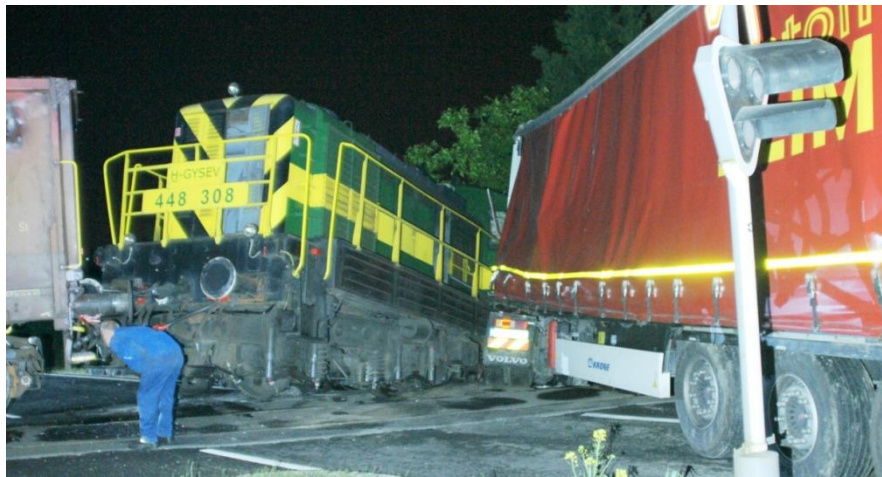
The warning lights protecting the level crossing were unserviceable (black) at the time of the occurrence.

**Factual statements directly related to the occurrence of the event**

The IC attributed the accident to human factors on the part of the truck driver who entered the level crossing without stopping and checking the possibility of safe crossing, despite the fact that nothing prevented him from perceiving the train approaching from the left at low speed.

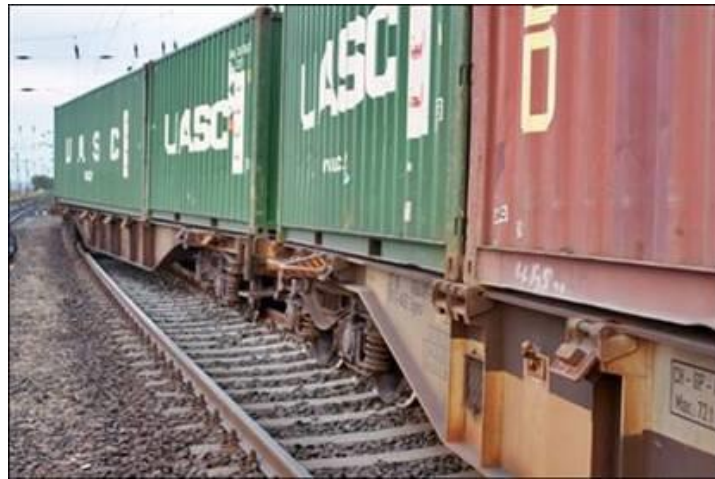
Due to the curve geometry of the track, some lighter wagons in the middle of the train were lifted by the heavier, yet unbraked wagons running behind them, which made the lighter wagons derail.

A contributing factor to the occurrence was that the buffers of the vehicles involved in derailment were unlubricated and made the sliding of the surfaces more difficult, thus increasing the willingness of the wagons to derail.

Factual statements directly related to the occurrence of the event

Based on available data, the IC concluded that the event had occurred as the resultant of the combined effects of various factors which were independent of one another. None of those contributing factors would have been sufficient in itself to produce the event, but their combined effect was.

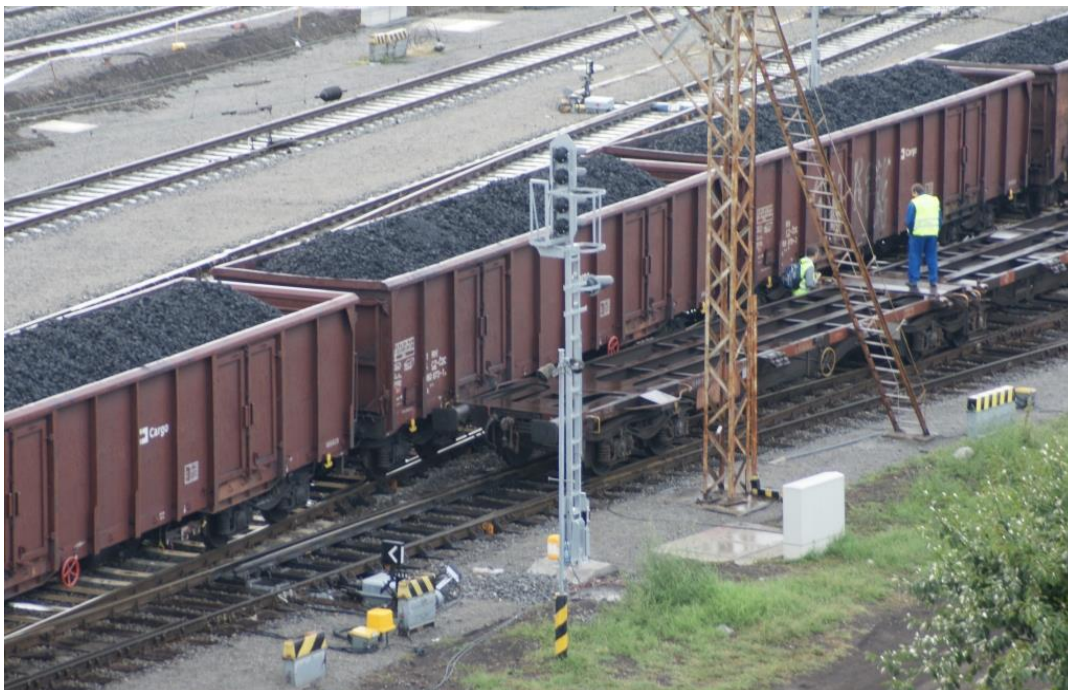
The IC found that the mistake made during the preparation of the diagrams was not revealed by the inadequate plan inspection process. However, the overcrowded traffic at the station with decreased capacity (due to construction works) also contributed to the occurrence.

Factual statements directly related to the occurrence of the event

The train № 44463-2 stopped with its tail remaining outside the shunting limit signal

As the quality of organisation of implementing a safety installation plays a decisive role in revealing possible mistakes in the design plans, the IC proposes that a safety recommendation be issued relating to a more accurate regulation of the certification process.
