MINISTRY FOR
INNOVATION AND TECHNOLOGY
TRANSPORTATION SAFETY BUREAU

ANNUAL REPORT 2018
Transportation Safety Bureau
Hungary

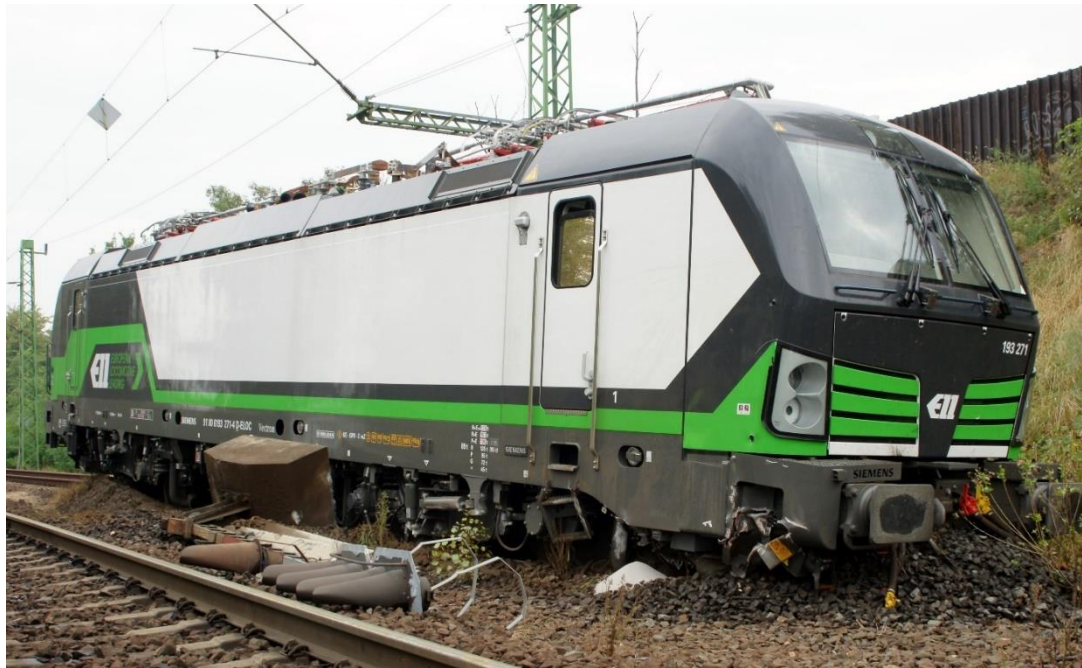
The locomotive type SIEMENS Vectron X4 was in shut-down state on the dead-end track № VI at Ferencváros Station, when it broke away. Bursting open the switch № 78 it rolled out through Track VI of the station, in the direction of the station in Soroksári út, it entered the right hand side track, covered a distance of ca. 4.5 km, when it was directed on the dead-end track № III of Soroksár Station, where it derailed with 4 bogies on an pile of earth at the end of the truck, while it hit the entry signal 'C' over.

No one was injured in the occurrence; the locomotive was damaged.

Figure: The locomotive hit the earth pile and derailed

The investigation found that, due to contamination in the triple valve, the spring brake had been able to get released without external impact within a short time (ca. 20 minutes), rendering the properly (i.e. in the manner specified in the operation manual of the locomotive) shut-off locomotive unfastened (unbraked).

There was contamination in the triple valve of the properly shut-off locomotive, which made the valve leak, which in turn allowed pilot pressure of the redundant function to exhaust completely through the double check valve, as a result of which the brake cylinders got released while the spring brake remained released, so the locomotive became unbraked, and it broke away on the track which had a downslope of 7 ‰.

Till exploration of the defect by the investigation was pending, the companies which operate type Vectron locomotives in Hungary took action to provide that such locomotives be secured also by fixing chocks against runaway.

Till exploration of the defect was pending, Siemens cautioned all the companies operating Vectron locomotives worldwide of the potential source of danger, and suggested alternative shutdown and fixing methods (by manual bleeding of the spring brake) until the defect was found.

After the defect was found, SIEMENS started to replace all type DRV7D-TSO double check valves with type DRV7-T double check valves in all Vectron locomotives affected.

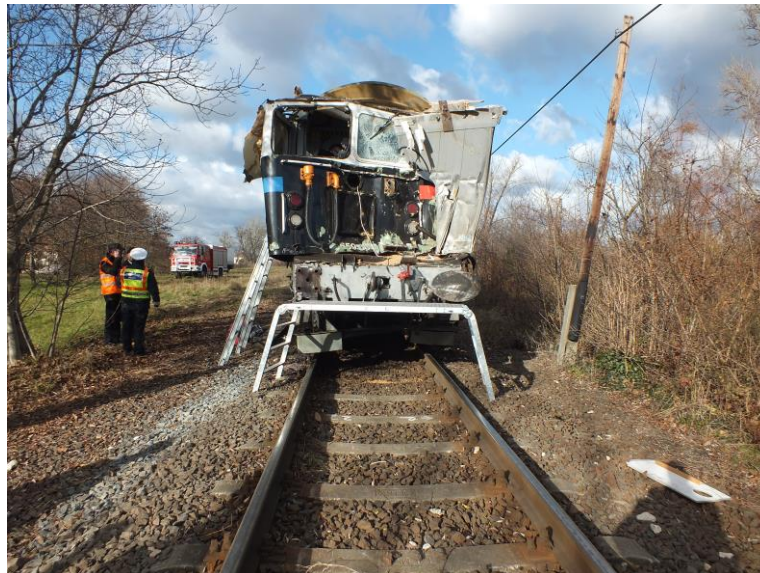
The front of the locomotive was badly damaged, as well as the tractor and the trailer; the level crossing and the railway line were closed to road and railway traffic for the duration of the investigation of the scene. Hazardous material did not spill into the environment from the 16 tank wagons carrying petroleum derivative. One bogie of the locomotive and one bogie of the second wagon derailed.

The position of the IC is that the accident occurred due to human factors on the part of the truck driver.

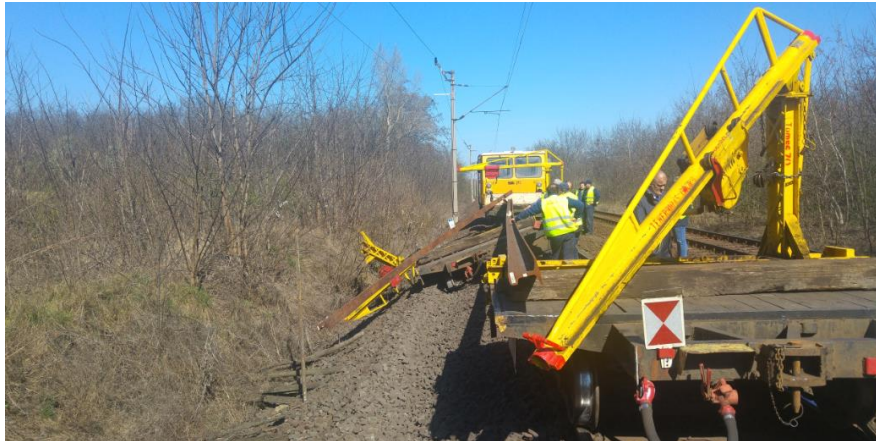
On 28 March 2017, at 09:19 am, the crane of a rail-carrying work train № 14449 departing from Dunaújváros station hit the entry signal “A”. The third wagon of the train derailed after the collision.

The IC found during the on-site investigation that the accident had been caused by the folded-out state of the boom of the crane. While the train was moving, the part reaching beyond the loading clearance hit the post of the entry signal, and the forces of the crash caused the third, rail-carrying wagon to derail. No one was injured due to the occurrence.

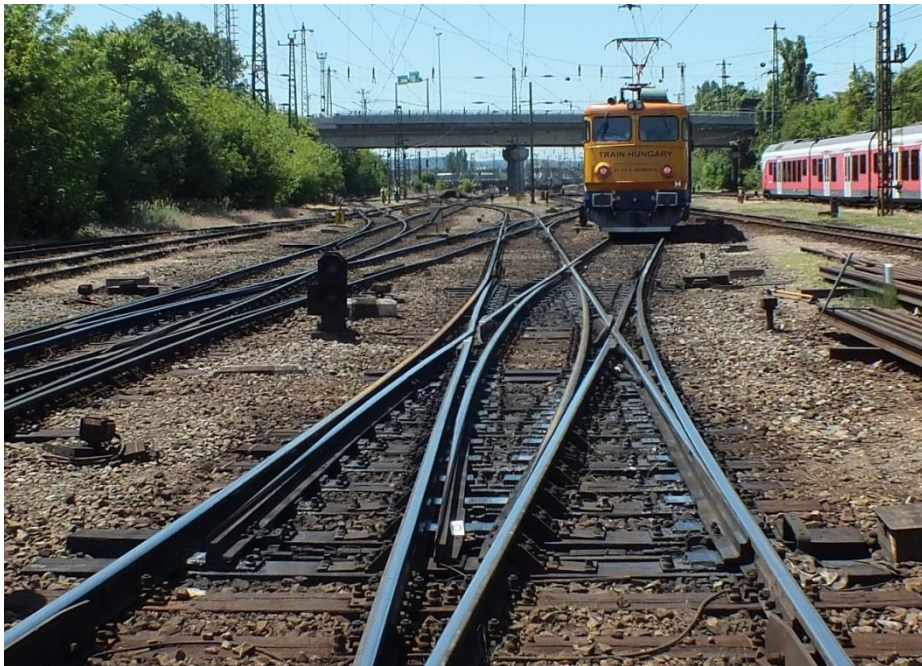
At Ferencváros station, a light engine arriving on a closed route was detoured (not in the direction determined by handling the safety installations) by a switch. The investigation found that the actuator apparatus of the switch tongue had come apart, which made the light engine derail, and then get back on the track again.

According to findings of the investigation, a connecting bolt between the switch tongue and its tab had loosened and broken, which the maintenance personnel did not realise; in addition, for design reasons, the safety installation had not detected the inappropriate position of the switch tongue.
