MINISTRY FOR  
INNOVATION AND TECHNOLOGY  
TRANSPORTATION SAFETY BUREAU

**ANNUAL REPORT 2019**  
**Transportation Safety Bureau**  
**Hungary**

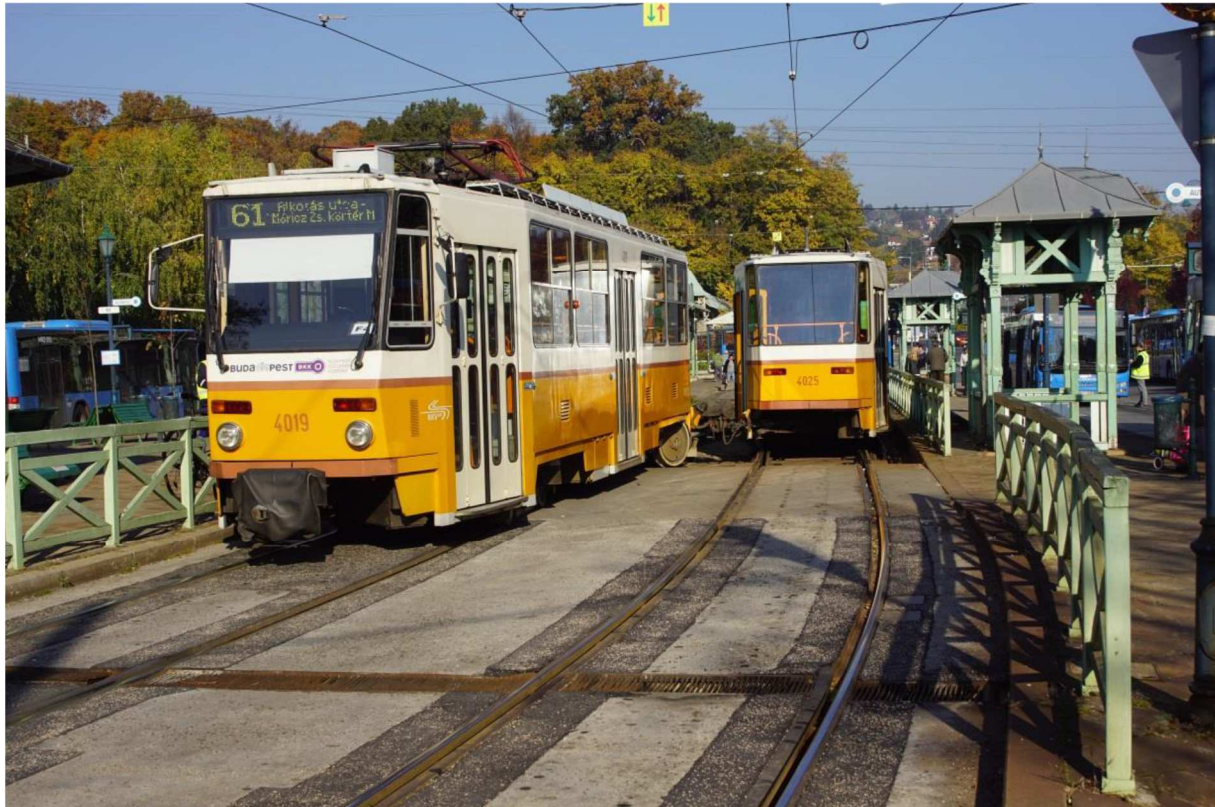
During the investigation at the scene, the IC found that the cause of derailment was the loose state of the straight switch tongue caused by breaking of the pull rod.

**Figure: The derailed tram**

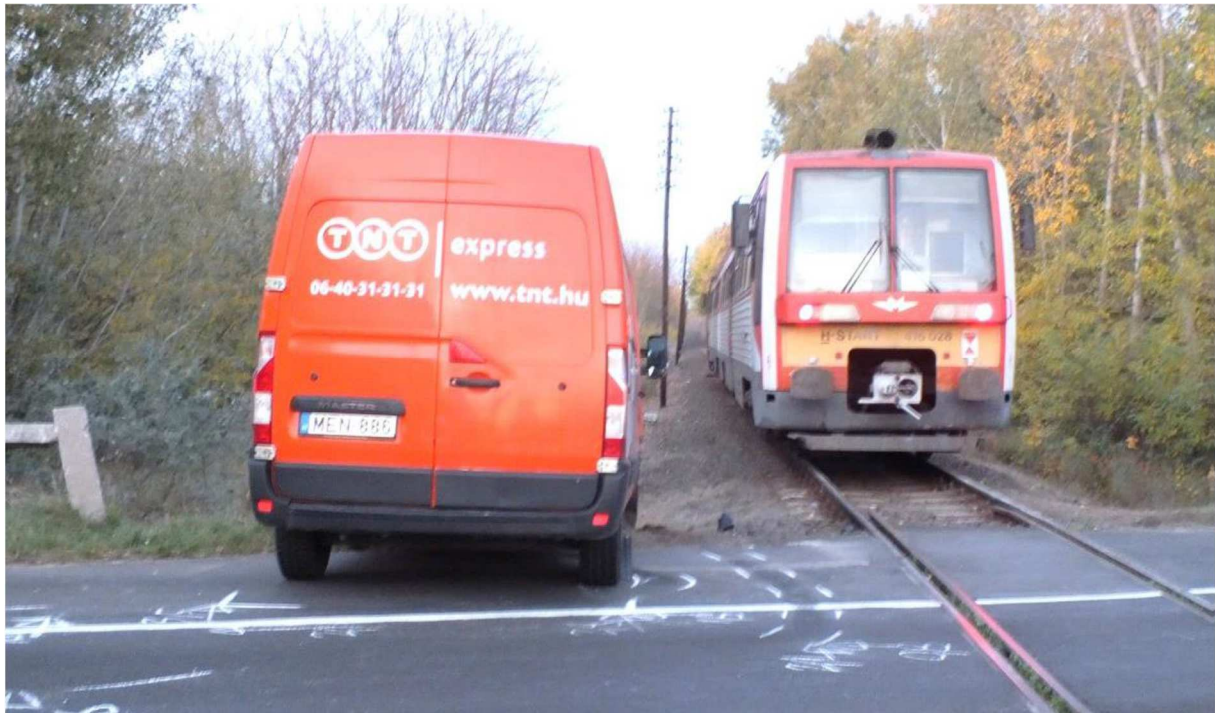
According to the IC, the cause of the accident was the dark state of the road barrier and a human factor on the part of the driver of the automobile.

**Figure: Positions of the vehicles following the collision**

The IC proposes a safety recommendation relating to the occurrence so that the locomotive driver approaching a level crossing in break-down state can be notified of a situation which is potentially dangerous for the train and can control the speed of his train accordingly.

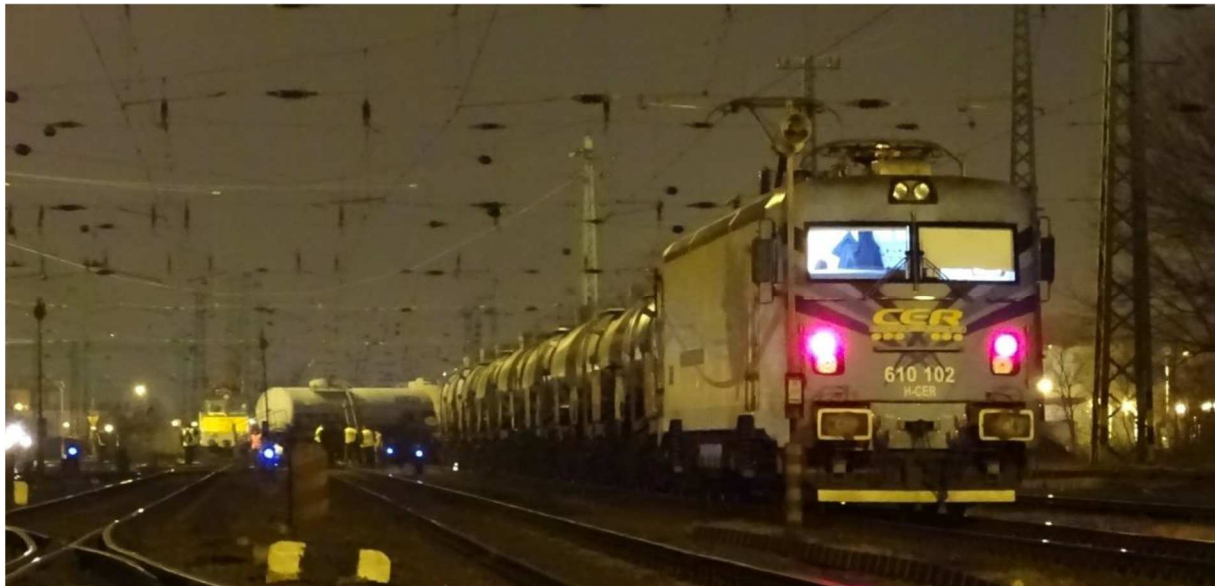
The cause of the loosening of the wheel rim could not be established clearly, but probably the decrease (approaching the lower limit) of the thickness off the wheel rim largely influenced the loosening of the wheel rim, and the lack of combined marking of the two pieces hindered the detection of the beginning dislocation.

The position of the IC is that loosening of the wheel rim may sometimes occur with the wearing of the wheel rim and can usually be identified by following the relevant inspection methods (combined marking of the wheel rim and the wheel) therefore the IC found no reason to propose a safety recommendation.

**Figure: The freight train and the derailed wagon**

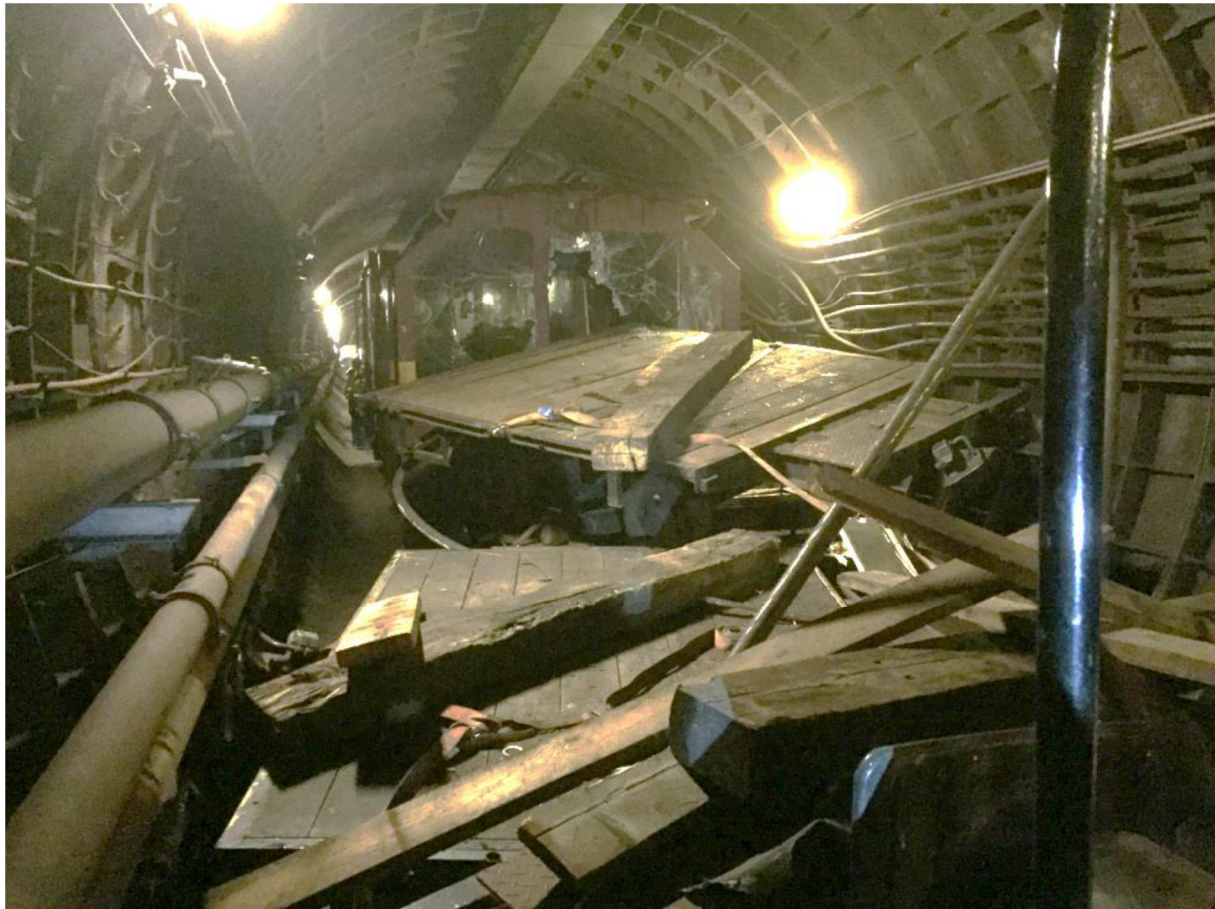
**Figure: Scene of the accident (Photo: BKV Zrt.)**

Therefore TSB issues a safety recommendation relating to the practice of managerial inspection of the company involved.

During the investigation, the railway company took action to modernise the data recorders of the vehicles, and to appropriate protection and marking of the people working on the railway lines.

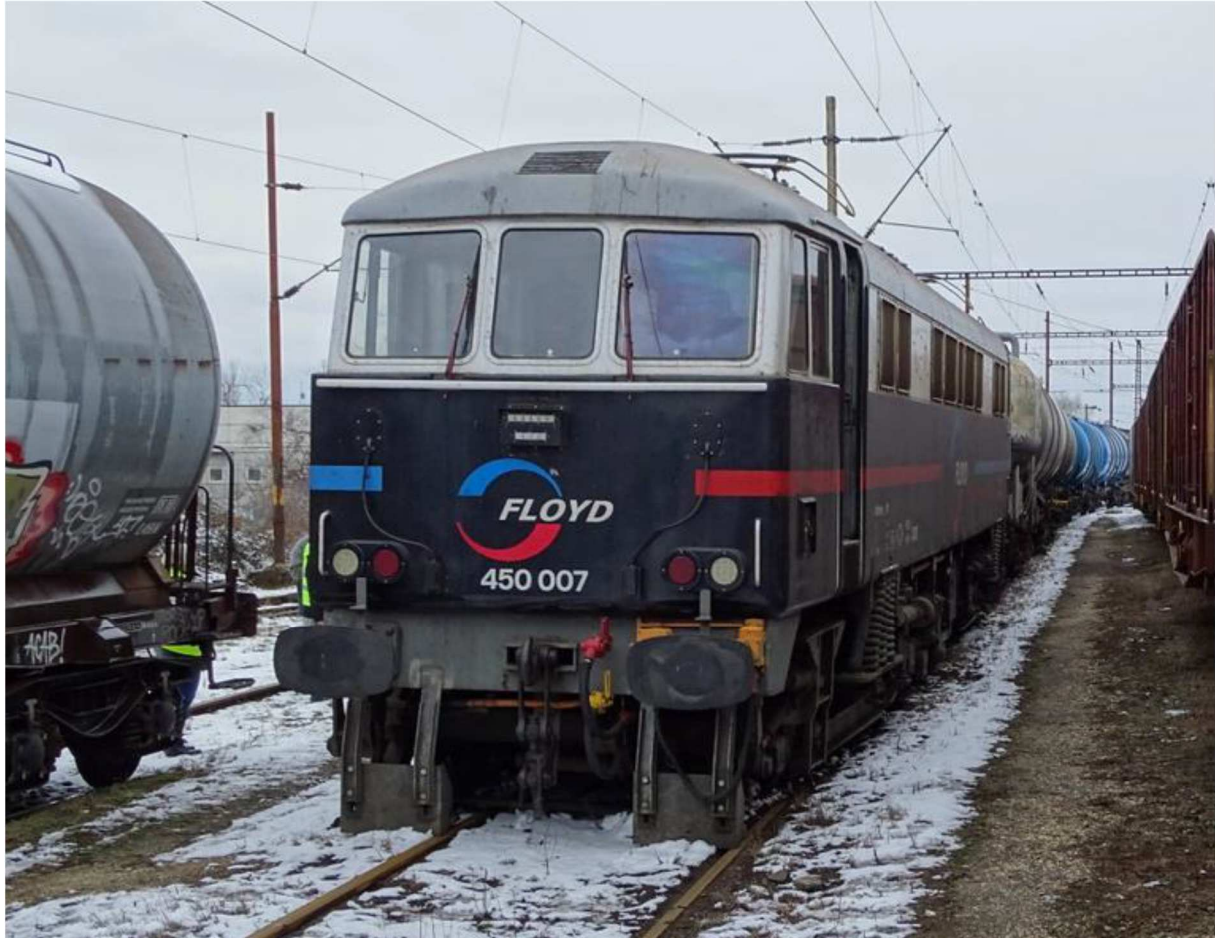
The locomotive with Reg. № 91 55 0450 007-4 of the train № 44281 derailed with one axle while approaching Soroksári út Marshalling Yard via Track X.

The IC attributes the occurrence to the worn-out condition of the track. In addition, the axle load of the locomotive slightly exceeded the limit for the given track, which cannot be directly related as cause to the occurrence, but increases safety risk.

**Figure: The locomotive which derailed**

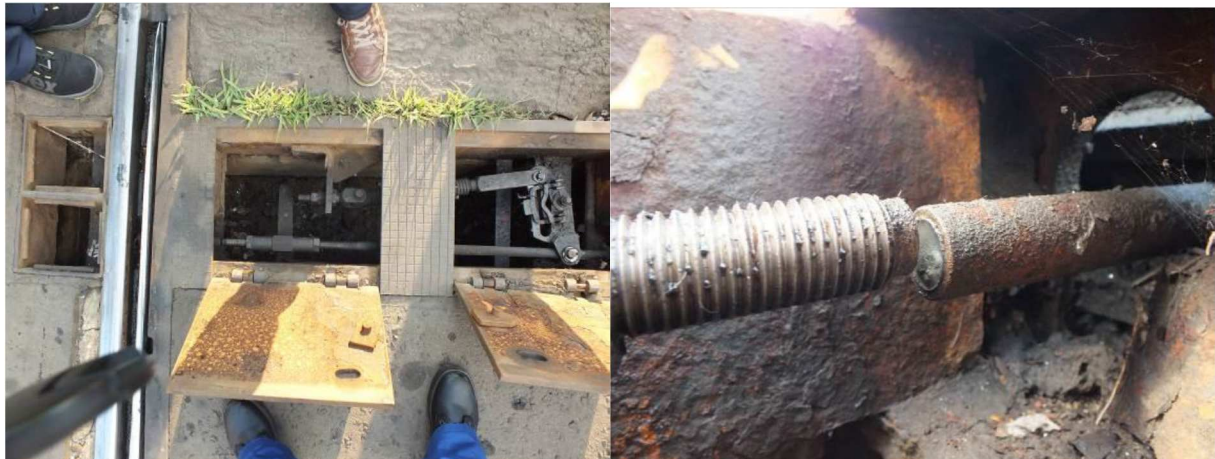
The IC attributes the occurrence to a fatigue fracture of the pull rod in the switch, which took place when the tram was rolling over the switch. The fastening of the switch tongue was loosened by such fracture, so the third bogey of the tram went on straight, unlike the others ahead of it, and the vehicle derailed due to the resulting forces of stress.

Possible cracks of the pull rods cannot be identified by visual inspection, and a crack testing would be disproportionately costly. The safety risk caused by the lack of testing is low, i.e. acceptable. A BKV Zrt. intends to prevent similar occurrences by replacing similar switches by modern devices (in which the likelihood of similar defects is lower) in more frequented, heavy-duty areas.

**Figure: Fracture of the short pull rod**

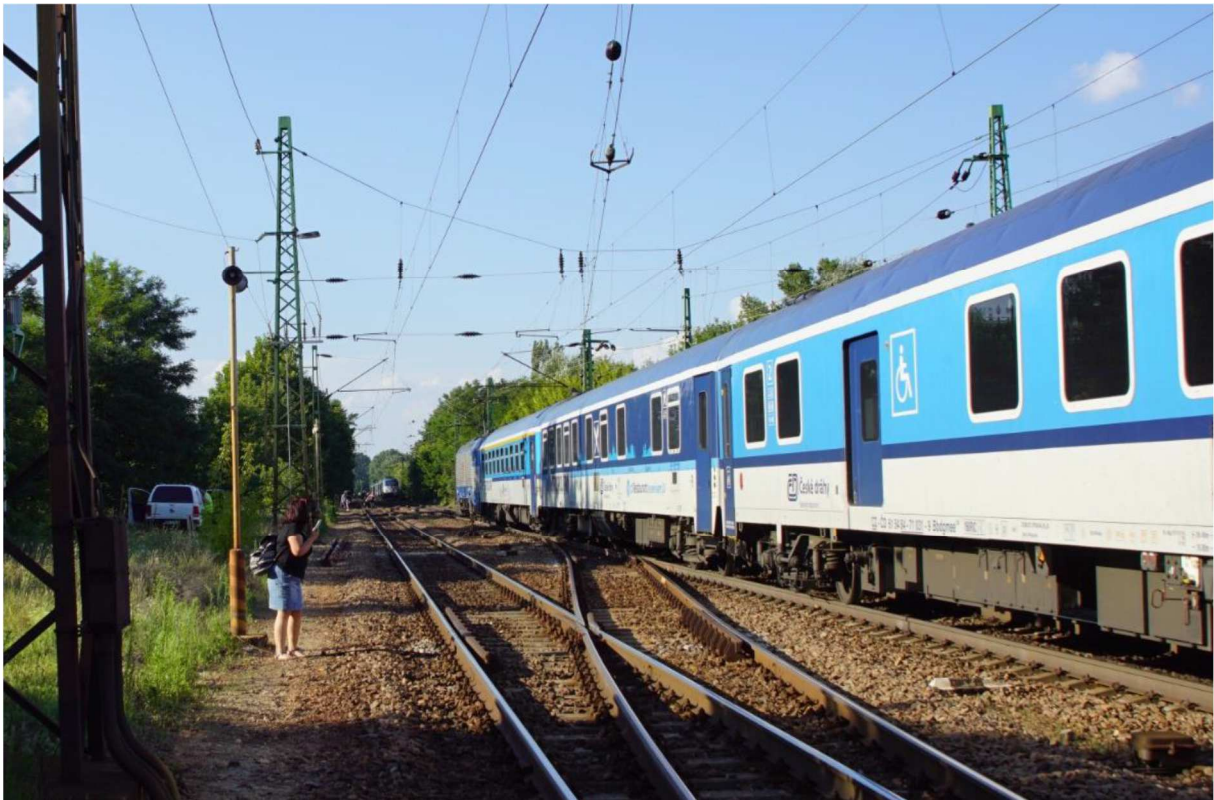
It contributed to the occurrence that other activities (closing the entry door, sitting down and getting settled) distracted the locomotive driver’s attention after departure, and that the senior ticket inspector did not observe the exit signal either before giving authorisation to the locomotive driver to start.

**Figure: Positions of the two trains relative to each other after the occurrence**

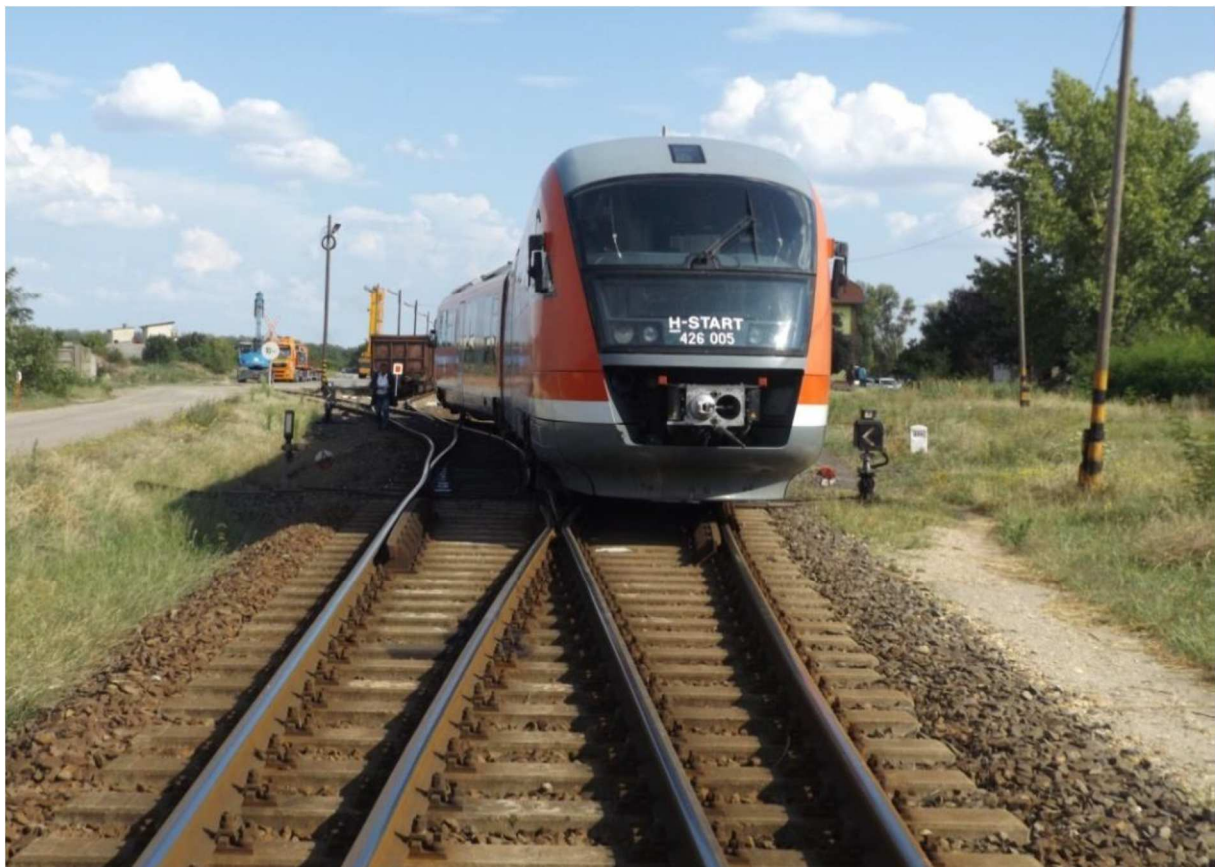
While positioning the hand-operated switch, the pointsman did not realise that both the straight and the curved switch tongues were lying against the stock rail.

**Figure: The derailed motor train set**

TSB maintains its Safety Recommendation issued relating to the occurrence of 8 June 2017 at Ferencváros Station and investigated by TSB under № 2017-0720-5: is the reliability of the switch tongue – point rod – control rod connection sufficient or is it necessary to integrate the inspection thereof into the rules of the safety management system. An appropriate addition would considerably improve detection of similar defects and prevention of similar occurrences.

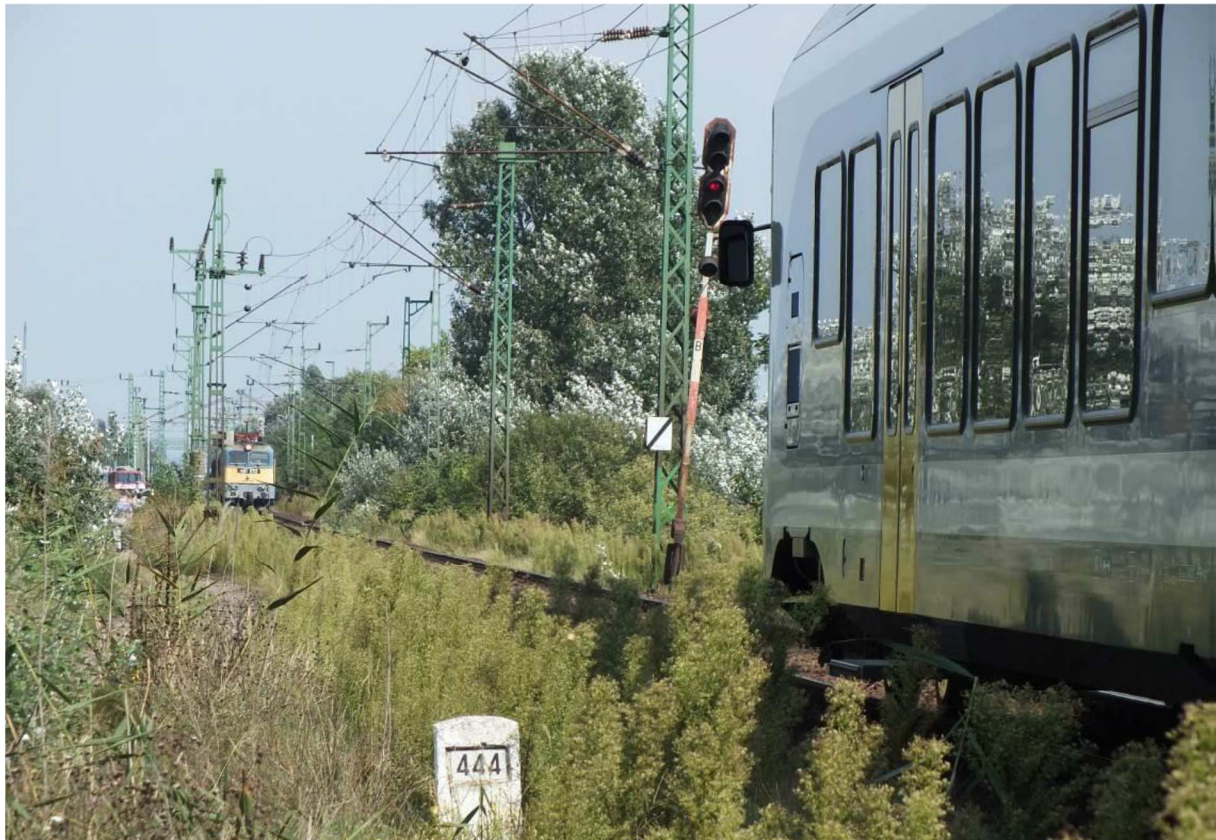
At Dömsöd station, the train № 343-2 , which was moving through according to schedule, passed the V3 signal at danger without authorisation, then burst the switch № 1 open, and stopped 62 metres after the switch. The train № 7927, coming from the direction of Kunszentmiklós-Tass and approaching the down-side entry signal of the station stopped before such entry signal; the distance between the two stopped train was 380 metres.

The IC attributed the occurrence to human factors on the part of the locomotive driver, but misleading, attention-diverting circumstances were also found.

**Figure: The trains after they stopped**
