MINISTRY FOR  
INNOVATION AND TECHNOLOGY  
TRANSPORTATION SAFETY BUREAU

# **ANNUAL REPORT 2020**

## **Transportation Safety Bureau**

### **Hungary**

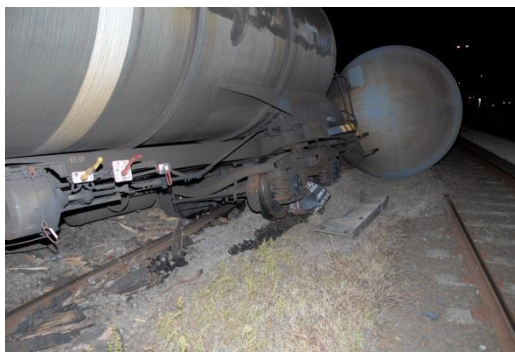
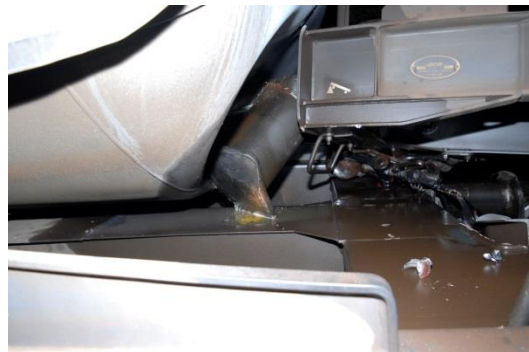
A freight train from the direction of Szombathely was approaching through several switches in diverging direction to Track V at Vép station when seven of its tank-cars derailed, two tipped over to the side, and one got back on track. Two tank-cars were damaged to such extent that their consignment (ca. 100 m<sup>3</sup> diesel oil) spilled on the ground.

The track and the derailed tank-cars were badly damaged. A large quantity of top soil had to be replaced due to the damage to the environment.

The investigation found that the poor condition of the track played a direct role in the accident; the track supervision system had known of the problem, but no effective action was taken before the accident.

#### The derailed wagons and the spilled oil

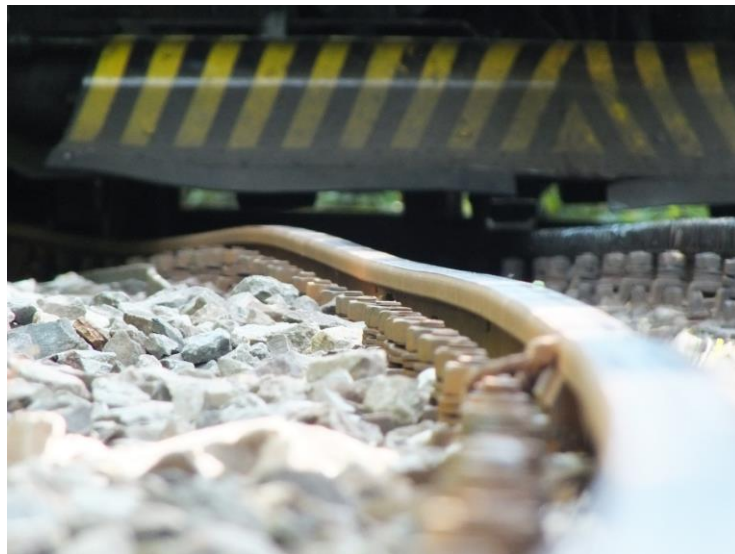
On 03 June 2019, in Budapest, a train actually used for driver training, running on the rack railway line (marked as tram line no. 60) derailed with one bogie. On 01 August, the same train derailed again, at the same location, now with passengers on board.

In addition to the investigation conducted by TSB, the operator's engineers tested the vehicle as well. The occurrence was attributed to track distortion and to low track distortion tolerance of the vehicle.

**The track distortion at the derailment point**

The IC proposes that safety recommendations be issued relating to:

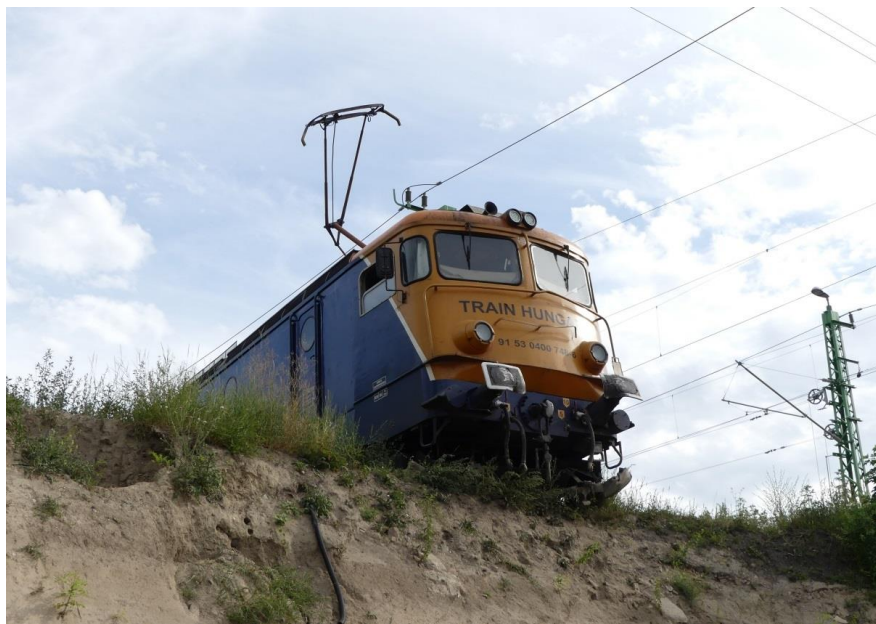
During the investigation, doubts emerged in connection with the reliability of the train control system, even the possibility of its deactivation was raised, but, neither the tests nor data from the data recorder confirmed any error or erroneous management which would have affected the occurrence.

**The final stop point above the road**

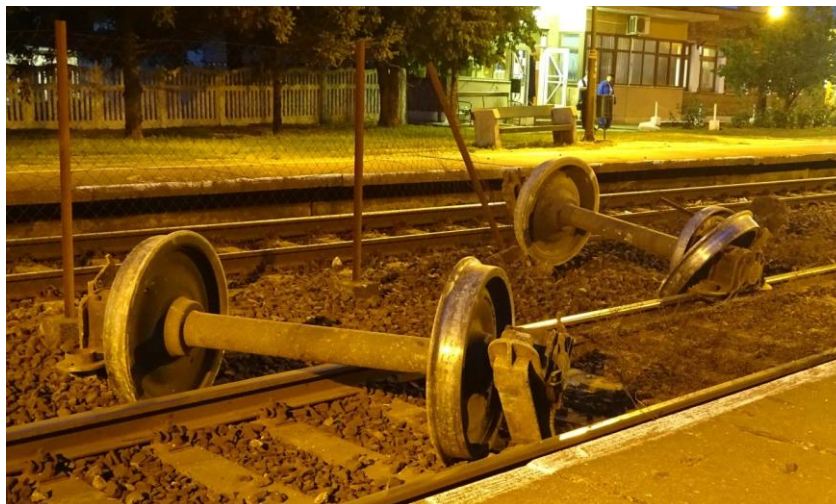
The cause of loosening of the rim wedge was not clearly identified, but it was probably influenced by the fact that the thickness of the wheel rim was close to the relevant lower limit.

Wear-out of the wheel rim may lead to loosening of the rim wedge rarely, but it may be identified by following the relevant inspection methods therefore the IC does not find it necessary to issue a safety recommendation.

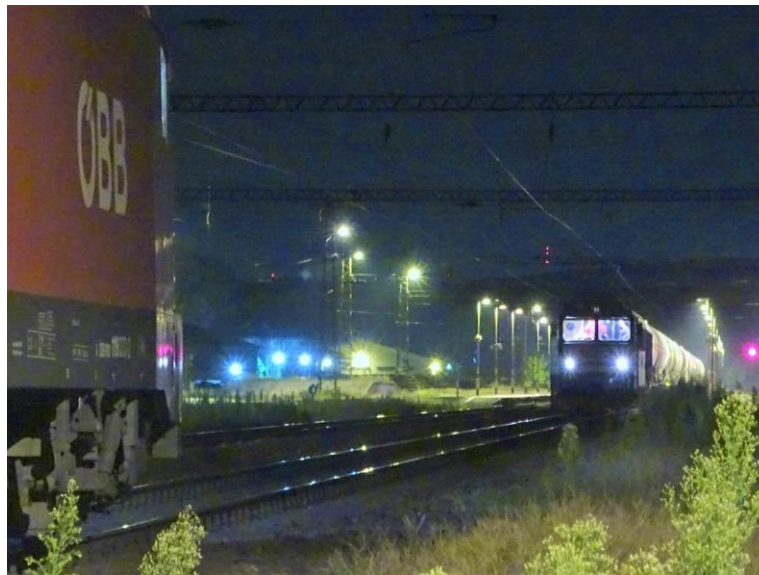
Due to a braking problem, the train № 47285 stopped between Bicske and Herceghalom stations at 01:15 o'clock on 06 September 2019. After finding and eliminating the problem, the train continued its journey at 01:47. At Herceghalom station, the train overran the entry signal at danger, burst the switch № 11 open, and stopped opposite the freight train which had been scheduled to transit there but stopped in the meantime. The distance left between the two stopped trains was 140 metres.

The IC attributes the occurrence to a dramatic brake malfunction occurring in one of the train's wagons and to human factors on the part of the locomotive driver. It was found that, due to the disabling of brakes in order to clear the track, the braking effect in the train decreased to such extent that the train had not been able to stop in front of the entry signal from the speed selected by the locomotive driver. The actions taken by the locomotive driver did not reflect any intent to apply the rules applicable in similar situations.

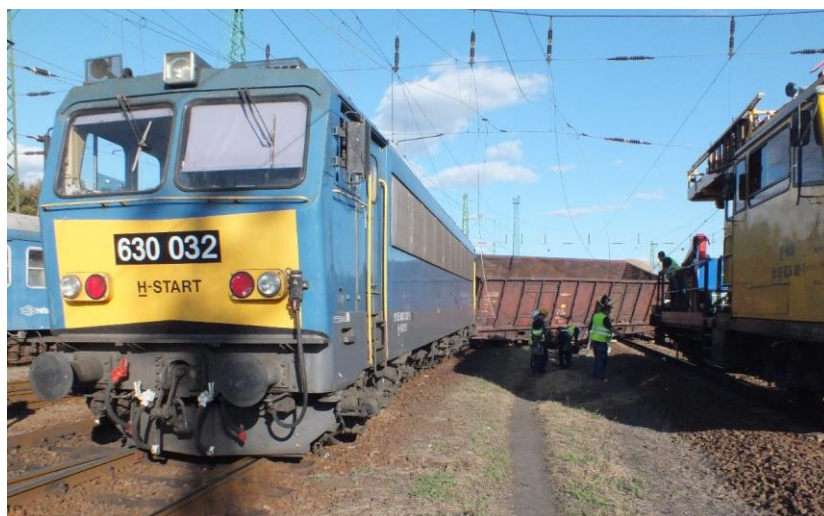
On 18 September 2019, at 14:30, the freight train № 45233 was approaching Miskolc-Tiszai station on a locked route, with signal handling. The train would have travelled on a crossing turnout from a main track to a main track, but its locomotive derailed with its two front axles on the turnout and was guided to a secondary track. The leading wagon derailed with 4 axles and was dragged crosswise relative to the track axis. No one was injured.

The IC found at the scene that, at the 'a' end of the crossing turnout, the securing of the pin was missing from the connection of the left switch tongue attachment, the stretcher bar and the control rod. As a result, the pin slipped out, and the switch tongue got critically close to the stock rail, which led to derailment of the train. The IC's position is that the occurrence was due to technical malfunction which may be attributed to human factors.

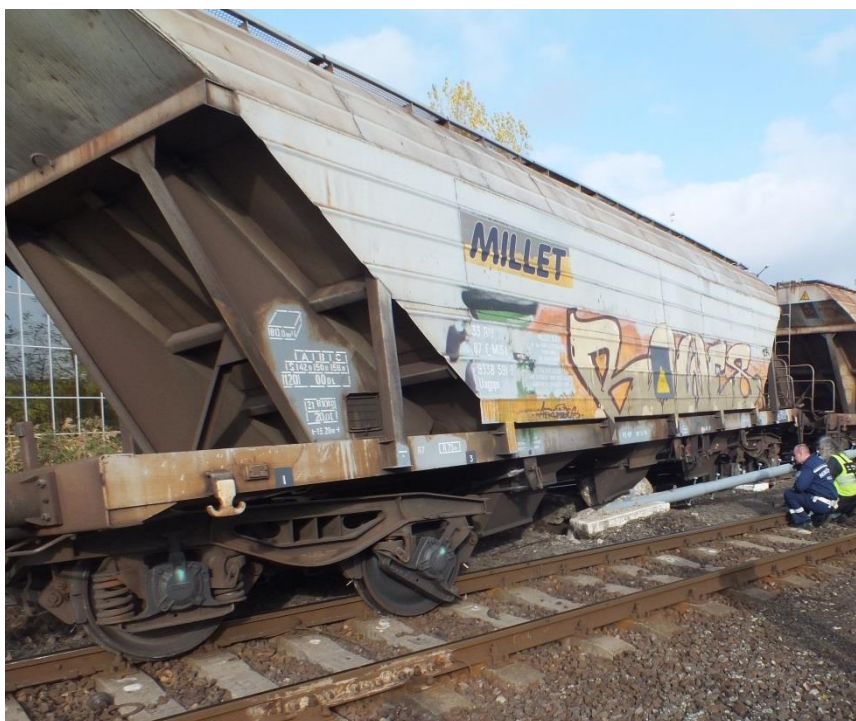
The IC found during the investigation that the pointsman had changed the (№ 6) switch position under the 29<sup>th</sup> wagon of the approaching train, to which a technical error of the safety installation also contributed.

Relating to the accident, TSB issues a safety recommendation proposing that the long-known possibility of failure of the type Siemens-Halske safety installations should be presented in the operation manual of the safety installations concerned.

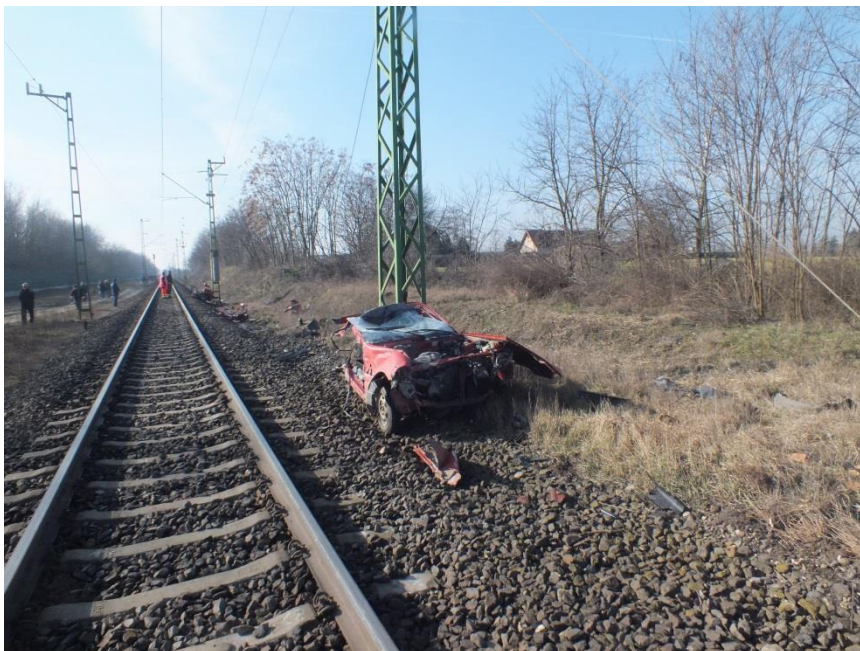
On 16 February 2020, the train № 712 collided with an automobile at the level crossing (SR1) protected with serviceable warning lights at Katonatelelep station. Two children, as passengers of the automobile died on the spot, and the driver of the car was injured seriously.

The investigation found that the warning lights had worked correctly, showing alternating red warning lights in the direction of the road at the time of the accident.

The IC attributes the occurrence to human factors on the part of the driver of the car, and found that the car had entered the level crossing despite the alternating red signal of the correctly working warning lights (SR1).
